# INSPECTION REPORT

**End of contract**

| License plate | 2APX672 |
| Make | Peugeot 5008 1.2PTech 96kW GT |

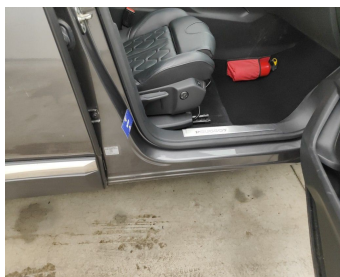
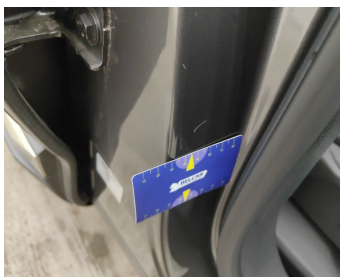
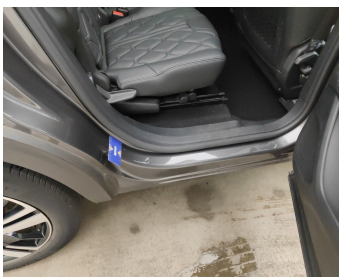
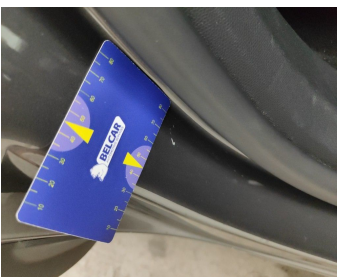
| Damages | Type | Acceptable |
|---|---|---|
| 202 | Rocker Panel Right // Painting | Y |

Rocker Panel Right // Painting-scratch

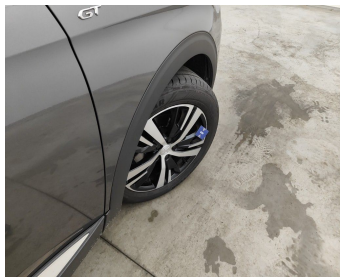
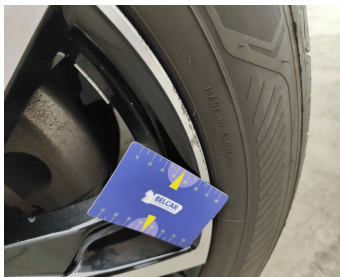
| Damages | Type | Acceptable |
|---|---|---|
| 340 | Wheel Two Tone Front Right // Repair | Y |

Wheel Two Tone Front Right // Repair-scratch

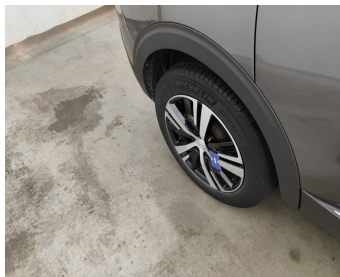
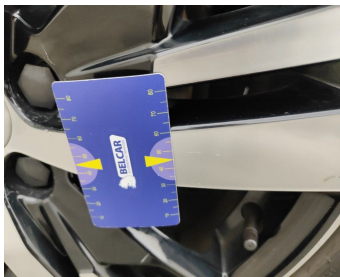
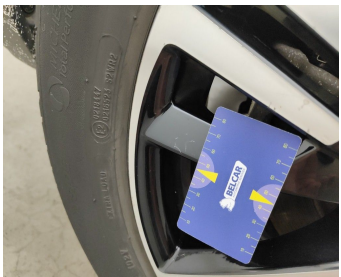
| Damages | Type | Acceptable |
|---|---|---|
| 330 | Wheel Two Tone Rear Right // Repair | Y |

Wheel Two Tone Rear Right // Repair-scratch

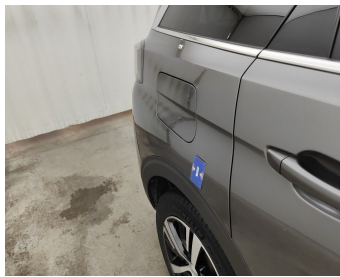
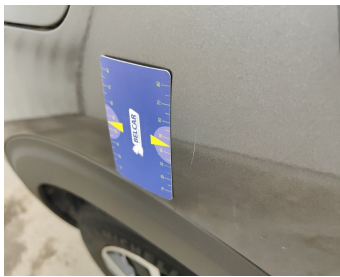
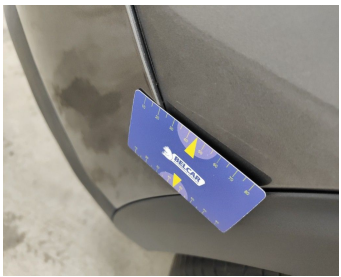
| Damages | Type | Acceptable |
|---|---|---|
| 186 | Wing Rear Right // Polish | Y |

Wing Rear Right // Polish-scratch

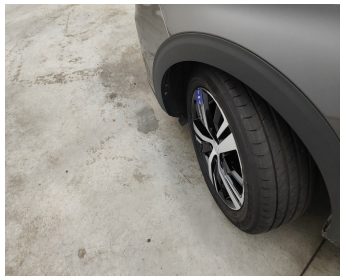
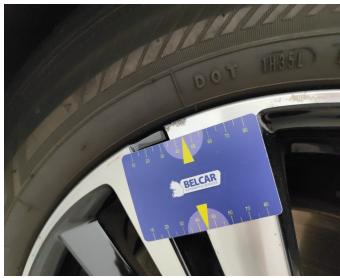
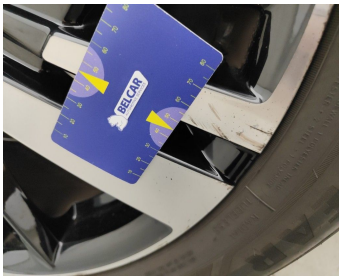
| Damages | Type | Acceptable |
|---|---|---|
| 310 | Wheel Two Tone Front Left // Repair | N |

Wheel Two Tone Front Left // Repair-scratch

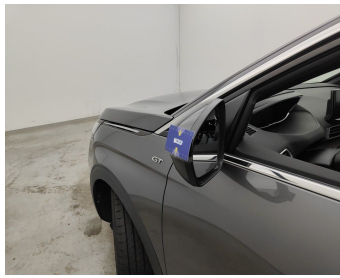
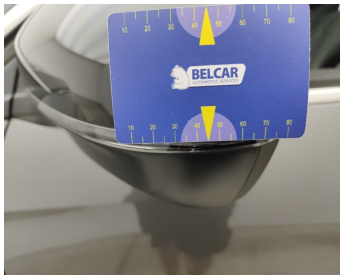
| Damages | Type | Acceptable |
|---|---|---|
| 78 | Side View Mirror Left / Direction Indicator / Replace | Y |

Side View Mirror Left / Direction Indicator / Replace-scratch

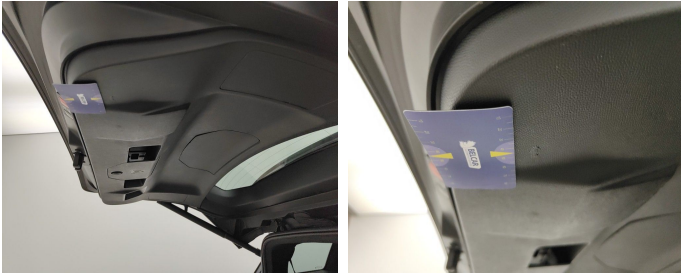
| Damages | Type | Acceptable |
|---|---|---|
| 594 | Trunk Lid Interior Coating / Complete Panel / Replace | Y |

Trunk Lid Interior Coating / Complete Panel / Replace-scratch

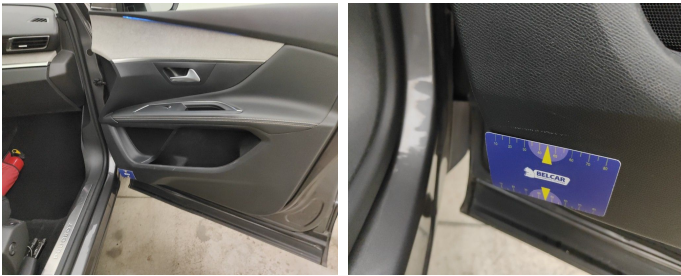
| Damages | Type | Acceptable |
|---|---|---|
| 624 | Front Right Door Interior Coating // Replace Completely | Y |

Front Right Door Interior Coating // Replace Completely-scratch

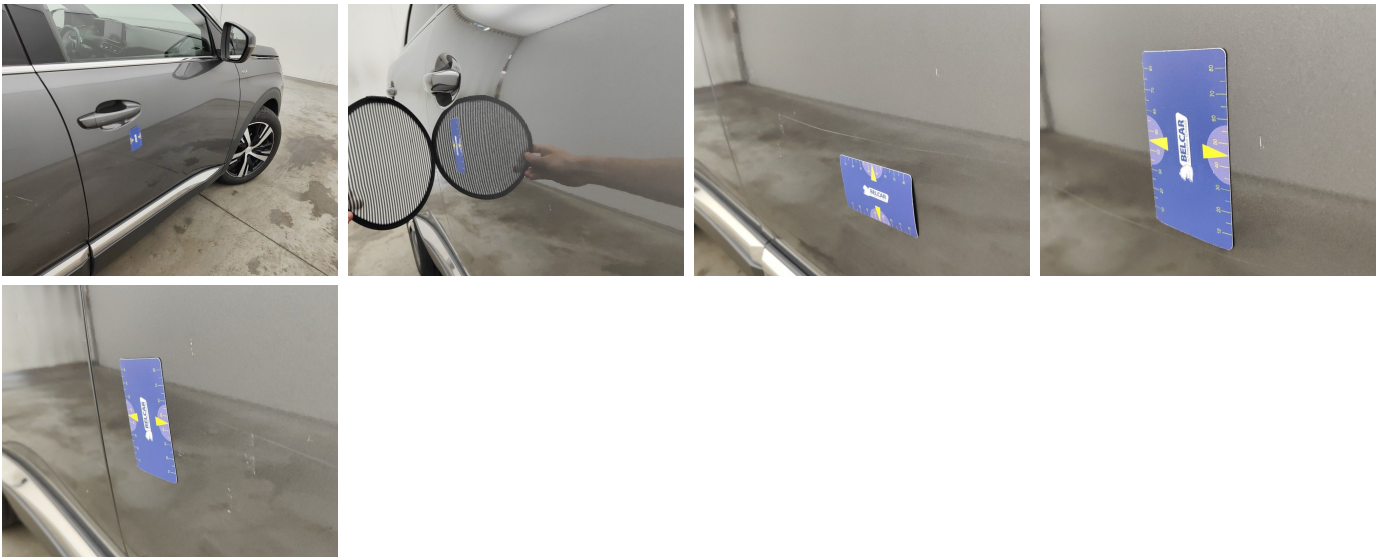
| Damages | Type | Acceptable |
|---|---|---|
| 210 | Door Front Right // Smart Repair Small | N |

Door Front Right // Smart Repair Small-dent

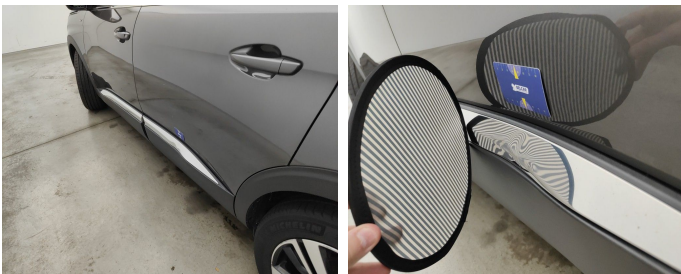
| Damages | Type | Acceptable |
|---|---|---|
| 107 | Door Rear Left / Trim / Replace | N |

Door Rear Left / Trim / Replace-dent

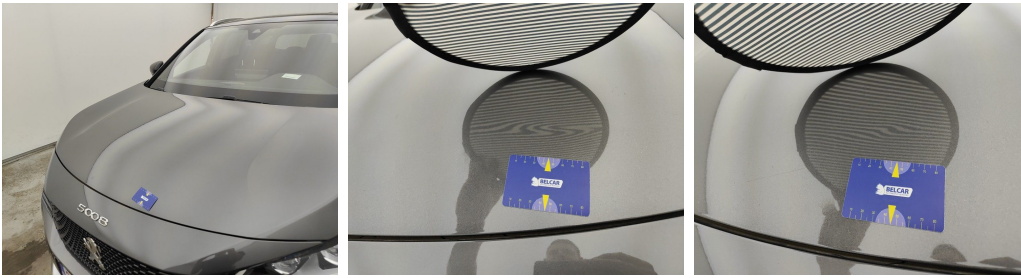
| Damages | Type | Acceptable |
|---|---|---|
| 31 | Front Bonnet // Smart Repair Small | N |

Front Bonnet // Smart Repair Small-dent

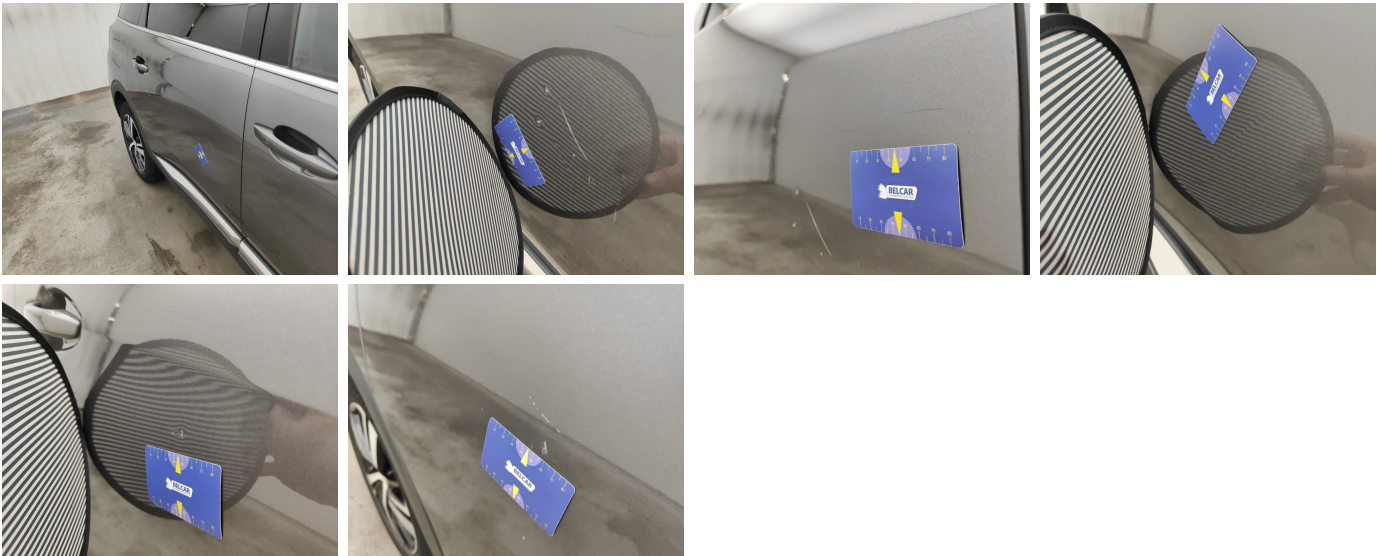
| Damages | Type | Acceptable |
|---|---|---|
| 194 | Door Rear Right // Repair & Painting | N |

Door Rear Right // Repair & Painting-scratch + dent

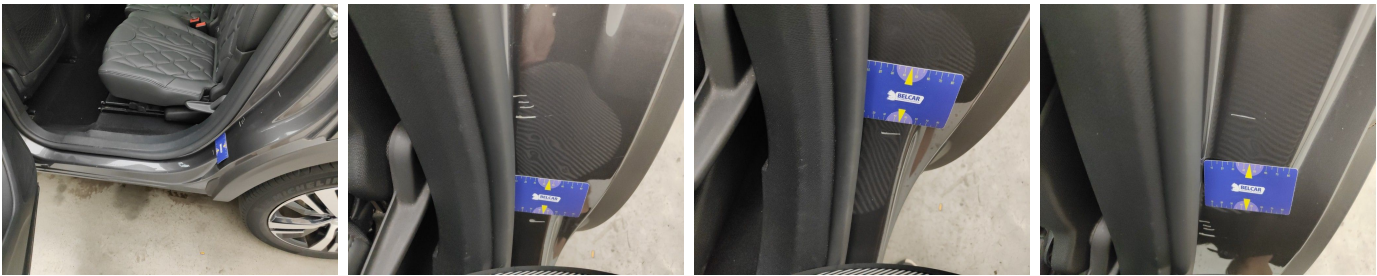
| Damages | Type | Acceptable |
|---|---|---|
| 91 | Rocker Panel Left // Smart Repair Medium | N |

Rocker Panel Left // Smart Repair Medium-scratch + dent

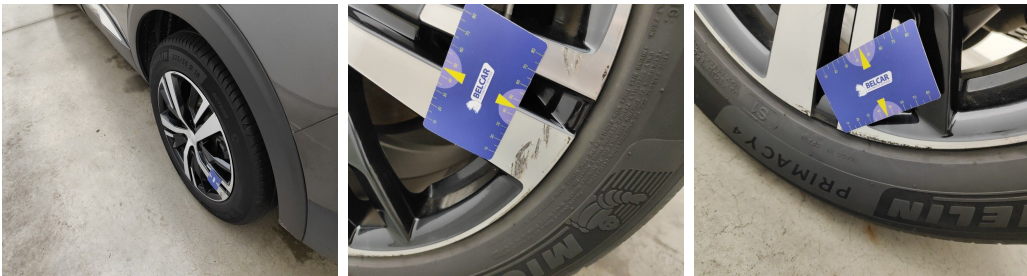
| Damages | Type | Acceptable |
|---|---|---|
| 320 | Wheel Two Tone Rear Left // Repair | Y |

Wheel Two Tone Rear Left // Repair-scratch

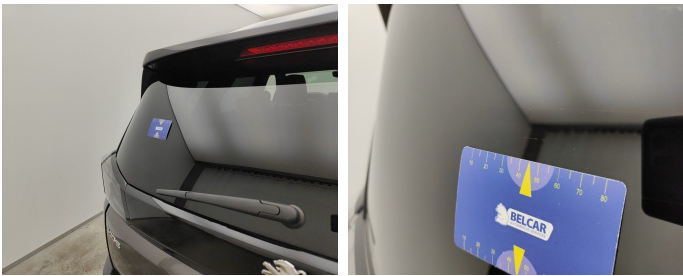
| Damages | Type | Acceptable |
|---|---|---|
| 159 | Rear Bonnet / Rear Window / Replace | Y |

Rear Bonnet / Rear Window / Replace-scratch

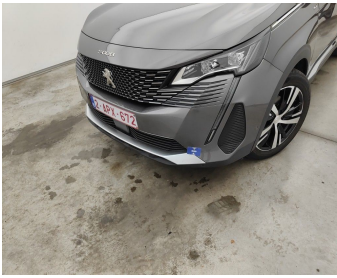
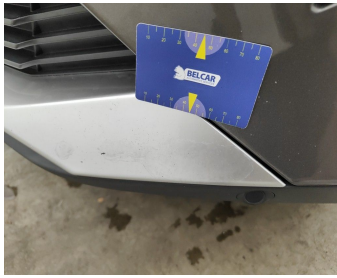
| Damages | Type | Acceptable |
|---|---|---|
| 18 | Bumper Front / Spoiler / Replace | Y |

Bumper Front / Spoiler / Replace-Chemical reaction

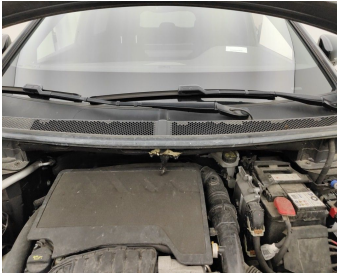
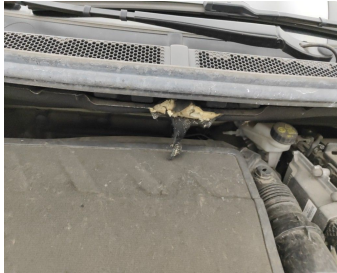
| Damages | Type | Acceptable |
|---|---|---|
| 39 | Engine Compartment / Silencer / Replace | N |

Engine Compartment / Silencer / Replace-tear

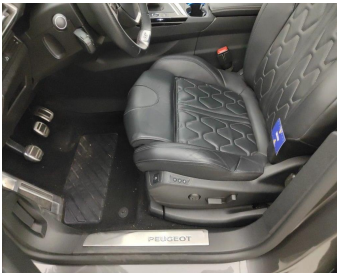
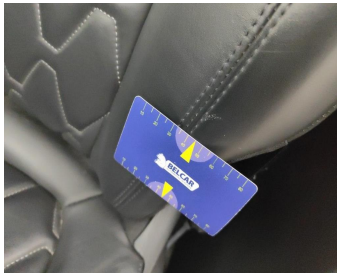
| Damages | Type | Acceptable |
|---|---|---|
| 413 | Seat Front Left / Rear Coating / Replace | Y |

Seat Front Left / Rear Coating / Replace-worn

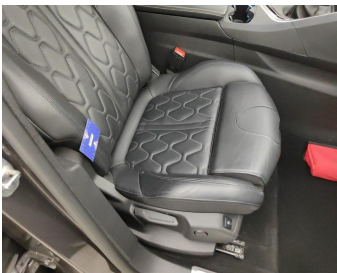
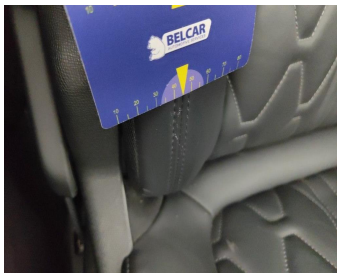
| Damages | Type | Acceptable |
|---|---|---|
| 423 | Seat Front Right / Rear Coating / Replace | Y |

Seat Front Right / Rear Coating / Replace-worn

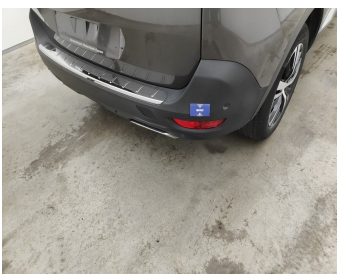
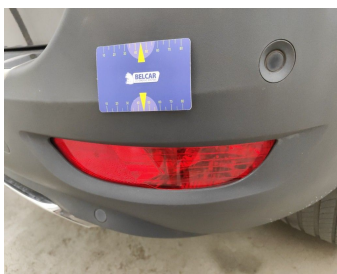
| Damages | Type | Acceptable |
|---|---|---|
| 148 | Back Side / Reflector R / Replace | Y |

Back Side / Reflector R / Replace-bad position

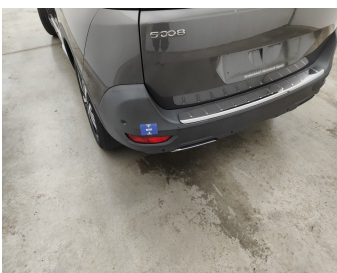
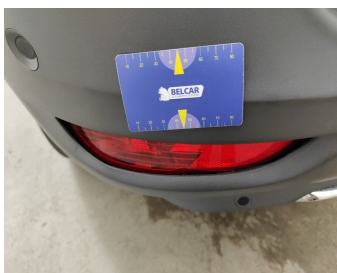
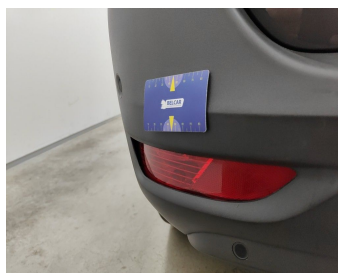
| Damages | Type | Acceptable |
|---|---|---|
| 146 | Back Side / Reflector L / Replace | Y |

Back Side / Reflector L / Replace-bad position

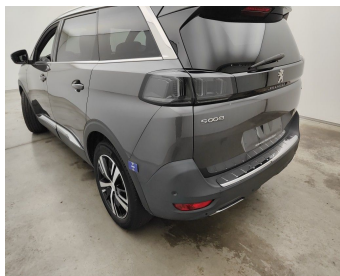
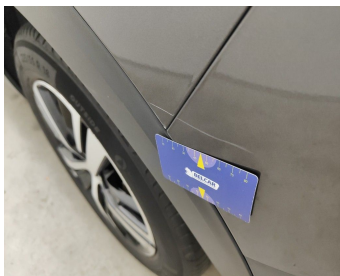
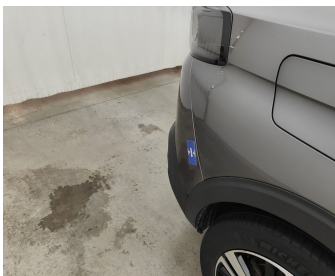
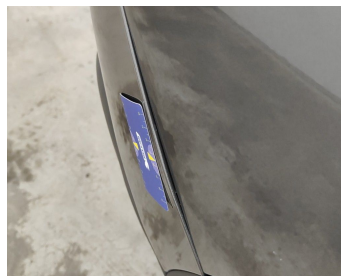
| Damages | Type | Acceptable |
|---|---|---|
| 134 | Bumper Rear // Repair & Painting | Y |

Bumper Rear // Repair & Painting-scratch

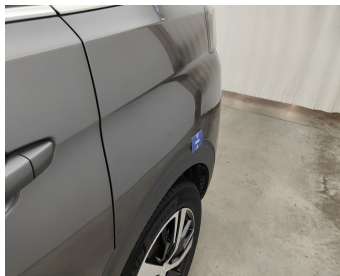
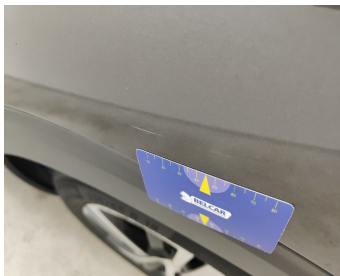
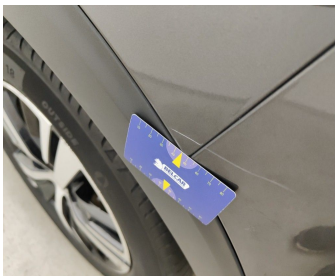
| Damages | Type | Acceptable |
|---|---|---|
| 113 | Wing Rear Left // Painting | Y |

Wing Rear Left // Painting-scratch

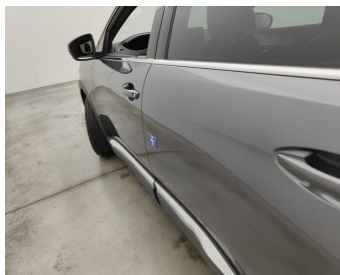
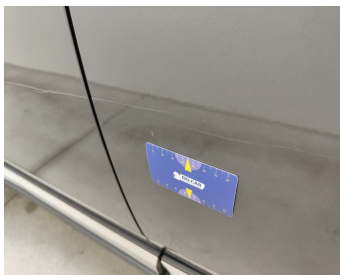
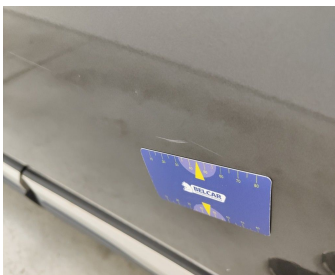
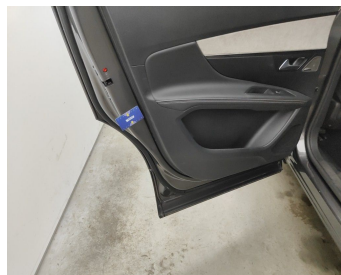
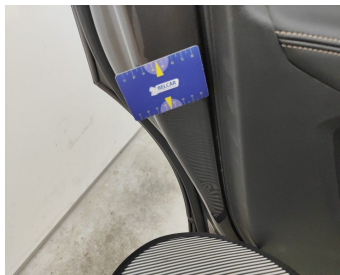
| Damages | Type | Acceptable |
|---|---|---|
| 104 | Door Rear Left // Repair & Painting | N |

Door Rear Left // Repair & Painting-scratch + dent

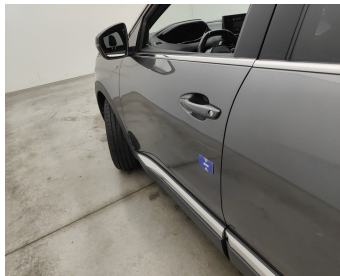
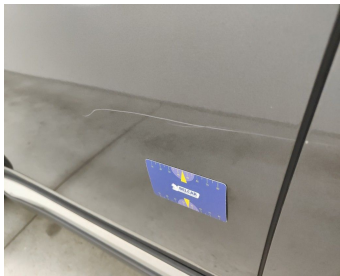
| Damages | Type | Acceptable |
|---|---|---|
| 83 | Door Front Left // Painting | N |

Door Front Left // Painting-scratch

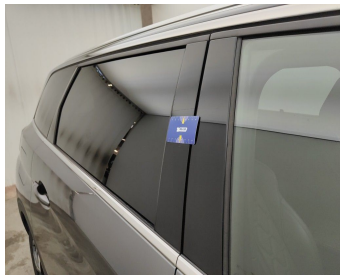
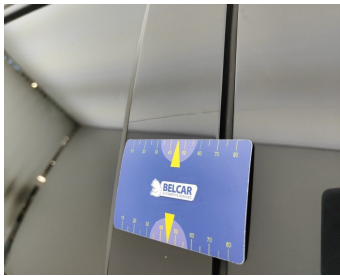
| Damages | Type | Acceptable |
|---|---|---|
| 197 | Door Rear Right / Trim / Replace | Y |

Door Rear Right / Trim / Replace-scratch

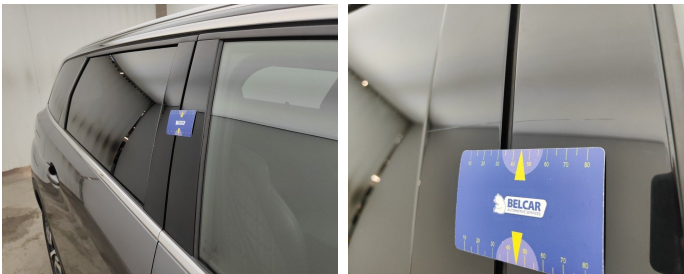
| Damages | Type | Acceptable |
|---|---|---|
| 217 | Door Front Right / Trim / Replace | Y |

Door Front Right / Trim / Replace-scratch
