# INSPECTION REPORT

End of contract

| License plate | 2CEA555 |
| Make | Mercedes GLC 300de 4M |

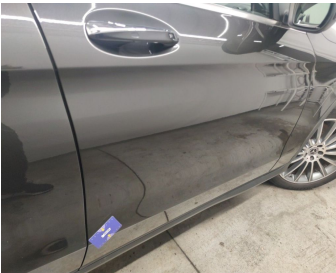
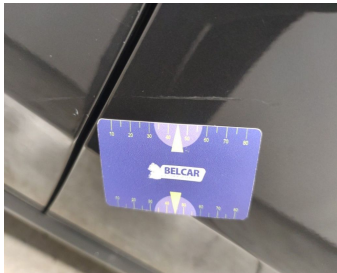
| Damages | Type | Acceptable |
|---|---|---|
| 211 | Door Front Right // Smart Repair Medium | Y |

Door Front Right // Smart Repair Medium-scratch

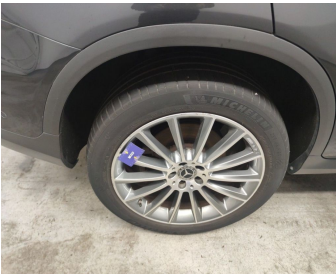
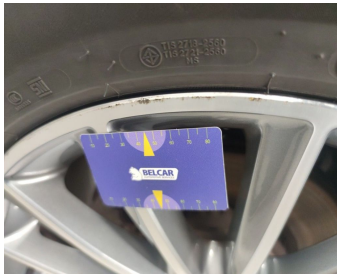
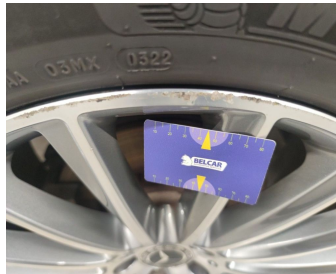
| Damages | Type | Acceptable |
|---|---|---|
| 330 | Wheel Two Tone Rear Right // Repair | N |

Wheel Two Tone Rear Right // Repair-scratch

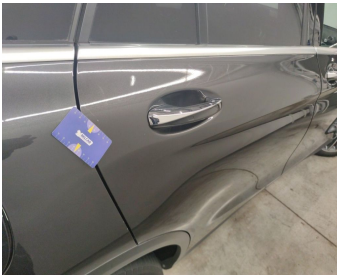
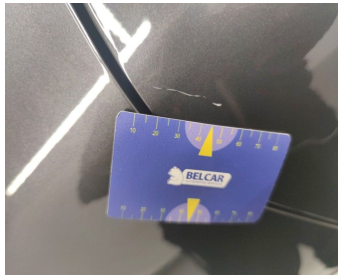
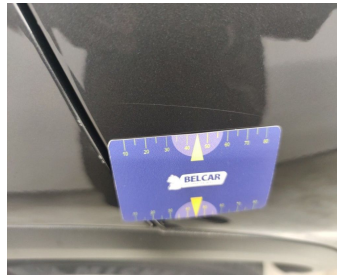
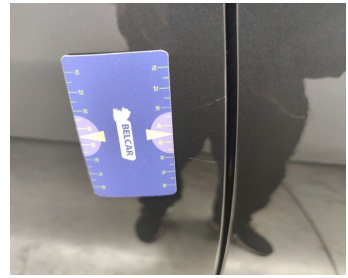
| Damages | Type | Acceptable |
|---|---|---|
| 191 | Door Rear Right // Smart Repair Medium | Y |

Door Rear Right // Smart Repair Medium-scratch

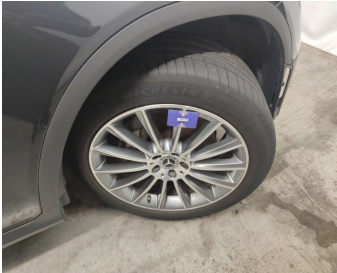
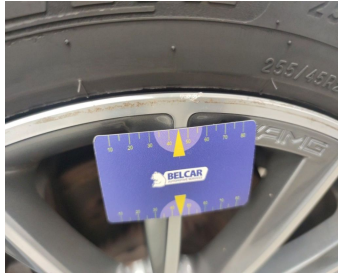
| Damages | Type | Acceptable |
|---|---|---|
| 340 | Wheel Two Tone Front Right // Repair | Y |

Wheel Two Tone Front Right // Repair-scratch

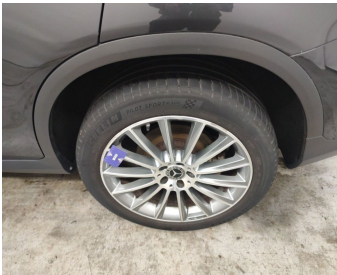
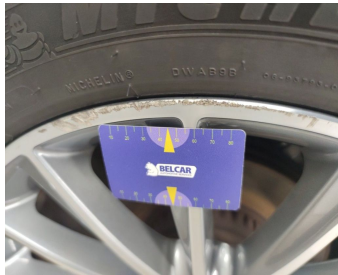
| Damages | Type | Acceptable |
|---|---|---|
| 320 | Wheel Two Tone Rear Left // Repair | N |

Wheel Two Tone Rear Left // Repair-scratch

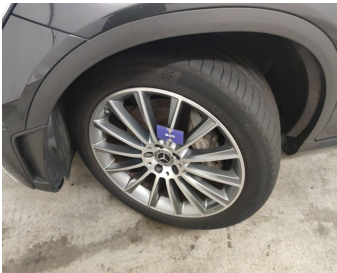
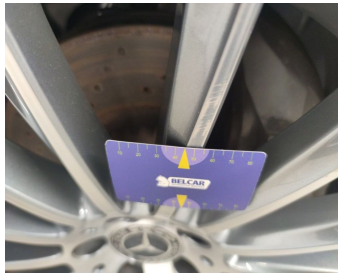
| Damages | Type | Acceptable |
|---|---|---|
| 310 | Wheel Two Tone Front Left // Repair | Y |

Wheel Two Tone Front Left // Repair-scratch

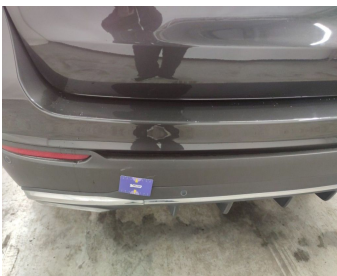
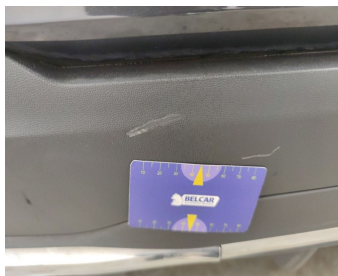
| Damages | Type | Acceptable |
|---|---|---|
| 138 | Bumper Rear / Lower Cover Not Painted / Replace | Y |

Bumper Rear / Lower Cover Not Painted / Replace-scratch

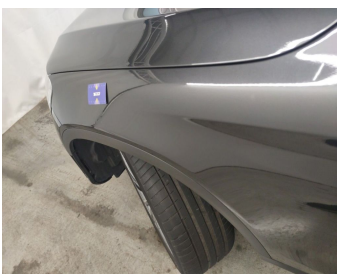
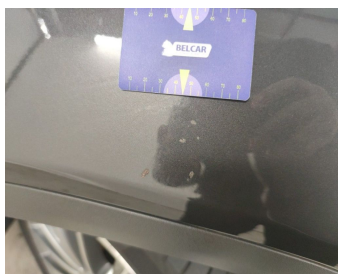
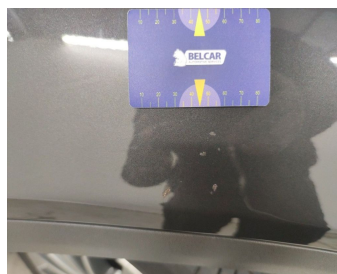
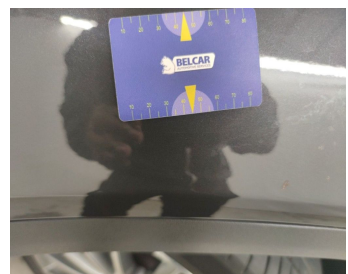
| Damages | Type | Acceptable |
|---|---|---|
| 66 | Wing Front Left // Polish | Y |

Wing Front Left // Polish-scratch

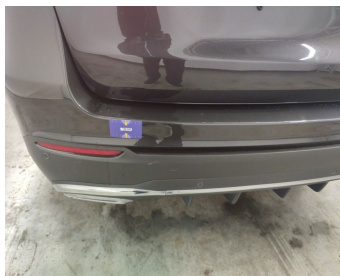
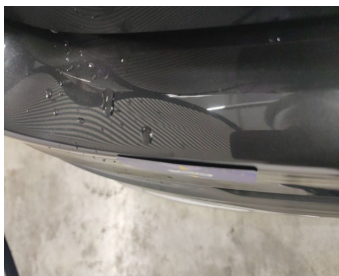
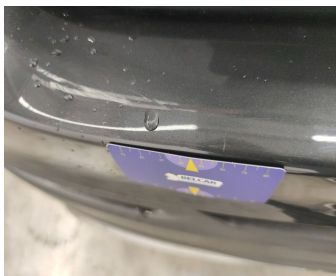
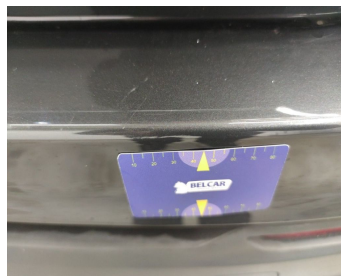
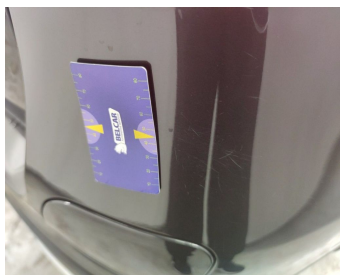
| Damages | Type | Acceptable |
|---|---|---|
| 133 | Bumper Rear // Painting | Y |

Bumper Rear // Painting-scratch

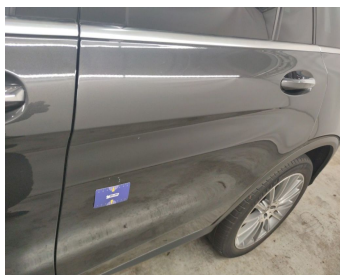
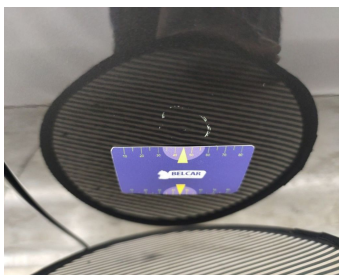
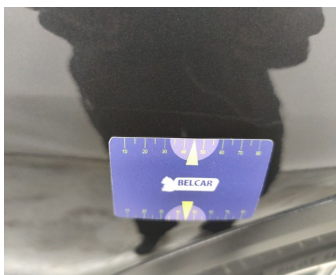
| Damages | Type | Acceptable |
|---|---|---|
| 104 | Door Rear Left // Repair & Painting | Y |

Door Rear Left // Repair & Painting-scratch + dent

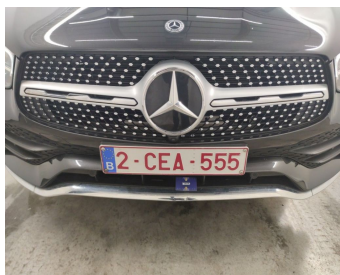
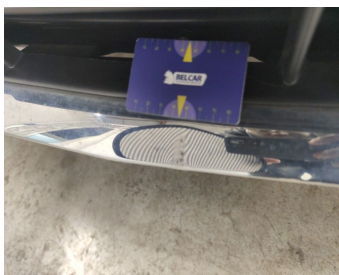
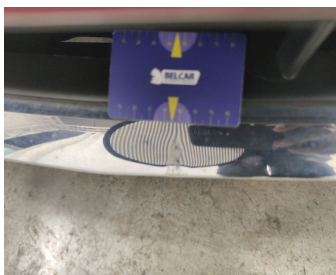
| Damages | Type | Acceptable |
|---|---|---|
| 18 | Bumper Front / Spoiler / Replace | N |

Bumper Front / Spoiler / Replace-scratch + dent

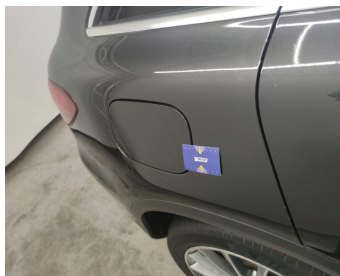
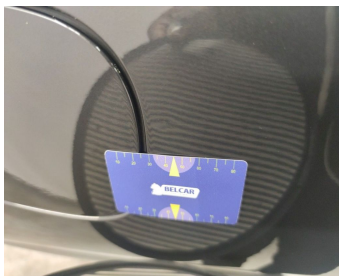
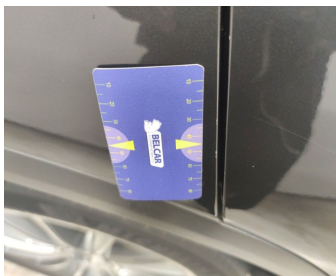
| Damages | Type | Acceptable |
|---|---|---|
| 184 | Wing Rear Right // Repair & Painting | Y |

Wing Rear Right // Repair & Painting-scratch + dent

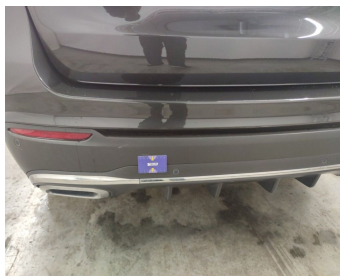
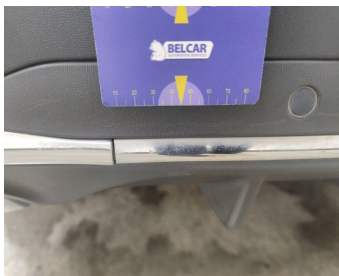
| Damages | Type | Acceptable |
|---|---|---|
| 282 | Bumper Rear / Trim Center / Replace | Y |

Bumper Rear / Trim Center / Replace-cracked
