# INSPECTION REPORT

**End of contract**

| Vehicle identification number | W1N2539111V371227 |
| Make | Mercedes GLC 300de 4M Bus.Sol. |

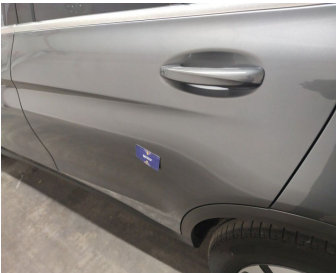
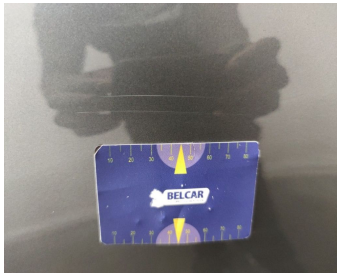
| Damages | Type | Acceptable |
|---|---|---|
| 106 | Door Rear Left // Polish | Y |

Door Rear Left // Polish-scratch

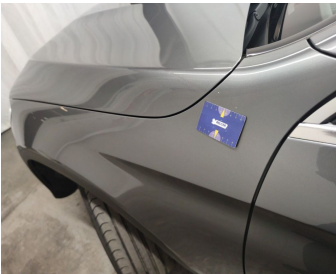
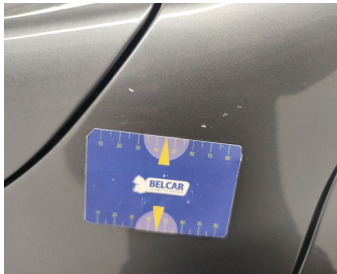
| Damages | Type | Acceptable |
|---|---|---|
| 63 | Wing Front Left // Painting | Y |

Wing Front Left // Painting-scratch

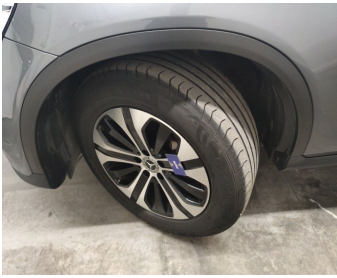
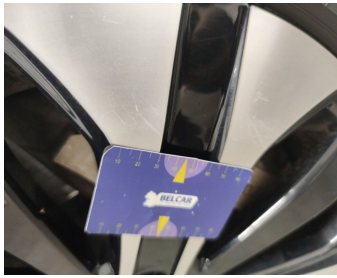
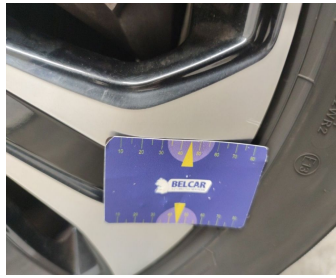
| Damages | Type | Acceptable |
|---|---|---|
| 310 | Wheel Two Tone Front Left // Repair | Y |

Wheel Two Tone Front Left // Repair-scratch

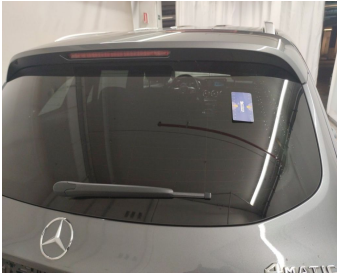
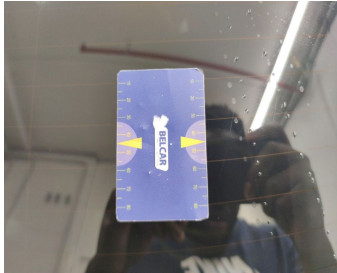
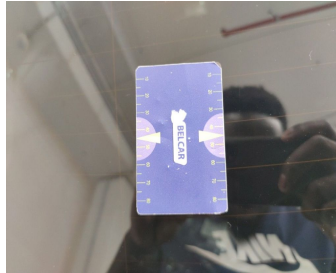
| Damages | Type | Acceptable |
|---|---|---|
| 159 | Rear Bonnet / Rear Window / Replace | Y |

Rear Bonnet / Rear Window / Replace-scratch

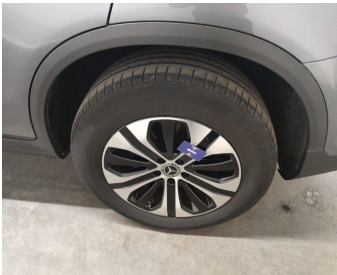
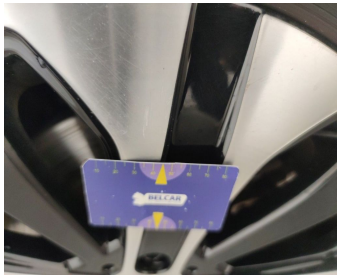
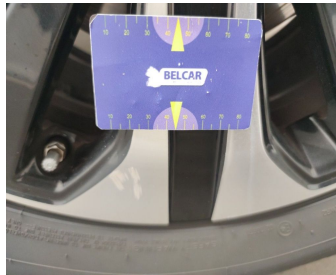
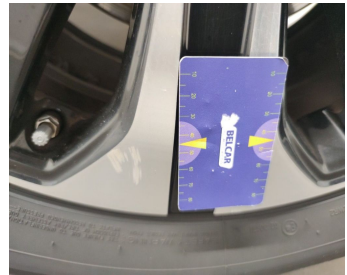
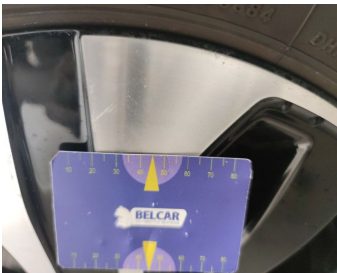
| Damages | Type | Acceptable |
|---|---|---|
| 320 | Wheel Two Tone Rear Left // Repair | N |

Wheel Two Tone Rear Left // Repair-scratch

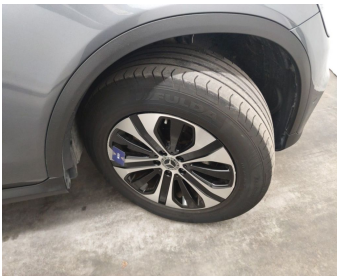
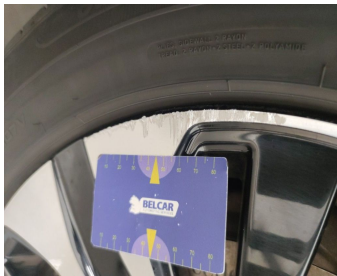
| Damages | Type | Acceptable |
|---|---|---|
| 340 | Wheel Two Tone Front Right // Repair | N |

Wheel Two Tone Front Right // Repair-scratch

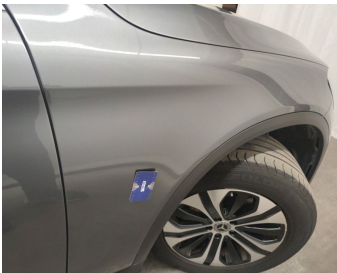
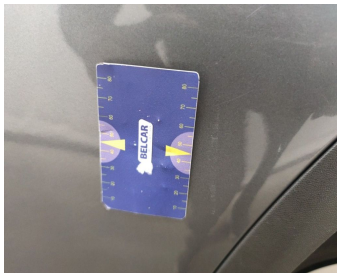
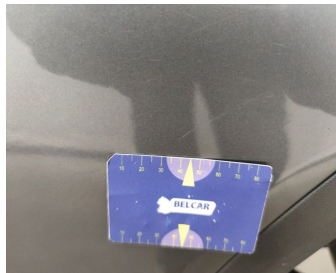
| Damages | Type | Acceptable |
|---|---|---|
| 236 | Wing Front right // Polish | Y |

Wing Front right // Polish-scratch

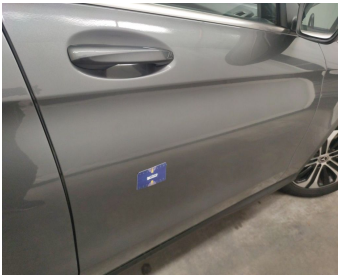
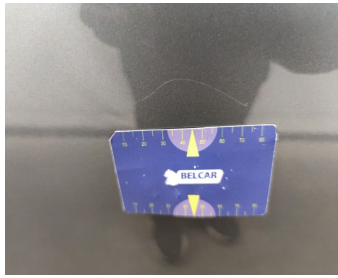
| Damages | Type | Acceptable |
|---|---|---|
| 216 | Door Front Right // Polish | Y |

Door Front Right // Polish-scratch

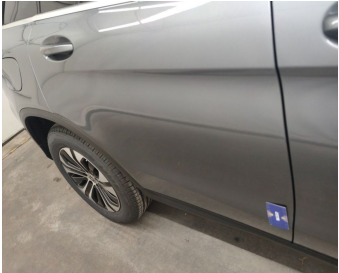
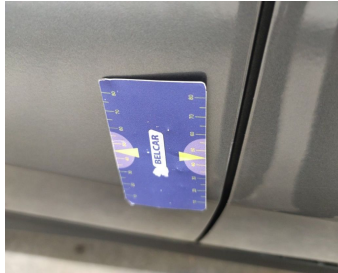
| Damages | Type | Acceptable |
|---|---|---|
| 191 | Door Rear Right // Smart Repair Medium | Y |

Door Rear Right // Smart Repair Medium-scratch

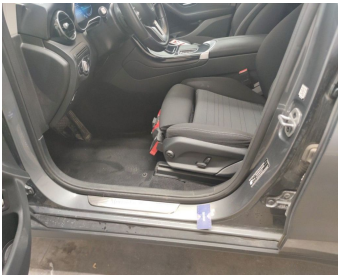
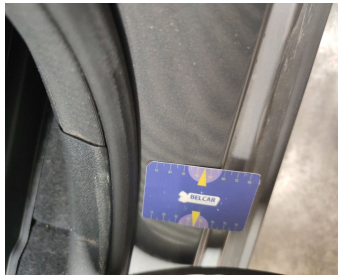
| Damages | Type | Acceptable |
|---|---|---|
| 91 | Rocker Panel Left // Smart Repair Medium | Y |

Rocker Panel Left // Smart Repair Medium-dent

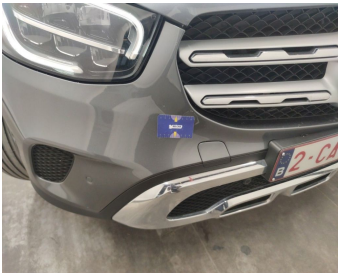
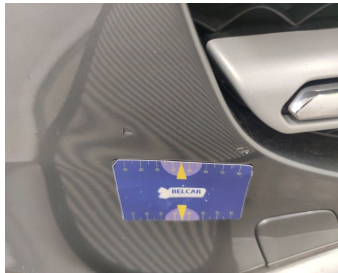
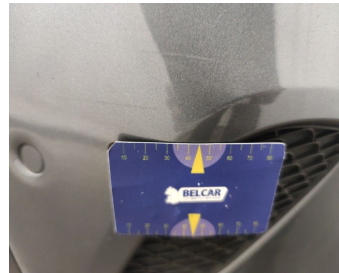
| Damages | Type | Acceptable |
|---|---|---|
| 14 | Bumper Front // Repair & Painting | N |

Bumper Front // Repair & Painting-scratch + dent

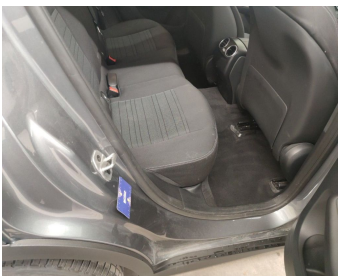
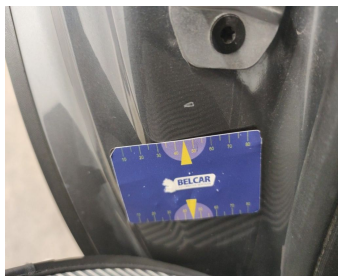
| Damages | Type | Acceptable |
|---|---|---|
| 201 | Rocker Panel Right // Smart Repair Medium | Y |

Rocker Panel Right // Smart Repair Medium-scratch + dent

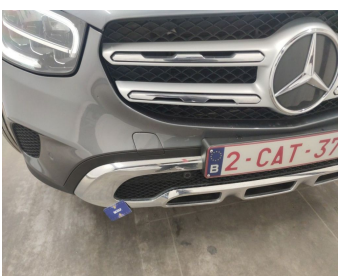
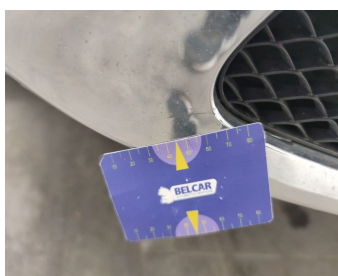
| Damages | Type | Acceptable |
|---|---|---|
| 18 | Bumper Front / Spoiler / Replace | N |

Bumper Front / Spoiler / Replace-cracked
