# INSPECTION REPORT

**End of contract**

| License plate | 2DRR738 |
| Make | Peugeot 308 SW 1.2 130 Active |

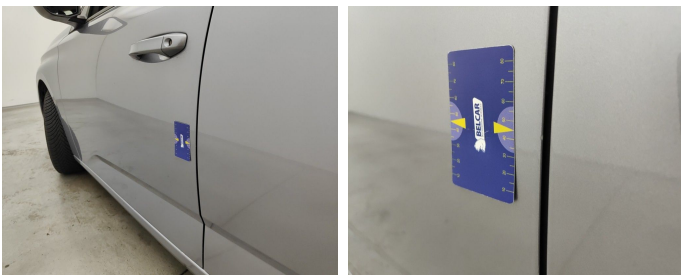
Door Front Left // Smart Repair Small-scratch

| Damages | Type | Acceptable |
|---|---|---|
| 80 | Door Front Left // Smart Repair Small | Y |

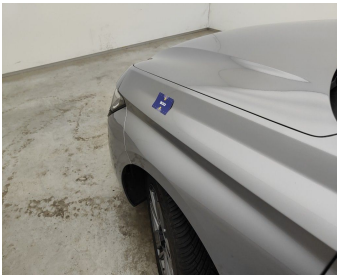
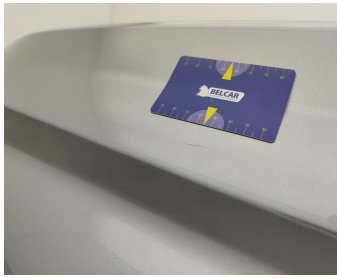
Wing Front Left // Painting-scratch

| Damages | Type | Acceptable |
|---|---|---|
| 63 | Wing Front Left // Painting | Y |

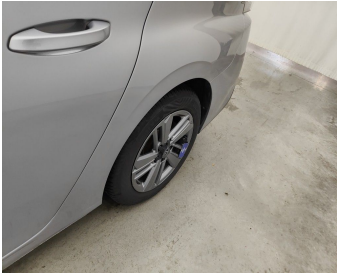
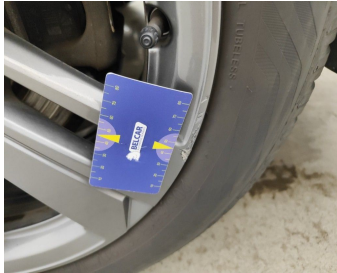
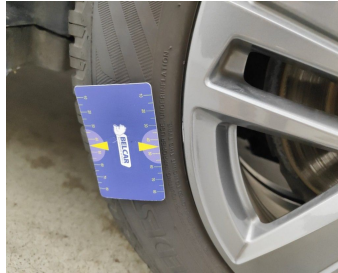
Wheel Alloy Rear Left // Repair-scratch

| Damages | Type | Acceptable |
|---|---|---|
| 321 | Wheel Alloy Rear Left // Repair | Y |

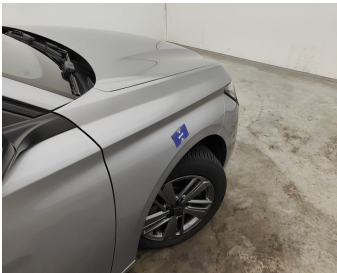
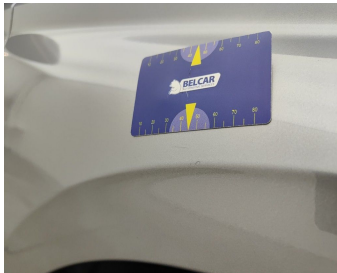
Wing Front right // Painting-scratch

| Damages | Type | Acceptable |
|---|---|---|
| 233 | Wing Front right // Painting | Y |

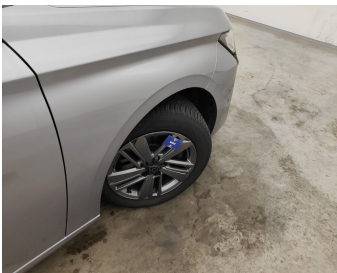
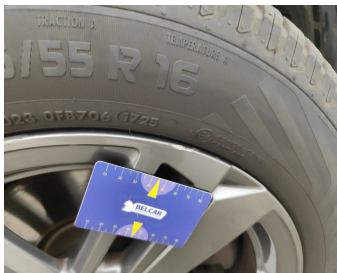
Wheel Alloy Front Right // Repair-scratch

| Damages | Type | Acceptable |
|---|---|---|
| 341 | Wheel Alloy Front Right // Repair | Y |

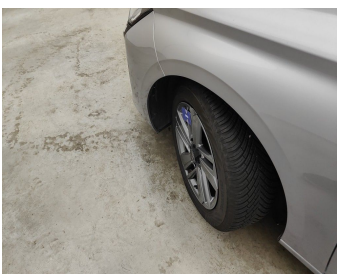
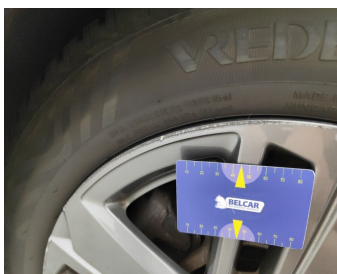
Wheel Alloy Front Left // Repair-scratch

| Damages | Type | Acceptable |
|---|---|---|
| 311 | Wheel Alloy Front Left // Repair | Y |

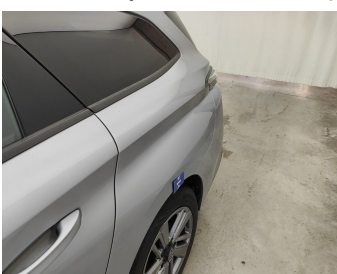
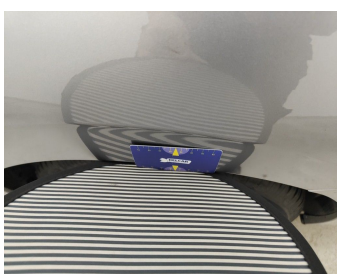
Wing Rear Left // Smart Repair Small-dent

| Damages | Type | Acceptable |
|---|---|---|
| 110 | Wing Rear Left // Smart Repair Small | Y |

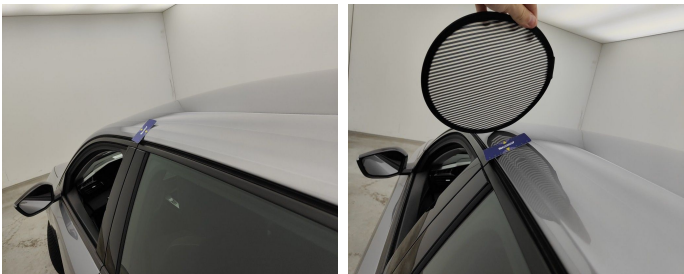
Roof // Smart Repair Medium-dent

| Damages | Type | Acceptable |
|---|---|---|
| 161 | Roof // Smart Repair Medium | Y |

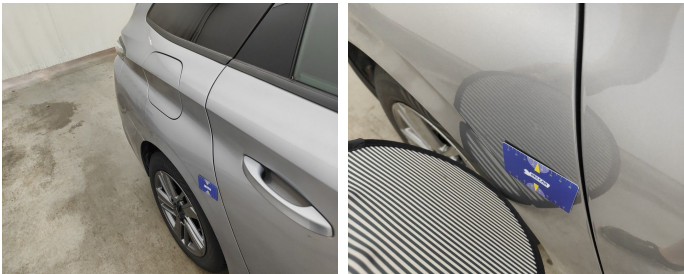
Wing Rear Right // Smart Repair Small-dent

| Damages | Type | Acceptable |
|---|---|---|
| 180 | Wing Rear Right // Smart Repair Small | Y |

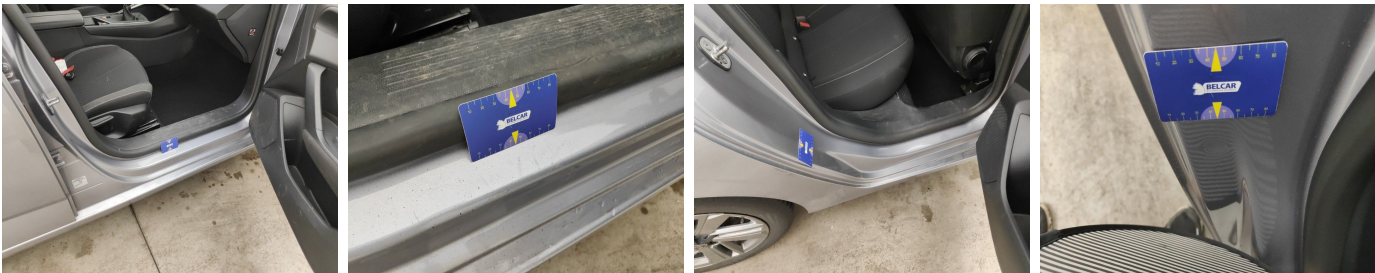
Rocker Panel Right // Smart Repair Medium-dent

| Damages | Type | Acceptable |
|---|---|---|
| 201 | Rocker Panel Right // Smart Repair Medium | Y |

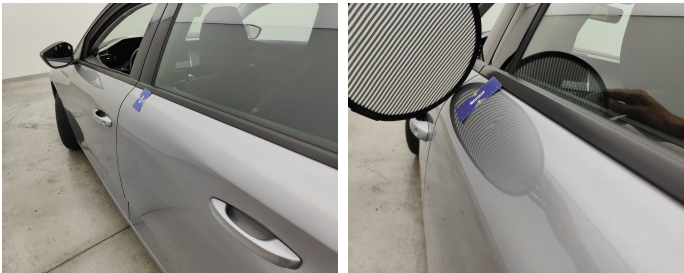
Door Rear Left // Smart Repair Small-dent

| Damages | Type | Acceptable |
|---|---|---|
| 100 | Door Rear Left // Smart Repair Small | Y |

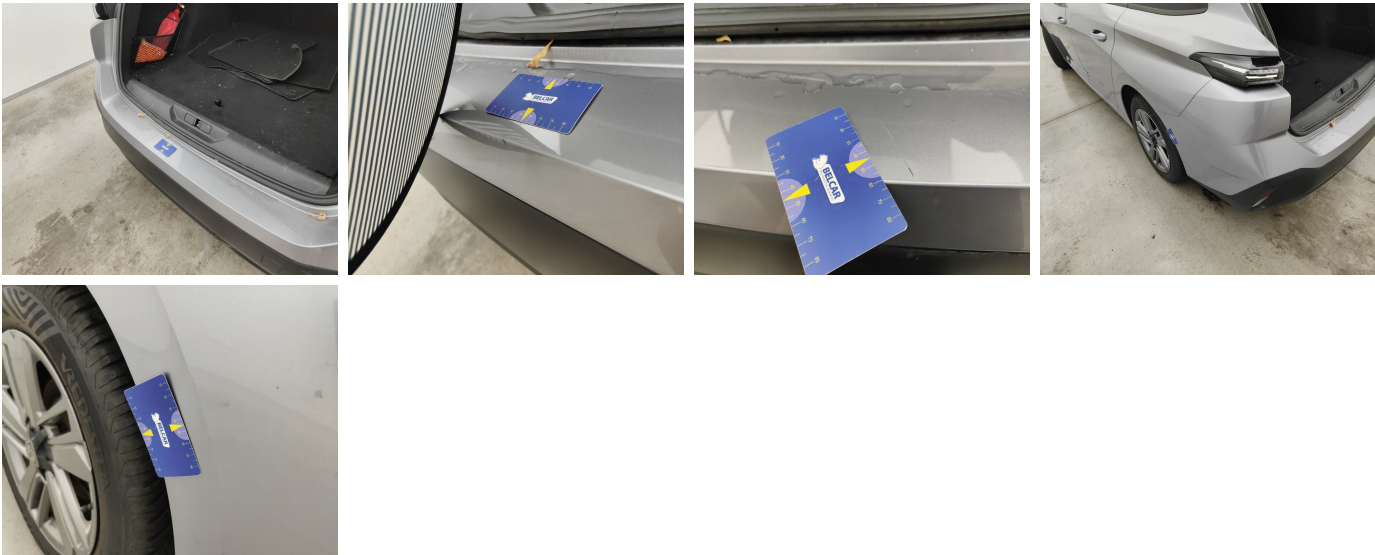
Bumper Rear // Repair & Painting-scratch + dent

| Damages | Type | Acceptable |
|---|---|---|
| 134 | Bumper Rear // Repair & Painting | Y |

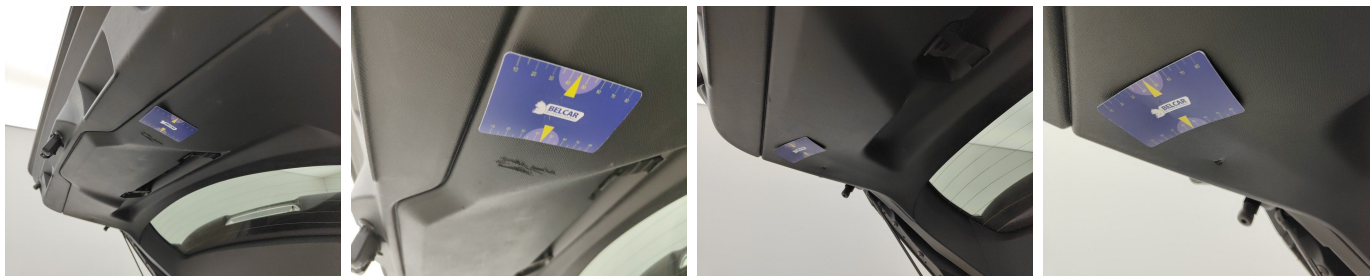
Trunk Lid Interior Coating / Complete Panel / Replace-scratch + dent

| Damages | Type | Acceptable |
|---|---|---|
| 594 | Trunk Lid Interior Coating / Complete Panel / Replace | Y |

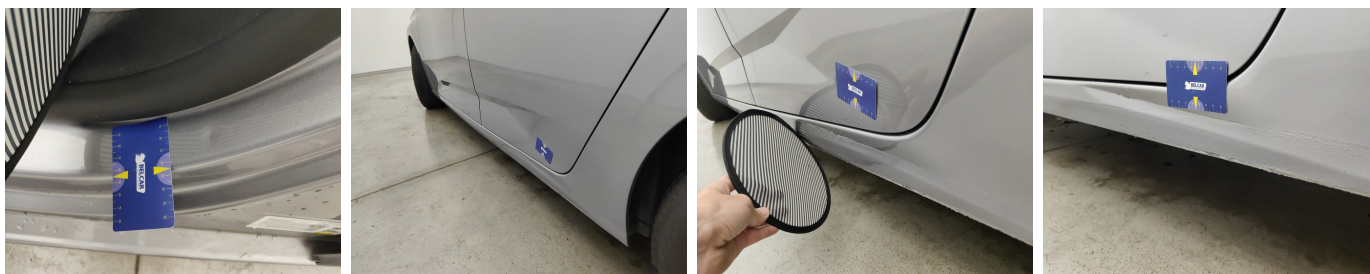
Rocker Panel Left // Repair & Painting-scratch + dent

| Damages | Type | Acceptable |
|---|---|---|
| 93 | Rocker Panel Left // Repair & Painting | Y |

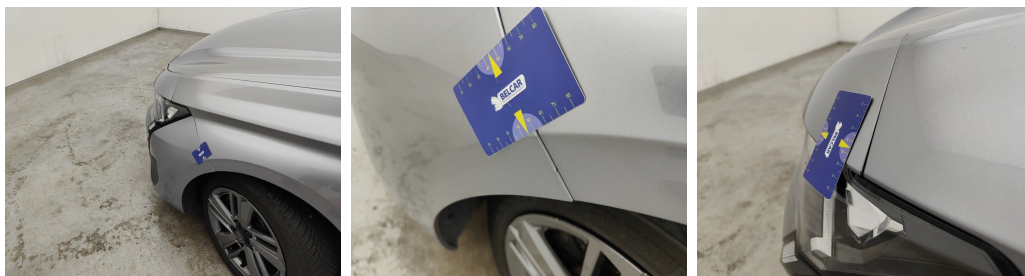
Bumper Front // Repair & Painting-bad repair

| Damages | Type | Acceptable |
|---|---|---|
| 14 | Bumper Front // Repair & Painting | Y |

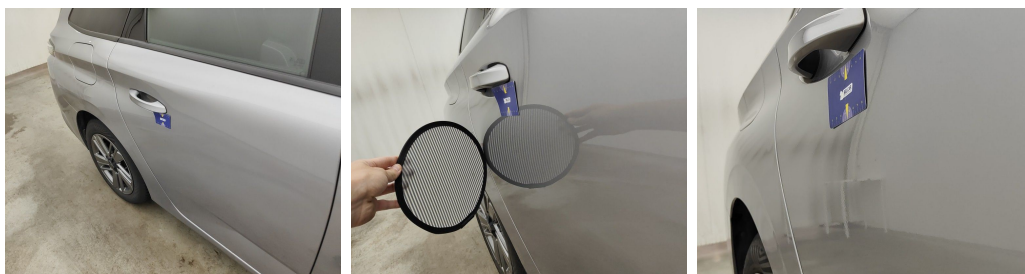
Door Rear Right // Painting-bad repair

| Damages | Type | Acceptable |
|---|---|---|
| 193 | Door Rear Right // Painting | Y |

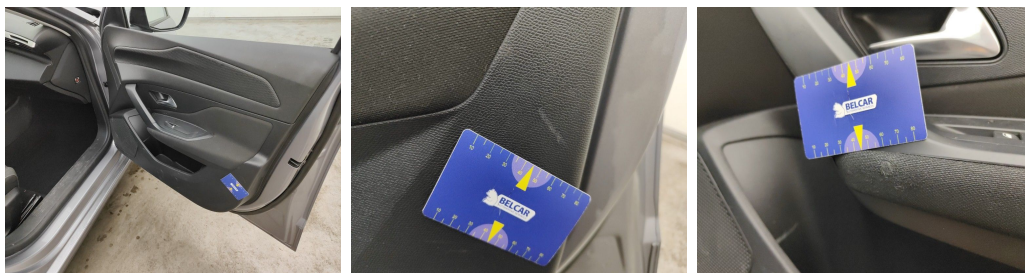
Front Right Door Interior Coating // Replace Completely-tear

| Damages | Type | Acceptable |
|---|---|---|
| 624 | Front Right Door Interior Coating // Replace Completely | Y |

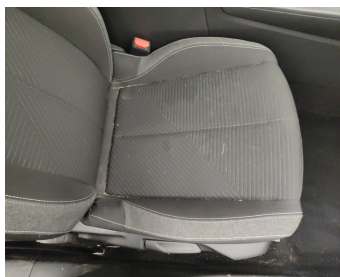
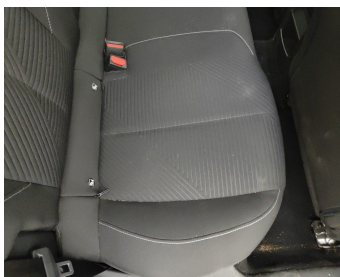
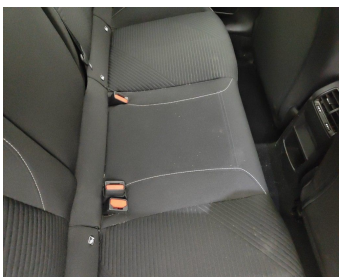
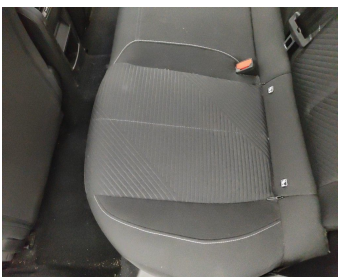
Interior Cleaning // Small-stain

| Damages | Type | Acceptable |
|---|---|---|
| 860 | Interior Cleaning // Small | Y |
