# INSPECTION REPORT

End of contract

File	309041
License plate	2AMV751
Vehicle identification number	VF3MRHNSMMS123131
Dossier	2021 035 162
Make	Peugeot 3008 1.2PTech 96kW All
Mileage	74501
First registration	18/05/2021
client availability date	01/04/2026
inspectionDate	09/04/2026

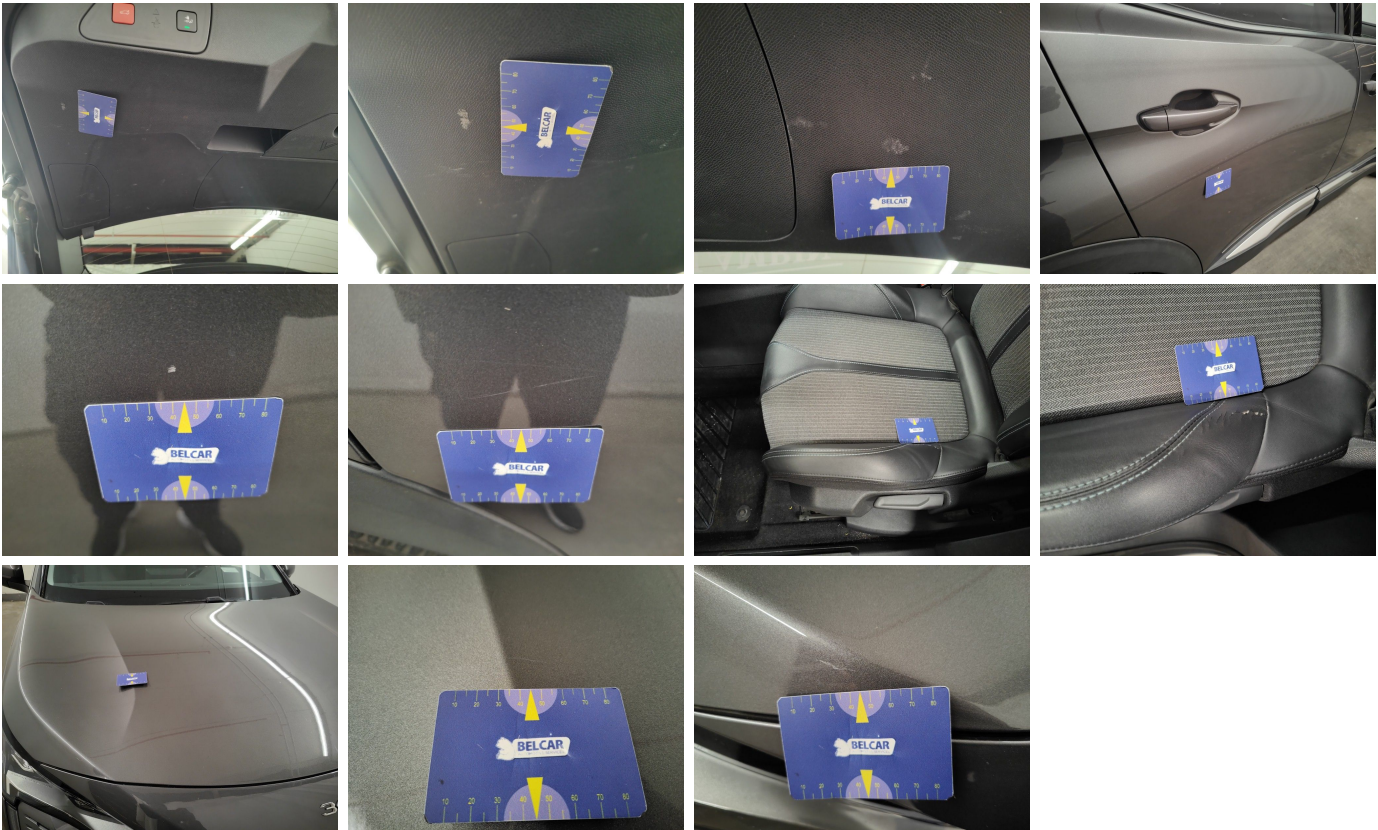
Damage within Renta-norm-

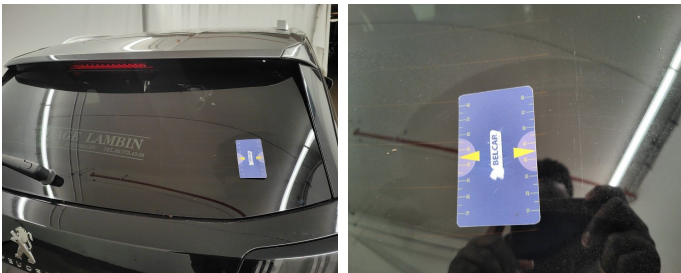
Rear Bonnet / Rear Window / Replace-scratch

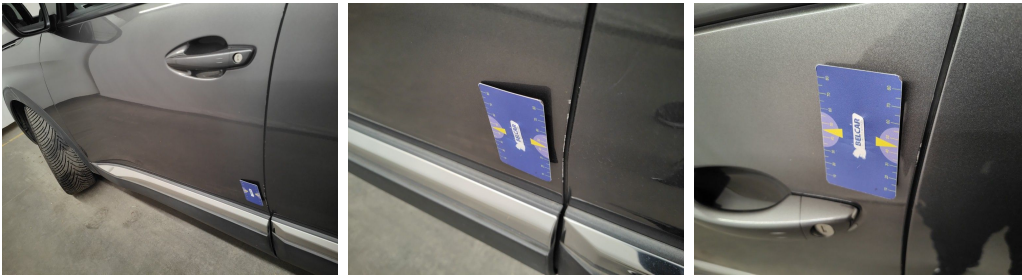
Door Front Left // Smart Repair Small-scratch

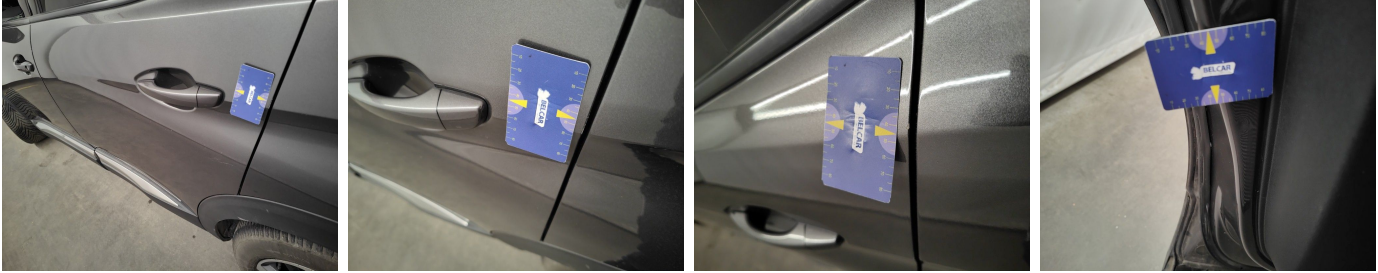
Door Rear Left // Smart Repair Medium-dent

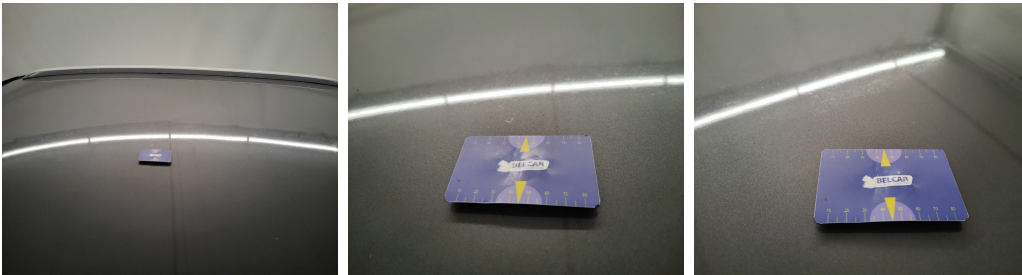
Roof // Polish-Chemical reaction

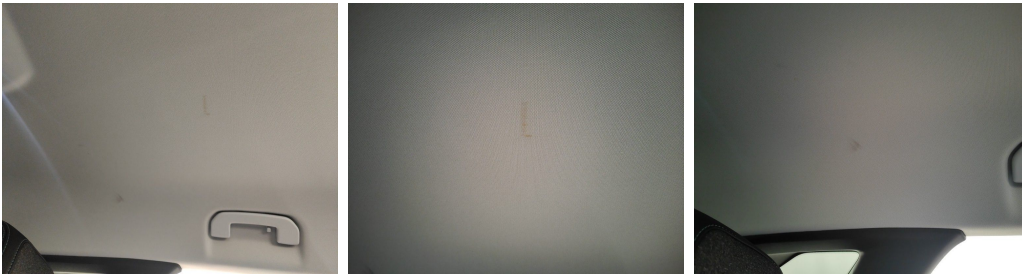
Interior Cleaning // Small-stain
