# INSPECTION REPORT

End of contract

| License plate | 1YVA117 |
| Make | Opel Comb.1.5D 55kW 2.0T L1H1 |

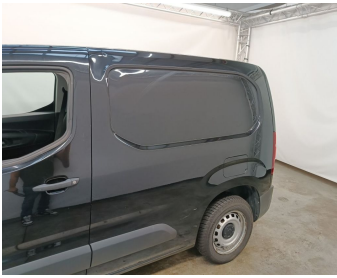
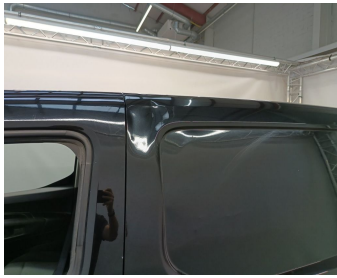
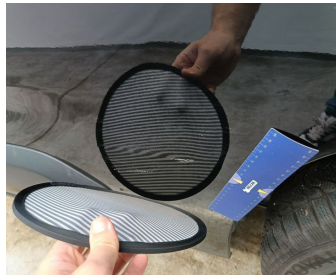
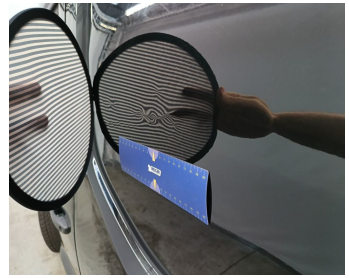
| Damages | Type | Acceptable |
|---|---|---|
| 294 | Rear Loading Door Left // Repair & Painting | Y |

Rear Loading Door Left // Repair & Painting-scratch + dent

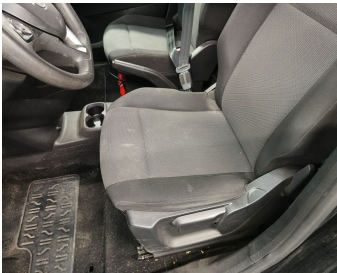
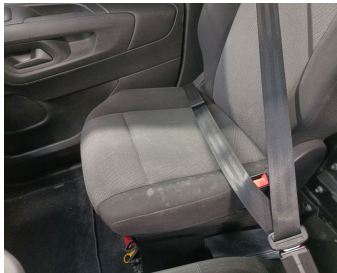
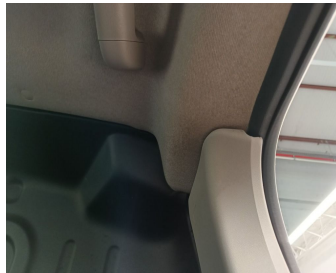
| Damages | Type | Acceptable |
|---|---|---|
| 540 | Interior // Repair 1 | N |

Interior // Repair 1-Incinerated

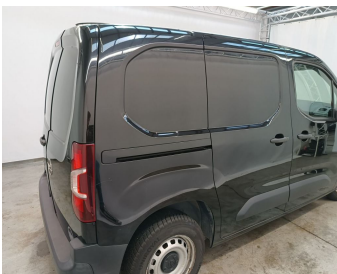
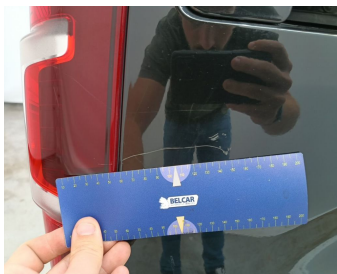
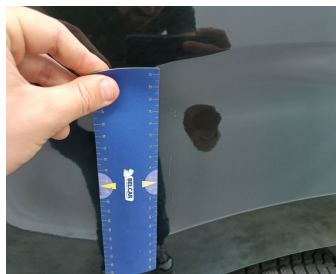
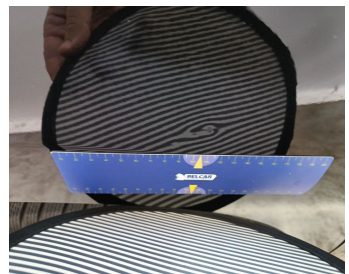
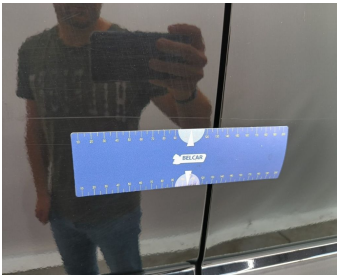
| Damages | Type | Acceptable |
|---|---|---|
| 194 | Door Rear Right // Repair & Painting | N |

Door Rear Right // Repair & Painting-scratch

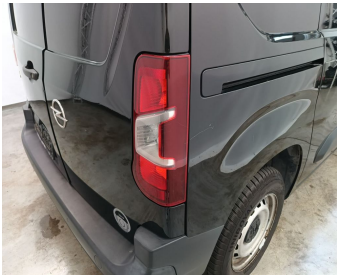
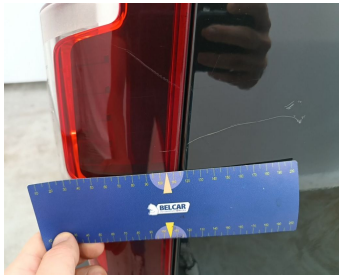
| Damages | Type | Acceptable |
|---|---|---|
| 184 | Wing Rear Right // Repair & Painting | N |

Wing Rear Right // Repair & Painting-scratch
