INSPECTION REPORT

End of contract

File	308896
License plate	2BNC331
Vehicle identification number	VF3MRHNSMMS258884
Dossier	2021112080
Make	Peugeot 5008 1.2PTech 96kW GT
Mileage	81469
First registration	20/01/2022
client availability date	25/03/2026
inspectionDate	31/03/2026

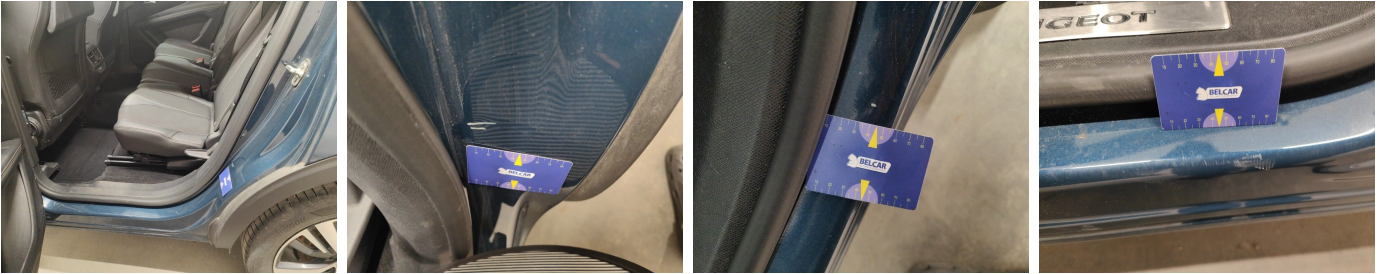
Door Rear Left // Smart Repair Medium-dent
