# INSPECTION REPORT

**End of contract**

| License plate | 2AAM247 |
| Make | Opel Comb.1.5D 75kW 2.3T L2H1 |

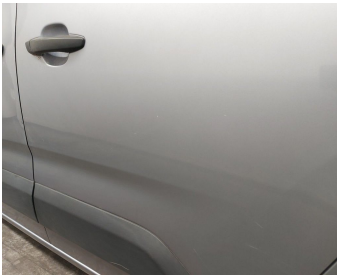
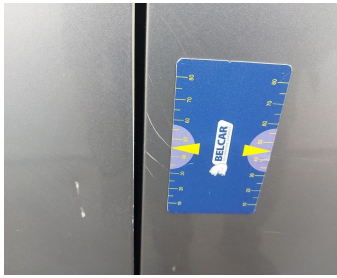
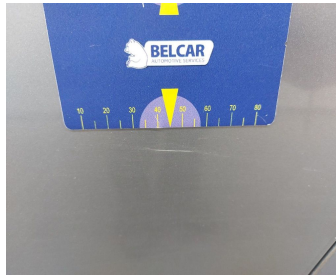
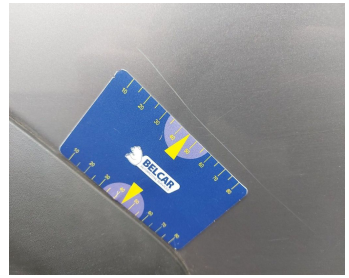
| Damages | Type | Acceptable |
|---|---|---|
| 107 | Door Rear Left / Trim / Replace | Y |

Door Rear Left / Trim / Replace-scratch

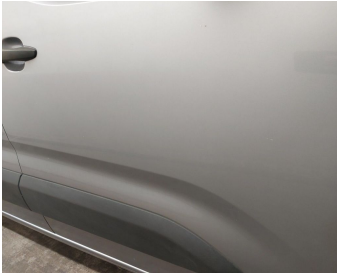
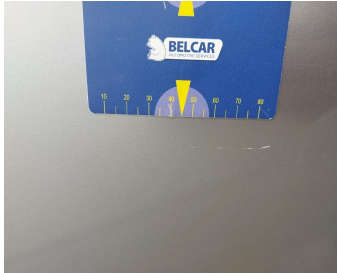
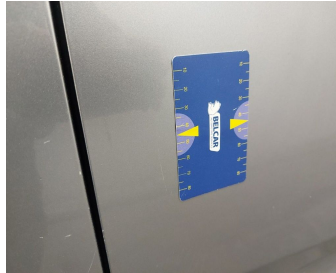
| Damages | Type | Acceptable |
|---|---|---|
| 106 | Door Rear Left // Polish | Y |

Door Rear Left // Polish-scratch

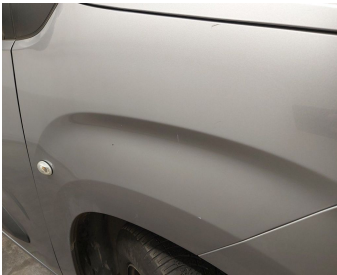
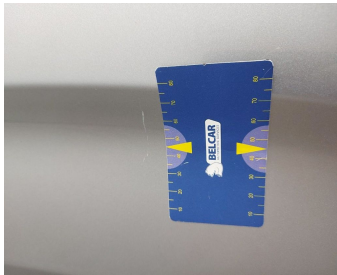
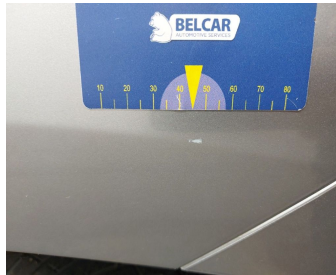
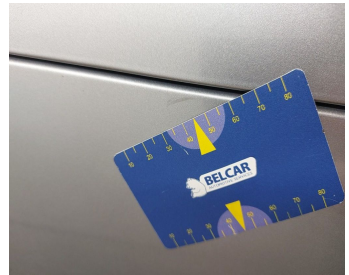
| Damages | Type | Acceptable |
|---|---|---|
| 216 | Door Front Right // Polish | Y |

Door Front Right // Polish-scratch

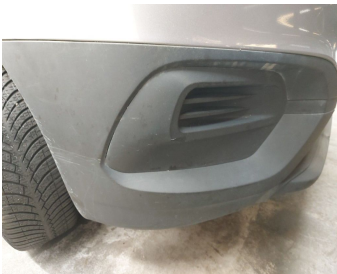
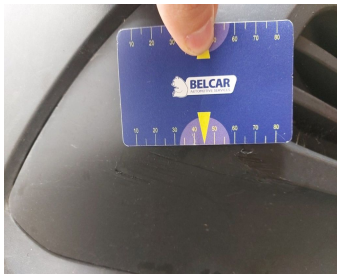
| Damages | Type | Acceptable |
|---|---|---|
| 18 | Bumper Front / Spoiler / Replace | Y |

Bumper Front / Spoiler / Replace-scratch

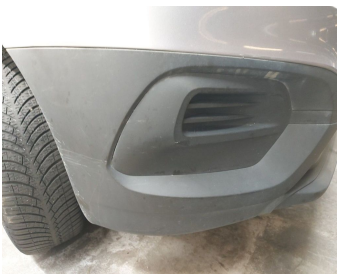
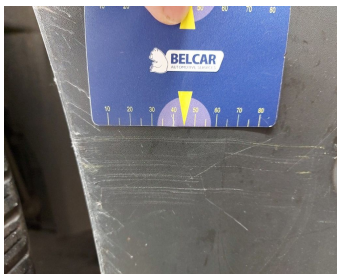
| Damages | Type | Acceptable |
|---|---|---|
| 272 | Bumper Front / Trim Right / Replace | Y |

Bumper Front / Trim Right / Replace-scratch

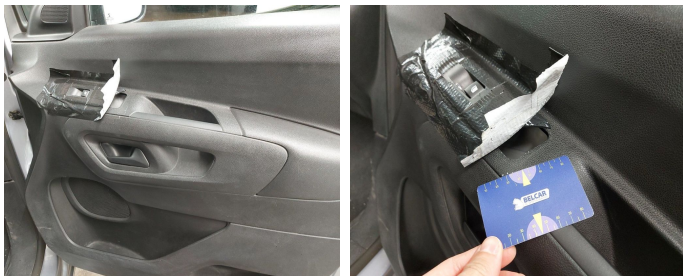
| Damages | Type | Acceptable |
|---|---|---|
| 297 | Rear Loading Door Left / Trim / Replace | N |

Rear Loading Door Left / Trim / Replace-cracked

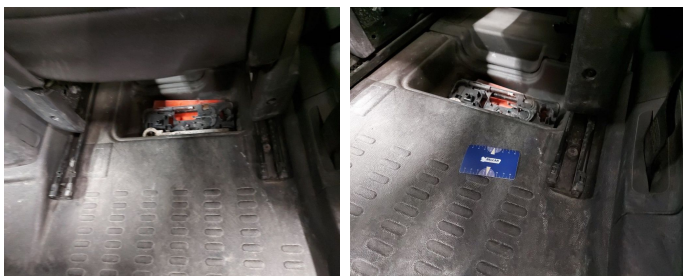
| Damages | Type | Acceptable |
|---|---|---|
| 624 | Front Right Door Interior Coating // Replace Completely | N |

Front Right Door Interior Coating // Replace Completely-cracked

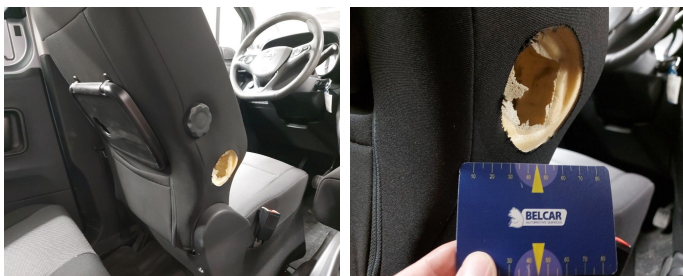
| Damages | Type | Acceptable |
|---|---|---|
| 540 | Interior // Repair 1 | N |

Interior // Repair 1-missing

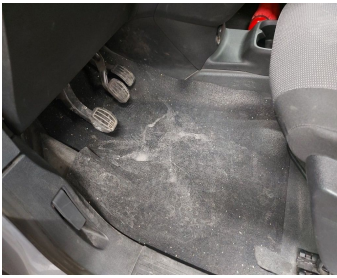
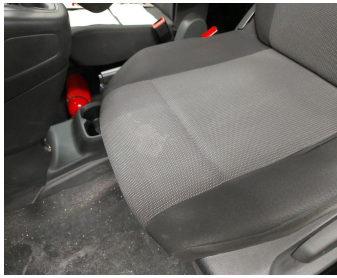
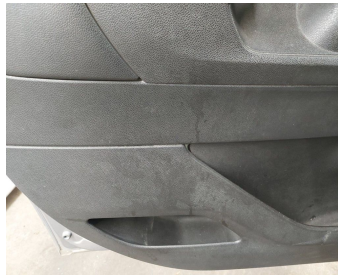
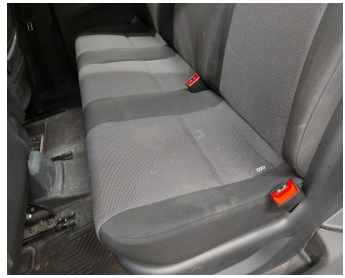
| Damages | Type | Acceptable |
|---|---|---|
| 411 | Seat Front Left // Repair | N |

Seat Front Left // Repair-missing

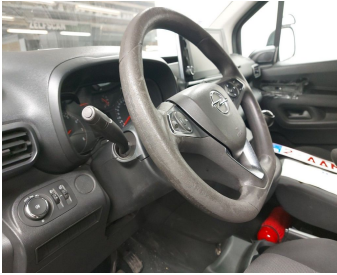
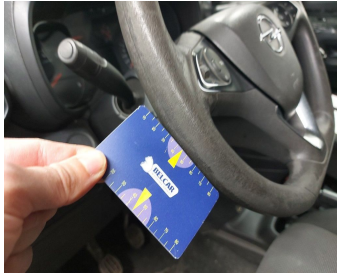
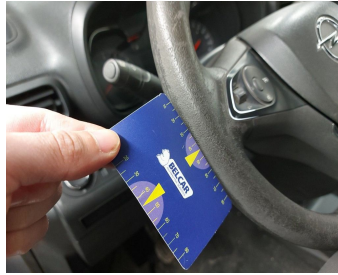
| Damages | Type | Acceptable |
|---|---|---|
| 860 | Interior Cleaning // Small | N |

Interior Cleaning // Small-dirty
