INSPECTION REPORT

End of contract

File	311174
License plate	2BSG731
Vehicle identification number	ZFA2250006W19526
Dossier	2021337129
Make	Fiat Fiorino C.1.3Mjet 80 E6D
Mileage	121879
First registration	07/03/2022
client availability date	22/04/2026
inspectionDate	06/05/2026

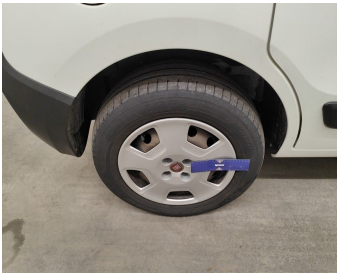
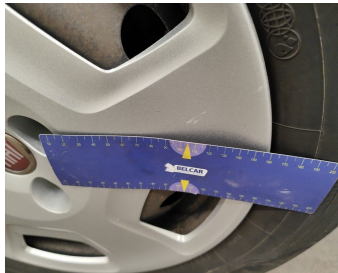
Wheel Front Right / Wheel Cover / Replace-scratch

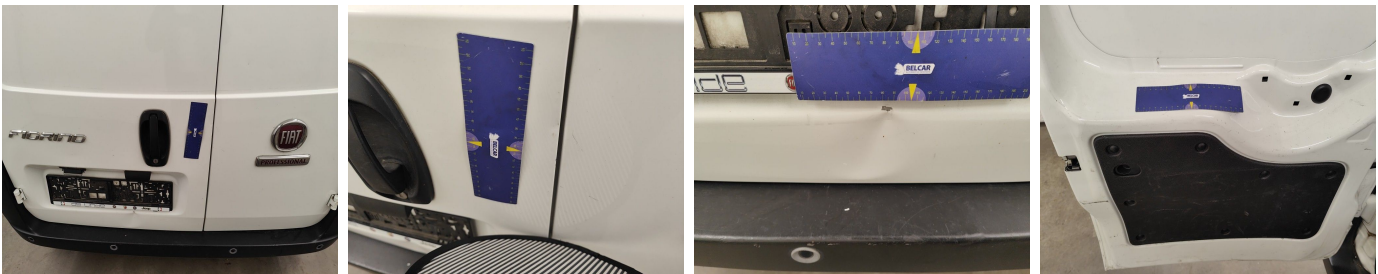
Rear Loading Door Right // Repair & Painting-scratch + dent

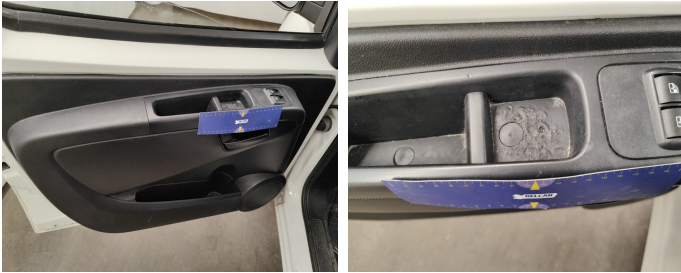
Interior // Repair 2-Incinerated

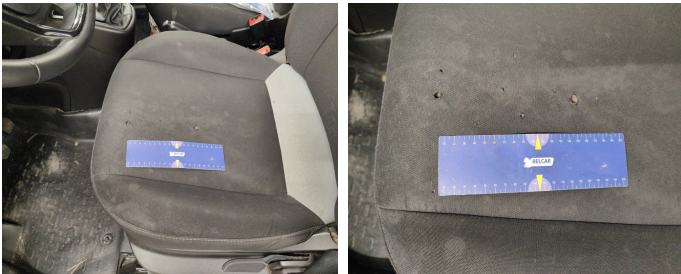
Interior // Repair 1-Incinerated
