# INSPECTION REPORT

End of contract

File	308736
License plate	2AEH118
Vehicle identification number	W0V7D9EJ3L4466498
Dossier	2021 043 113
Make	Opel Crossland X 1.5D 88kW Edi
Mileage	125395
First registration	09/03/2021
client availability date	26/03/2026
inspectionDate	30/03/2026

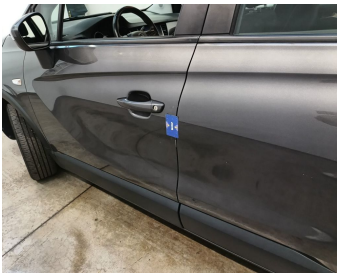
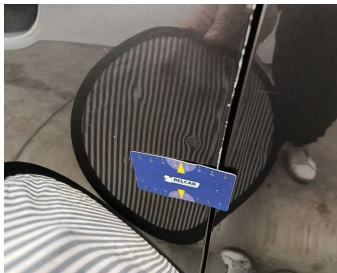
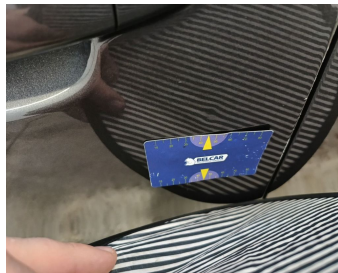
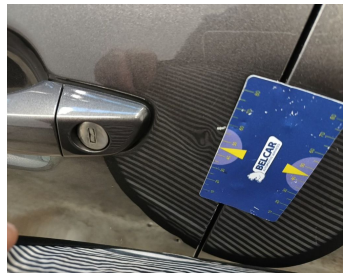
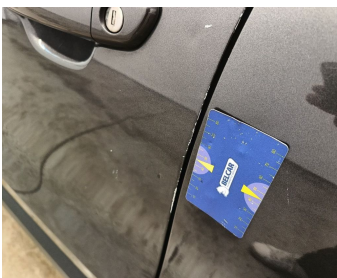
Door Front Left // Smart Repair Large-scratch + dent

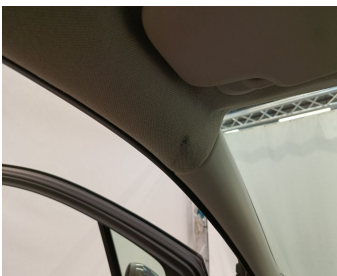
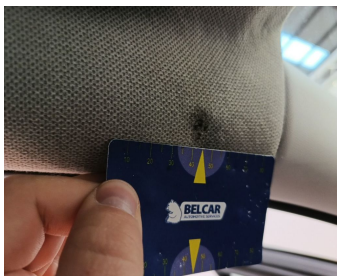
Interior // Repair 1-Incinerated

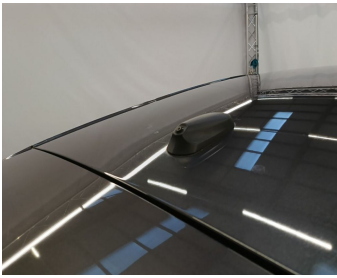
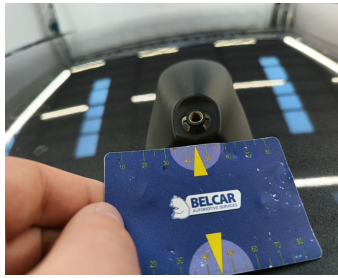
Roof / Antenna / Replace-missing

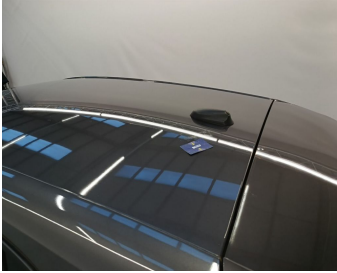
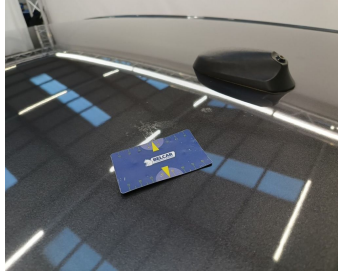
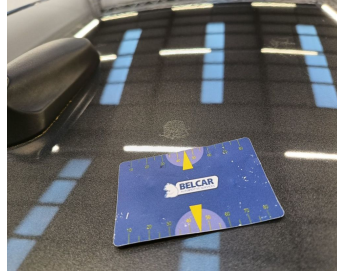
Roof // Painting-Chemical reaction

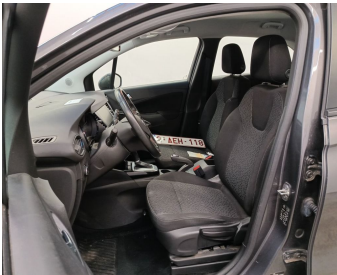
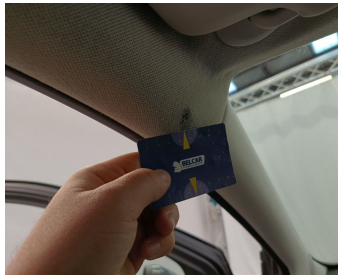
Interior // Ionization Odor-bad smell

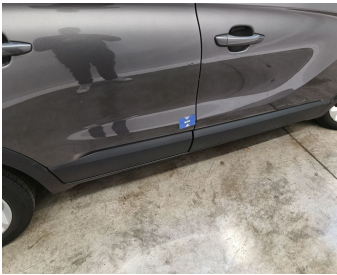
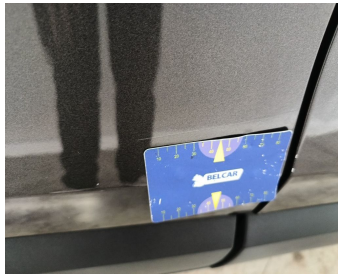
Door Rear Right // Polish-scratch

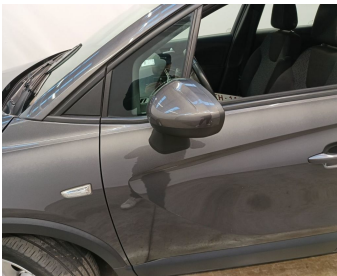
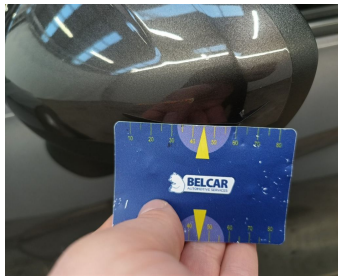
Side View Mirror Left // Painting-scratch

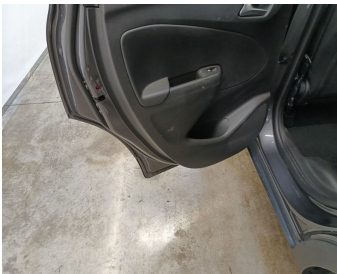
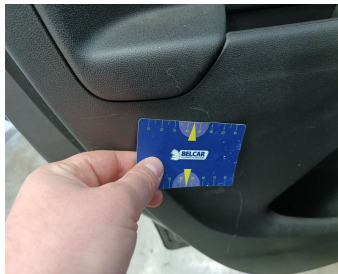
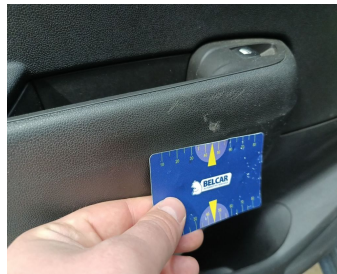
Rear Left Door Interior Coating // Repair-scratch

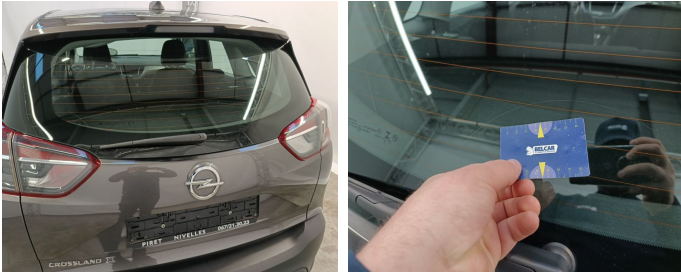
Rear Bonnet / Rear Window / Replace-scratch

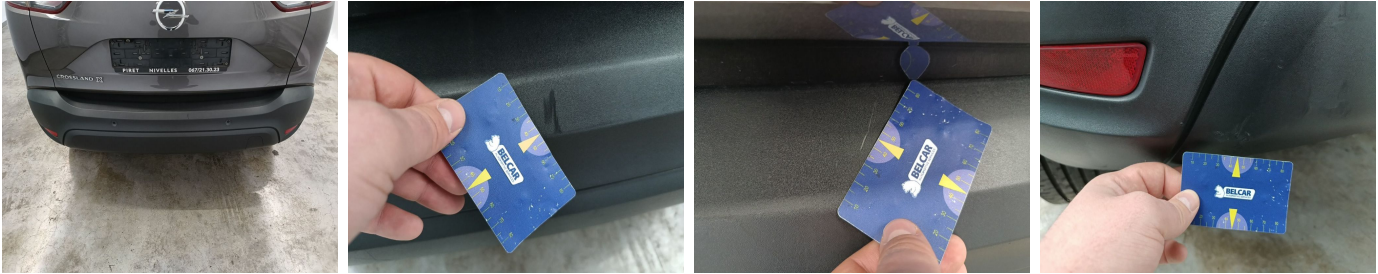
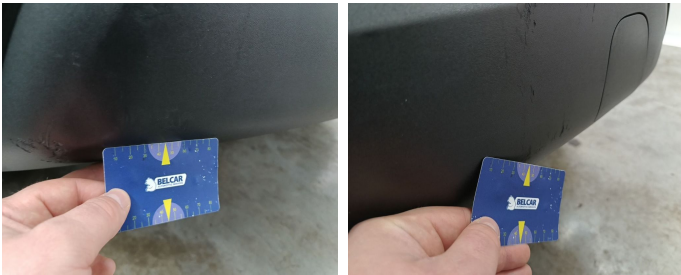
Bumper Rear // Replace without painting-scratch

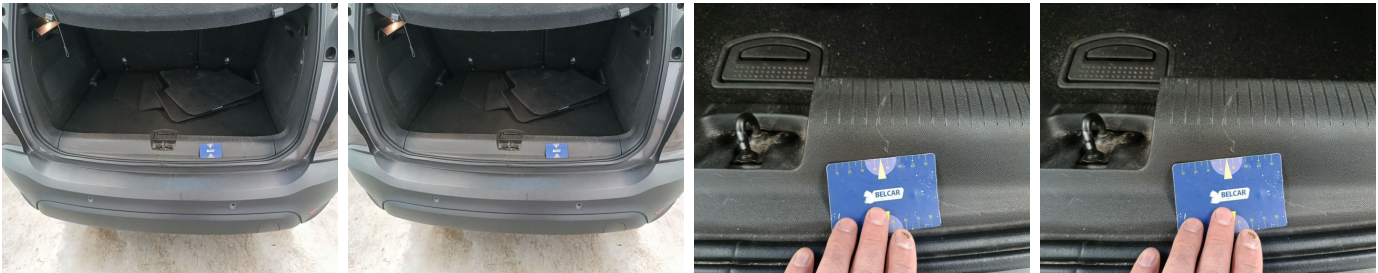
Trunk Lid Interior Coating / MDF Rear Right / Replace-scratch

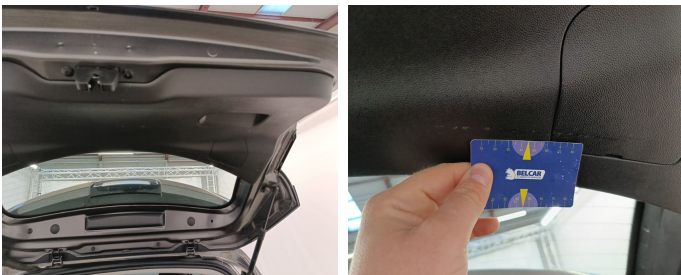
Trunk Lid Interior Coating / Complete Panel / Replace-scratch

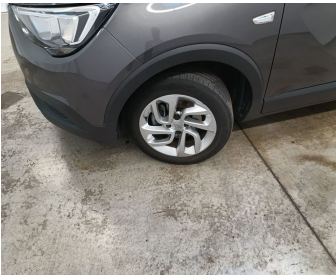
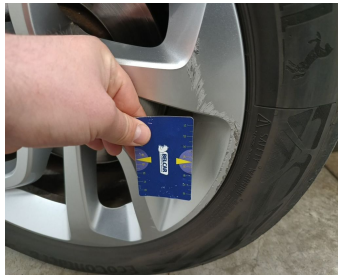
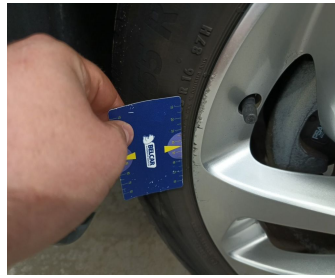
Wheel Alloy Front Left // Repair-scratch

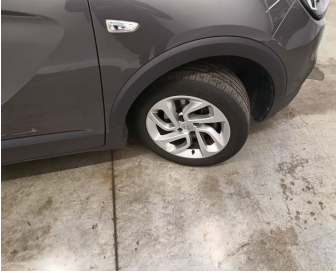
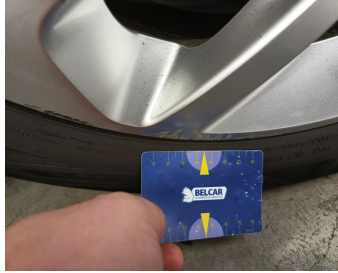
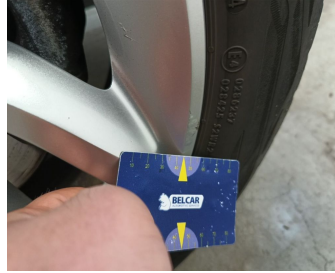
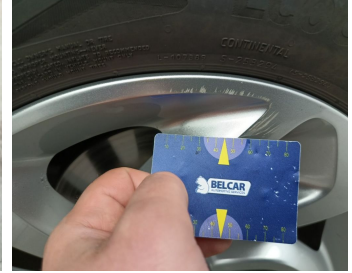
Wheel Alloy Front Right // Repair-scratch

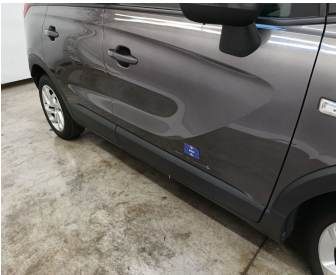
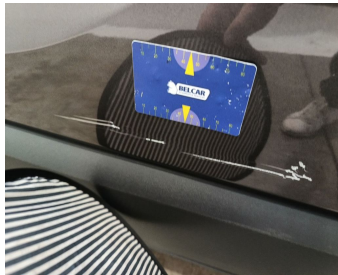
Door Front Right // Repair & Painting-scratch + dent

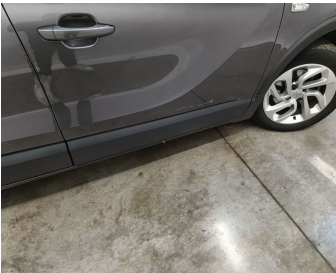
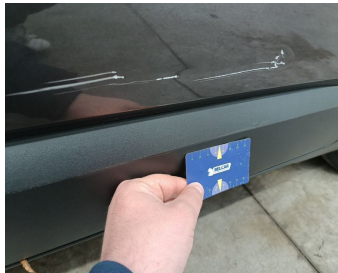
Door Front Right / Trim / Replace-scratch
