# INSPECTION REPORT

**End of contract**

| License plate | 2ACK832 |
| Make | Opel Viv.TD 90kW 29 L3H1 Edit. |

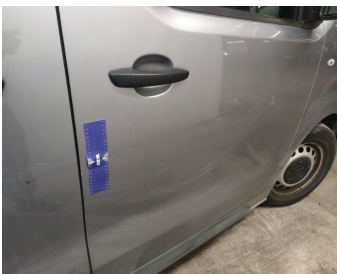
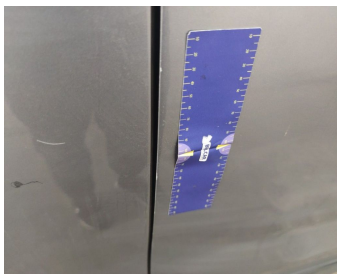
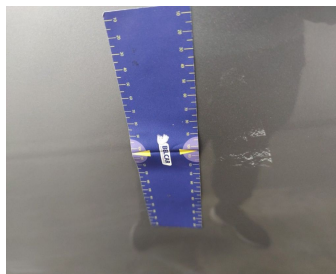
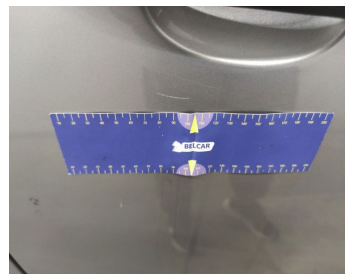
| Damages | Type | Acceptable |
|---|---|---|
| 213 | Door Front Right // Painting | Y |

Door Front Right // Painting-scratch

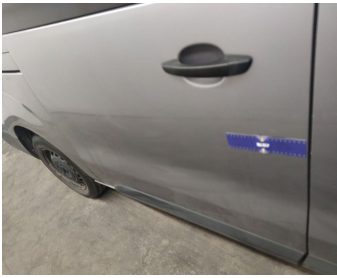
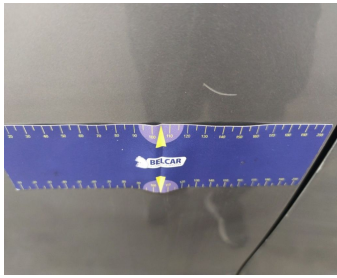
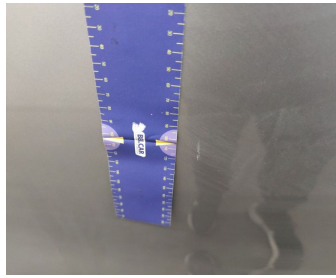
| Damages | Type | Acceptable |
|---|---|---|
| 193 | Door Rear Right // Painting | Y |

Door Rear Right // Painting-scratch

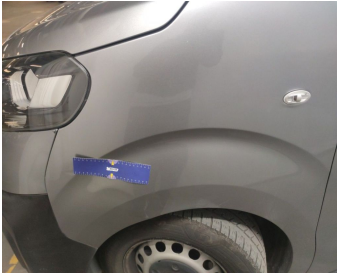
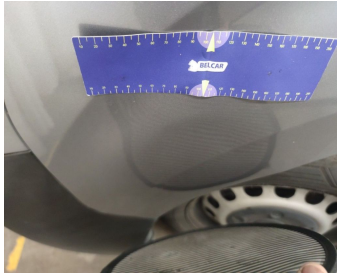
| Damages | Type | Acceptable |
|---|---|---|
| 64 | Wing Front Left // Repair & Painting | N |

Wing Front Left // Repair & Painting-dent

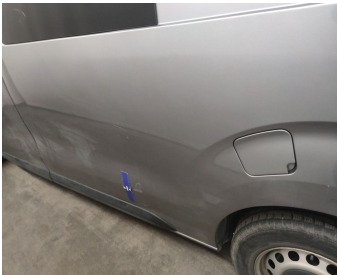
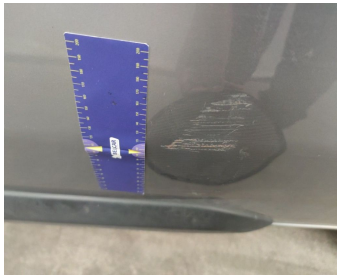
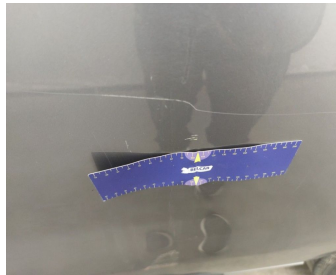
| Damages | Type | Acceptable |
|---|---|---|
| 114 | Wing Rear Left // Repair & Painting | N |

Wing Rear Left // Repair & Painting-scratch + dent

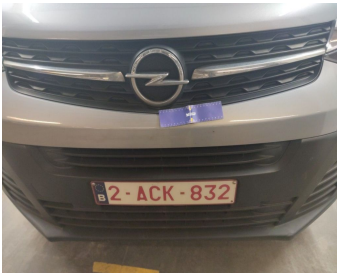
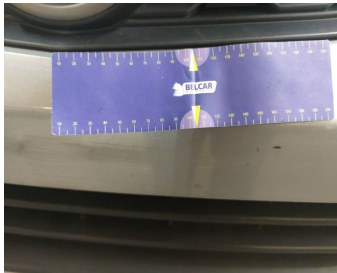
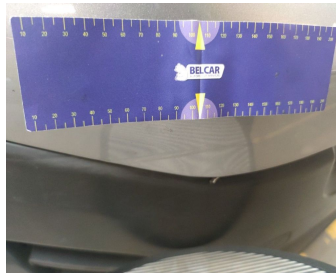
| Damages | Type | Acceptable |
|---|---|---|
| 14 | Bumper Front // Repair & Painting | Y |

Bumper Front // Repair & Painting-scratch + dent

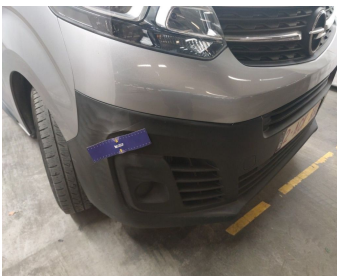
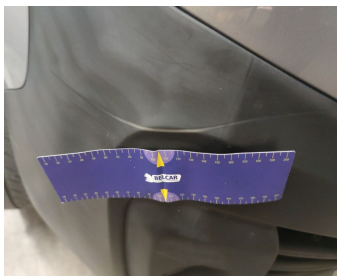
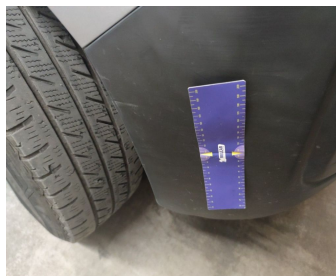
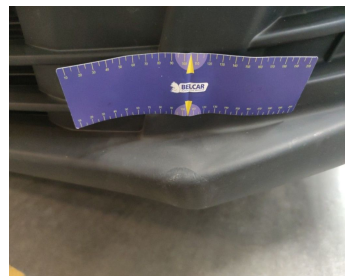
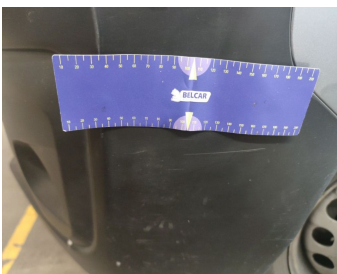
| Damages | Type | Acceptable |
|---|---|---|
| 19 | Bumper Front / Lower Cover Not Painted / Replace | N |

Bumper Front / Lower Cover Not Painted / Replace-scratch + dent

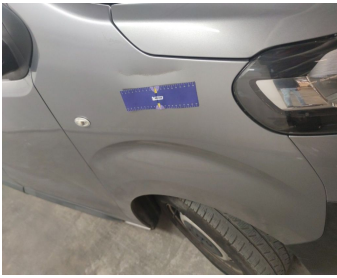
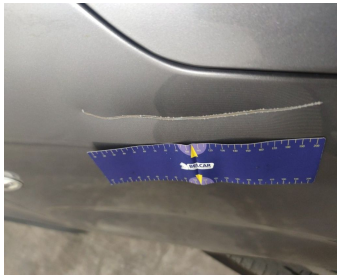
| Damages | Type | Acceptable |
|---|---|---|
| 234 | Wing Front right // Repair & Painting | N |

Wing Front right // Repair & Painting-scratch + dent

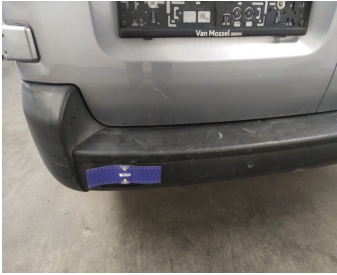
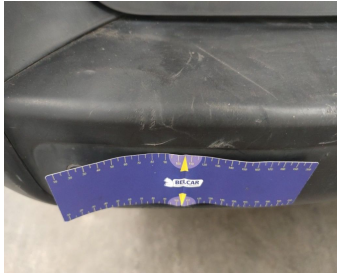
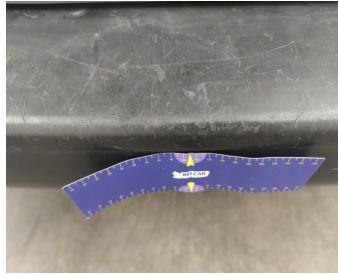
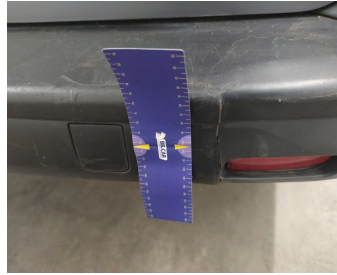
| Damages | Type | Acceptable |
|---|---|---|
| 138 | Bumper Rear / Lower Cover Not Painted / Replace | N |

Bumper Rear / Lower Cover Not Painted / Replace-cracked

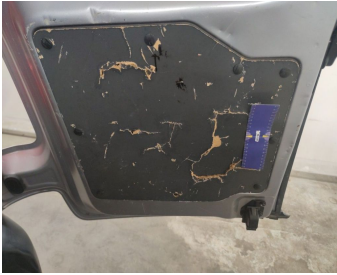
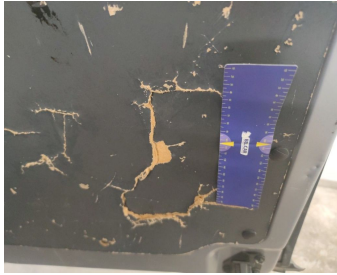
| Damages | Type | Acceptable |
|---|---|---|
| 593 | Trunk Lid Interior Coating / MDF Rear Right / Replace | Y |

Trunk Lid Interior Coating / MDF Rear Right / Replace-cracked

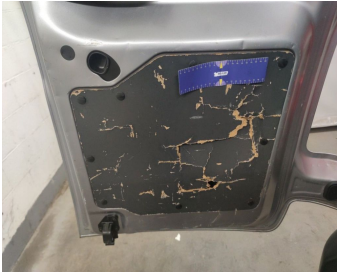
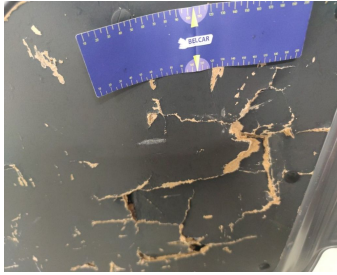
| Damages | Type | Acceptable |
|---|---|---|
| 592 | Trunk Lid Interior Coating / MDF Rear Left / Replace | Y |

Trunk Lid Interior Coating / MDF Rear Left / Replace-cracked

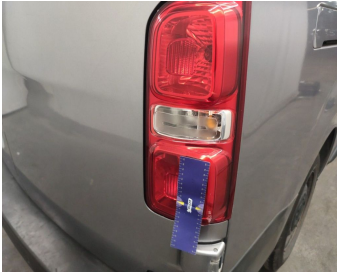
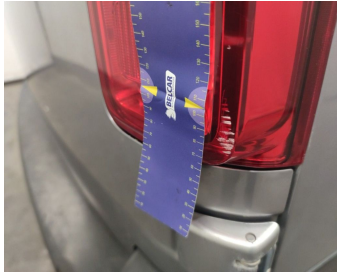
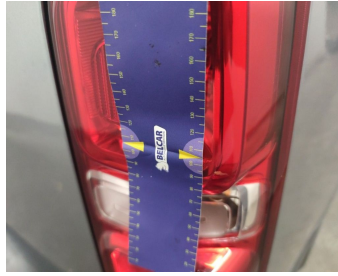
| Damages | Type | Acceptable |
|---|---|---|
| 174 | Light / Rear Right / Replace | N |

Light / Rear Right / Replace-cracked

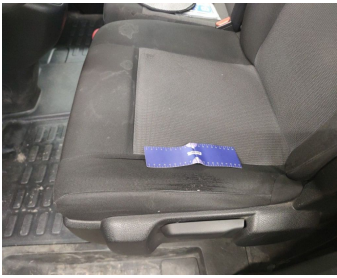
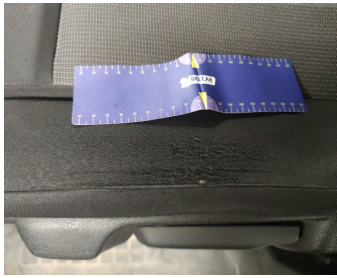
| Damages | Type | Acceptable |
|---|---|---|
| 412 | Seat Front Left / Bottom Coating / Replace | Y |

Seat Front Left / Bottom Coating / Replace-worn

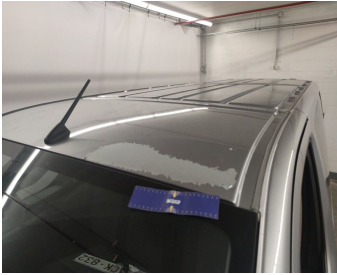
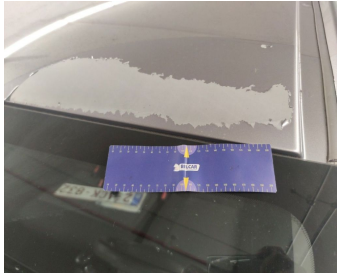
| Damages | Type | Acceptable |
|---|---|---|
| 162 | Roof // Painting | N |

Roof // Painting-Chipped paint

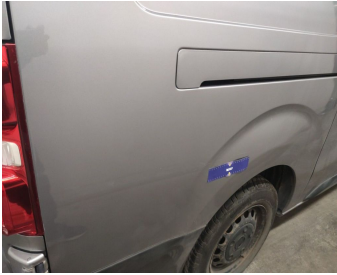
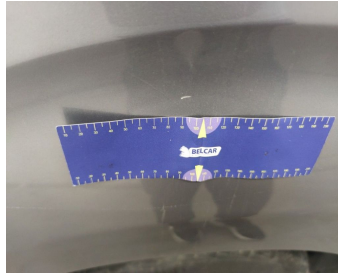
| Damages | Type | Acceptable |
|---|---|---|
| 183 | Wing Rear Right // Painting | Y |

Wing Rear Right // Painting-scratch

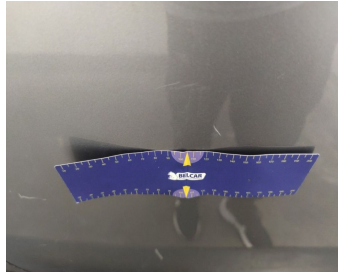
| Damages | Type | Acceptable |
|---|---|---|
| 303 | Rear Loading Door Right // Painting | N |

Rear Loading Door Right // Painting-scratch

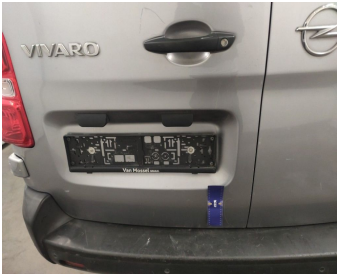
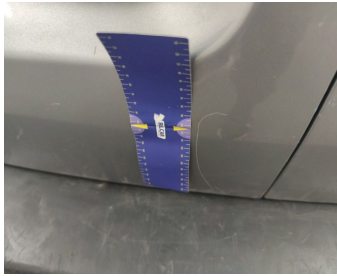
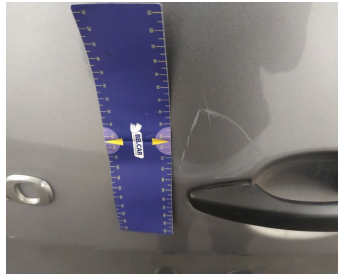
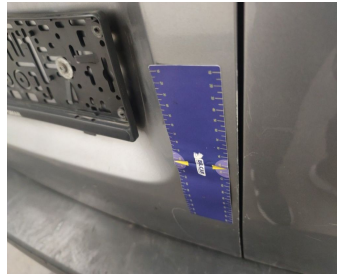
| Damages | Type | Acceptable |
|---|---|---|
| 293 | Rear Loading Door Left // Painting | N |

Rear Loading Door Left // Painting-scratch

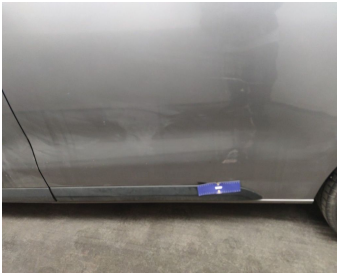
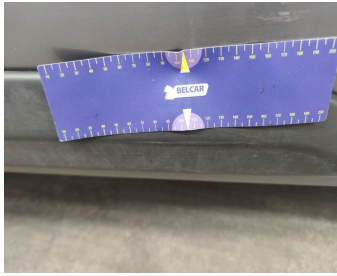
| Damages | Type | Acceptable |
|---|---|---|
| 117 | Wing Rear Left / Trim / Replace | N |

Wing Rear Left / Trim / Replace-scratch

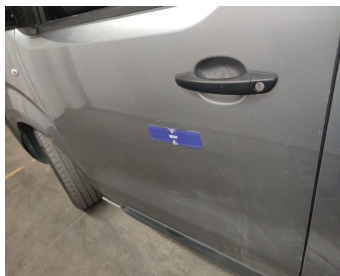
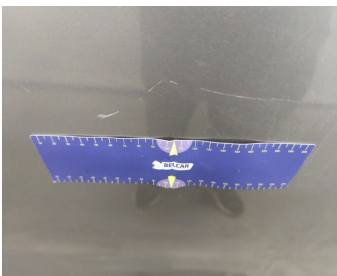
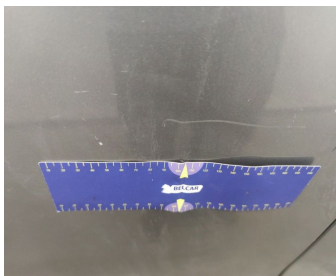
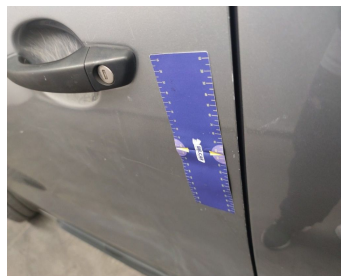
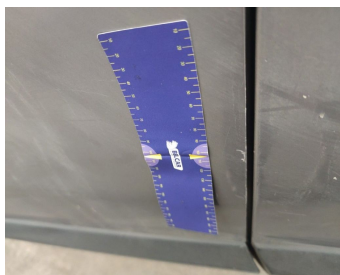
| Damages | Type | Acceptable |
|---|---|---|
| 83 | Door Front Left // Painting | N |

Door Front Left // Painting-scratch

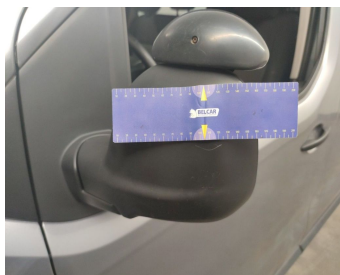
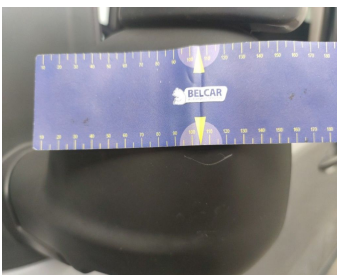
| Damages | Type | Acceptable |
|---|---|---|
| 77 | Side View Mirror Left / Shell / Replace Not Painted | Y |

Side View Mirror Left / Shell / Replace Not Painted-scratch

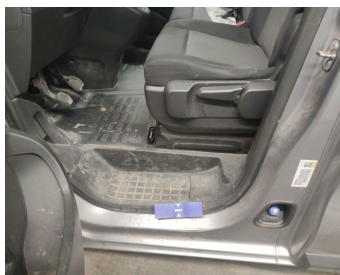
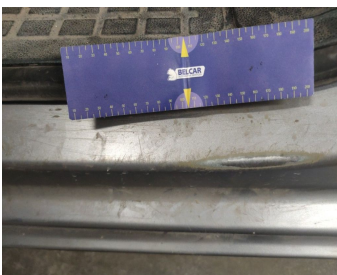
| Damages | Type | Acceptable |
|---|---|---|
| 91 | Rocker Panel Left // Smart Repair Medium | N |

Rocker Panel Left // Smart Repair Medium-scratch

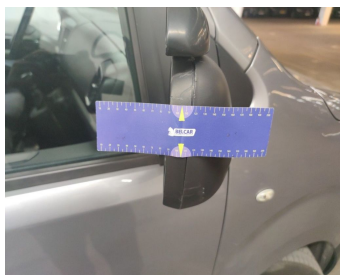
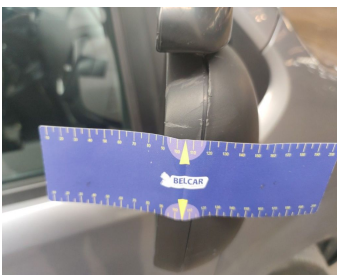
| Damages | Type | Acceptable |
|---|---|---|
| 223 | Side View Mirror Right // Replace Not Painted | Y |

Side View Mirror Right // Replace Not Painted-scratch

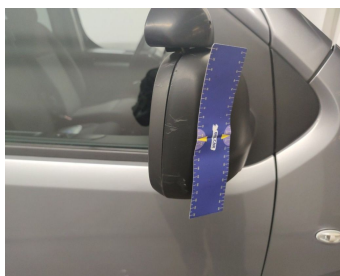
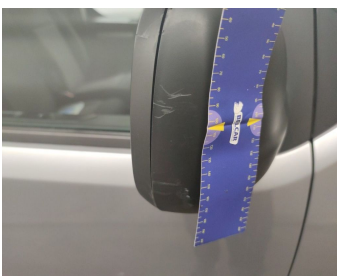
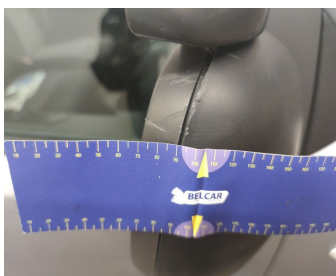
| Damages | Type | Acceptable |
|---|---|---|
| 226 | Side View Mirror Right / Shell / Replace Painted | Y |

Side View Mirror Right / Shell / Replace Painted-scratch
