INSPECTION REPORT

End of contract

File	307187
License plate	2ASW159
Vehicle identification number	VR3FCYHZTMY510141
Dossier	2021 075 172
Make	Peugeot 508SW 1.5 BHDi Allure
Mileage	188240
First registration	05/07/2021
client availability date	03/03/2026
inspectionDate	24/03/2026

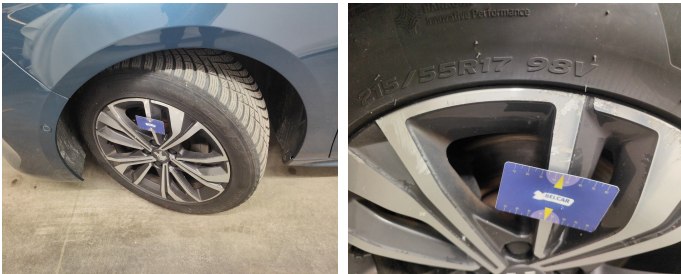
Wheel Two Tone Front Left // Repair-scratch

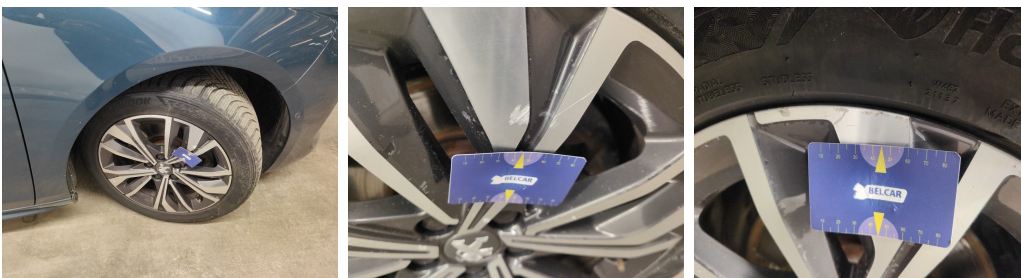
Wheel Two Tone Front Right // Repair-scratch

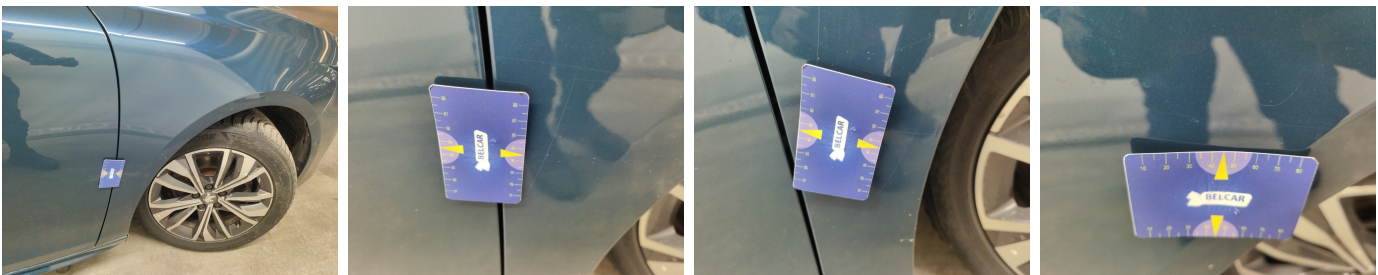
Wing Front right // Polish-scratch

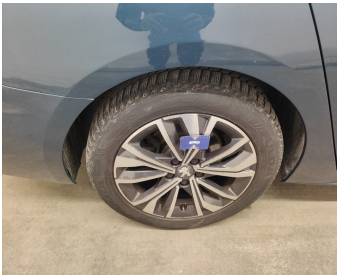
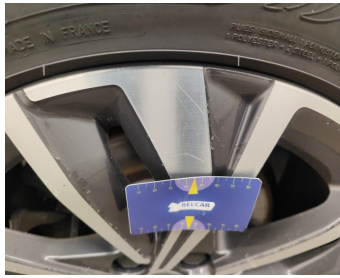
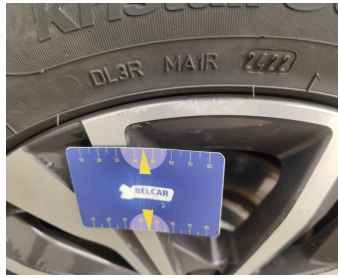
Wheel Two Tone Rear Right // Repair-scratch

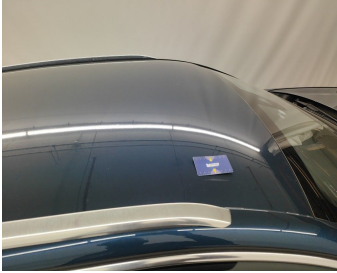
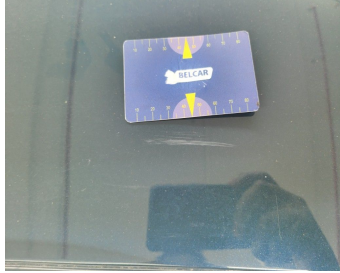
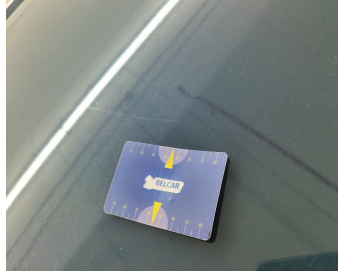
Roof // Polish-scratch

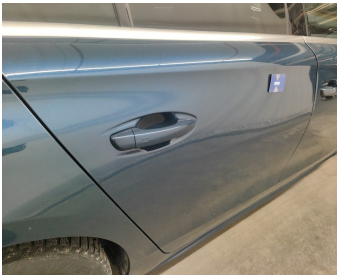
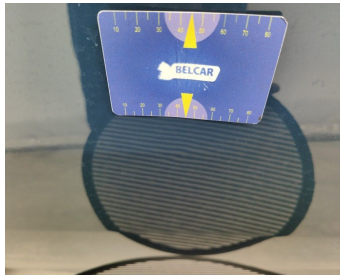
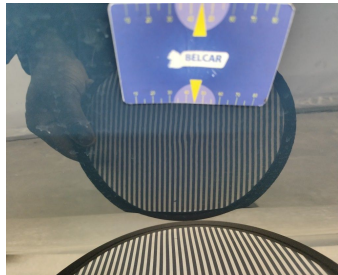
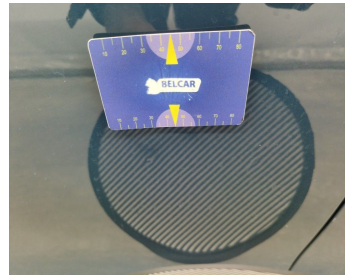
Door Rear Right // Repair & Painting-dent

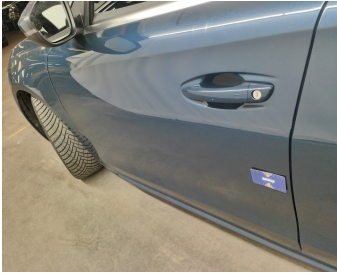
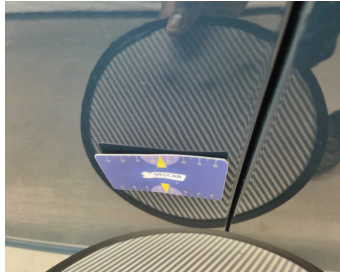
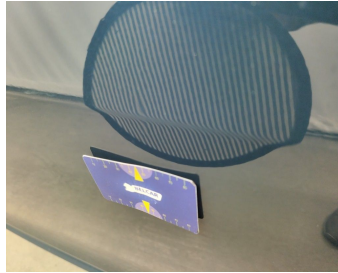
Door Front Left // Repair & Painting-dent

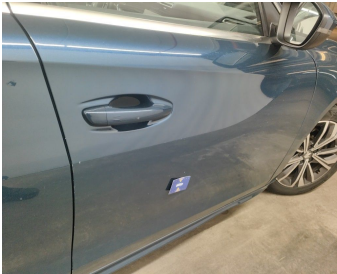
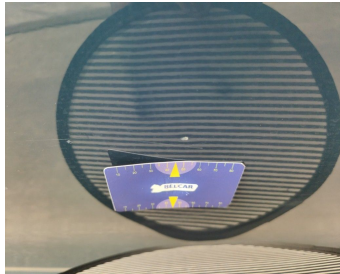
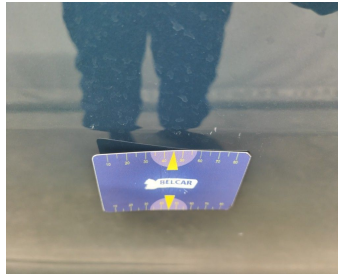
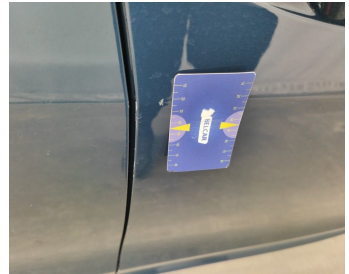
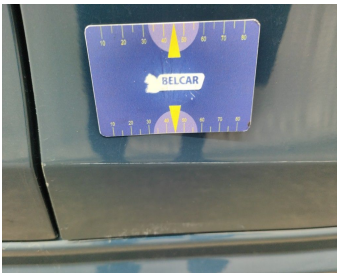
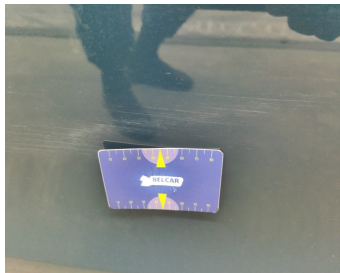
Door Front Right // Repair & Painting-scratch + dent

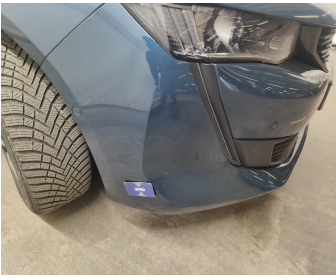
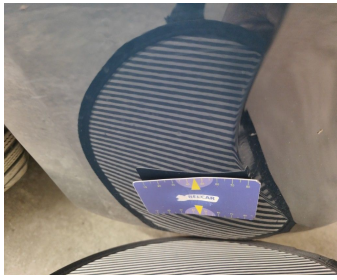
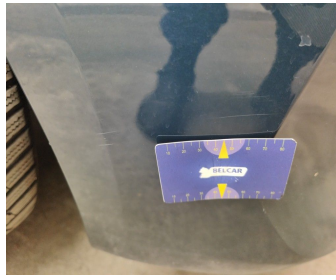
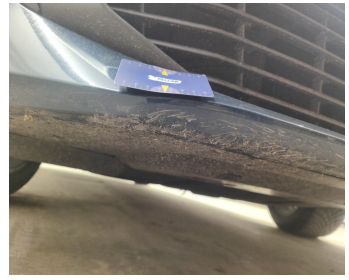
Bumper Front // Repair & Painting-scratch + dent

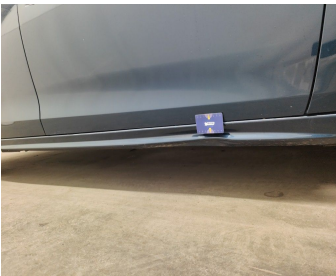
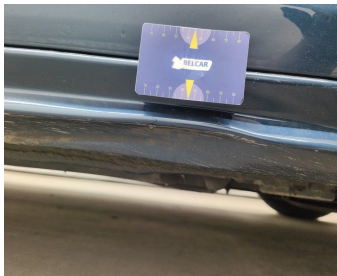
Rocker Panel Right // Repair & Painting-scratch + dent

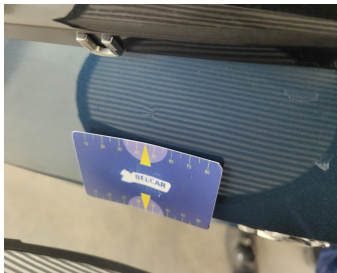
Rear Bonnet // Painting-bad repair

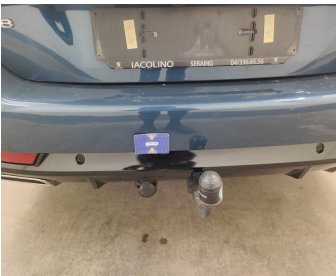
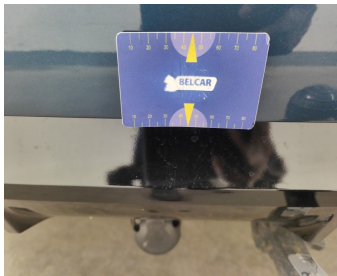
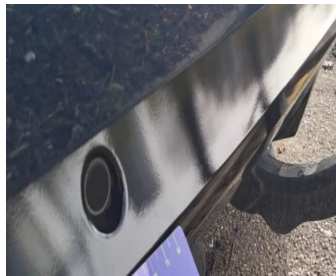
Bumper Rear / Lower Cover Not Painted / Replace-bad repair

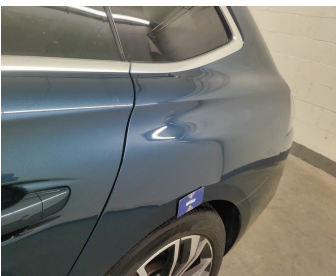
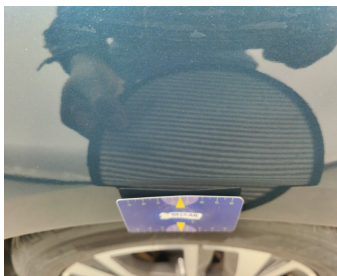
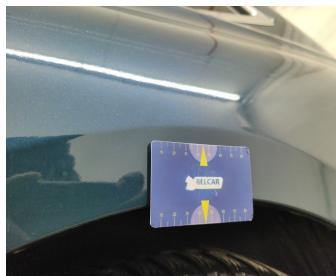
Wing Rear Left // Painting-bad repair

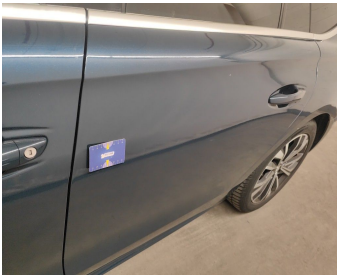
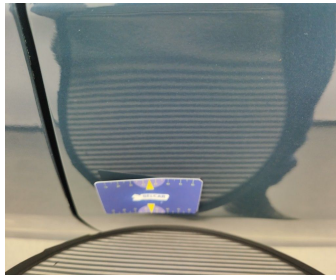
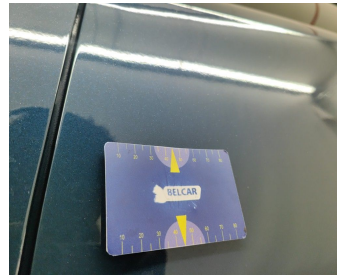
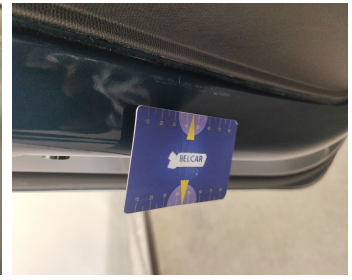
Door Rear Left // Painting-bad repair

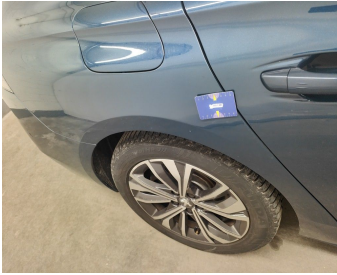
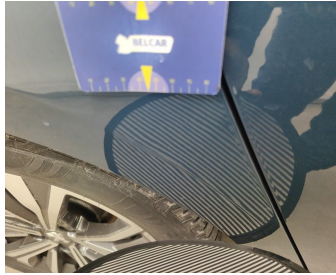
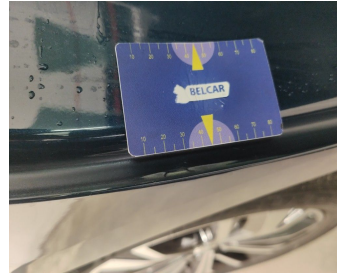
Wing Rear Right // Painting-bad repair

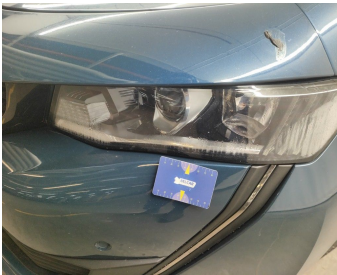
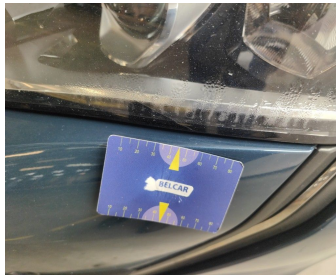
Headlight / Front left / Replace-cracked

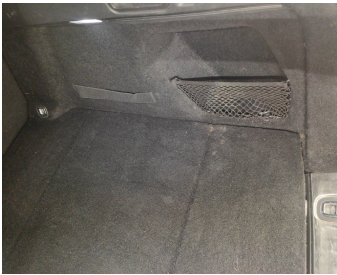
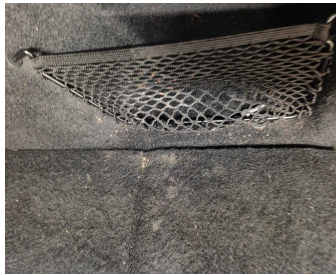
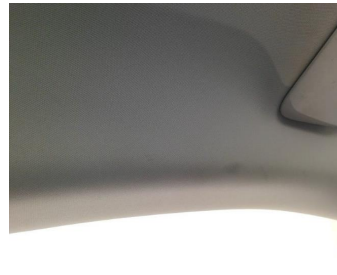
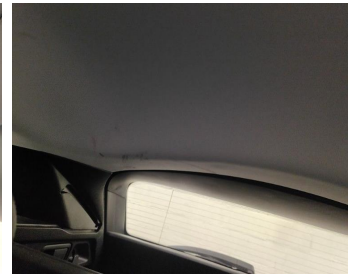
Interior Cleaning // Small-stain

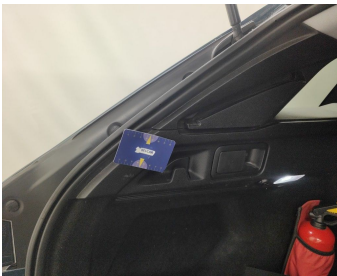
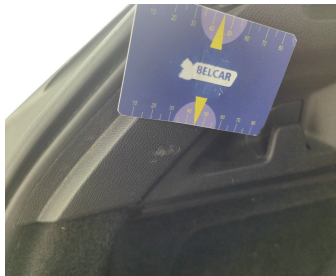
Trunk Compartment / Side Cover Left / Replace-scratch

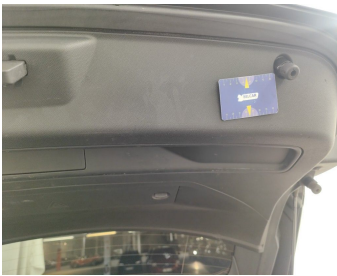
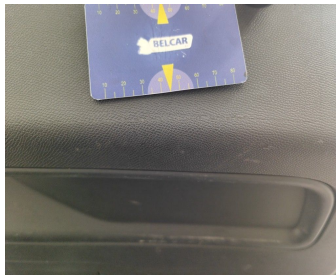
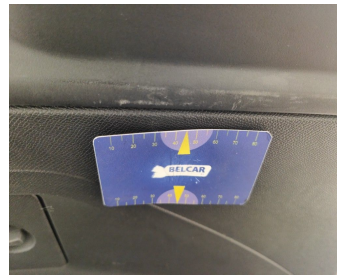
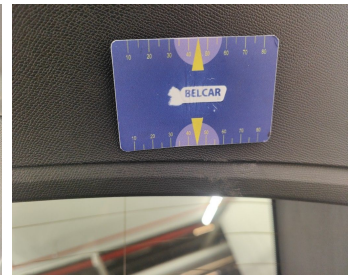
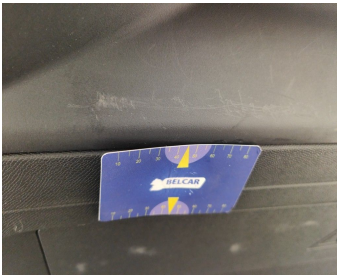
Trunk Lid Interior Coating / Complete Panel / Replace-scratch

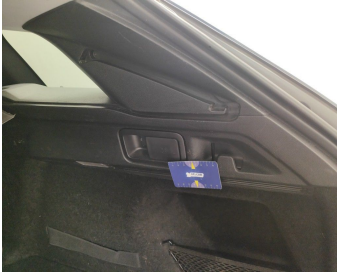
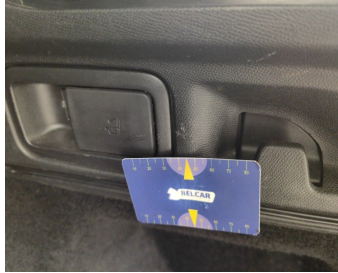
Trunk Compartment / Side Cover Right / Replace-scratch

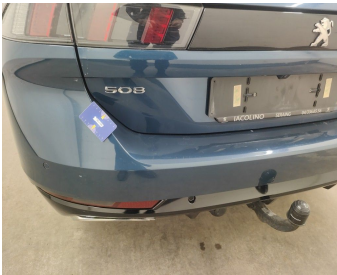
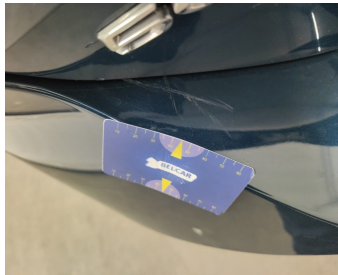
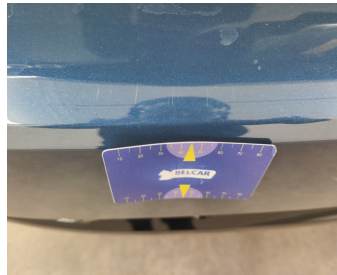
Bumper Rear // Smart Repair Medium-scratch

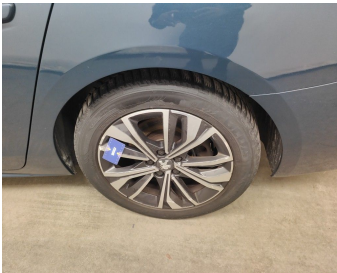
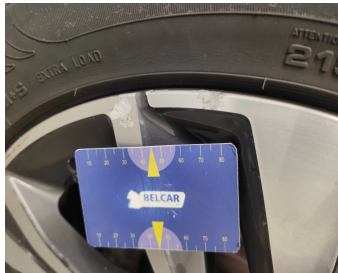
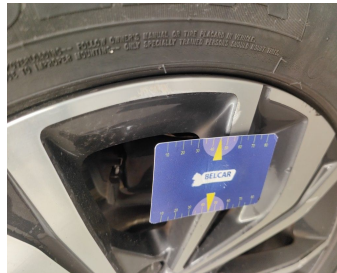
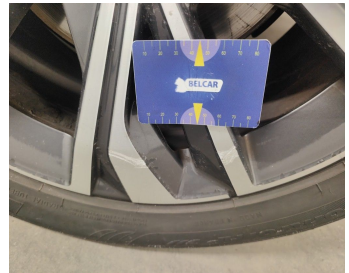
Wheel Two Tone Rear Left // Repair-scratch

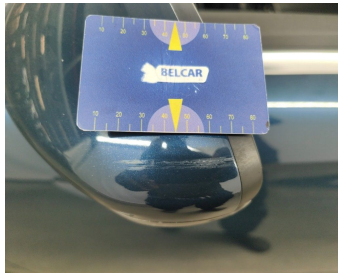
Side View Mirror Left // Painting-scratch

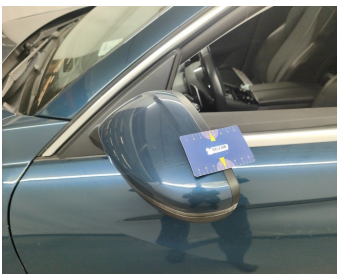
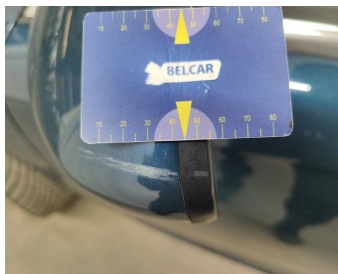
Side View Mirror Left // Replace Not Painted-scratch
