# INSPECTION REPORT

End of contract

| License plate | 2AGQ166 |
| Make | Peugeot 308 SW 1.5BHDi 130 Act |

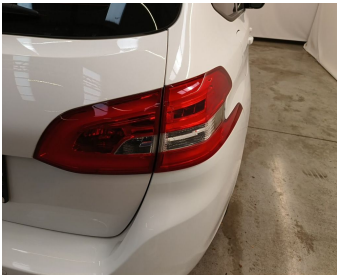
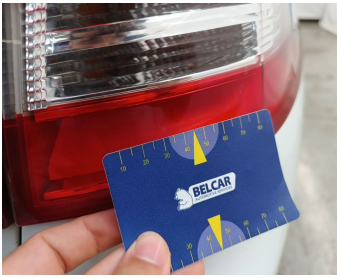
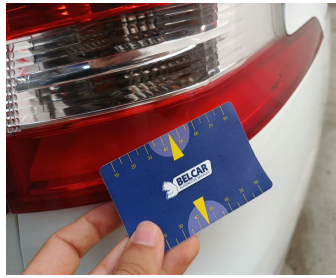
| Damages | Type | Acceptable |
|---|---|---|
| 174 | Light / Rear Right / Replace | Y |

Light / Rear Right / Replace-scratch

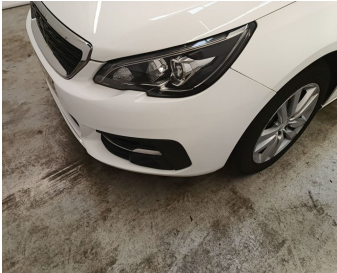
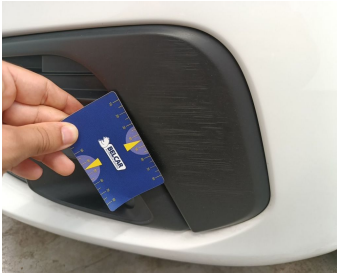
| Damages | Type | Acceptable |
|---|---|---|
| 273 | Bumper Front / Grid Left / Replace | N |

Bumper Front / Grid Left / Replace-scratch

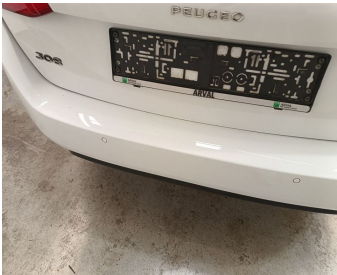
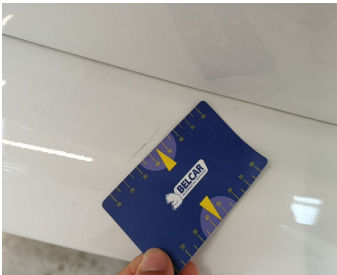
| Damages | Type | Acceptable |
|---|---|---|
| 136 | Bumper Rear // Polish | Y |

Bumper Rear // Polish-scratch

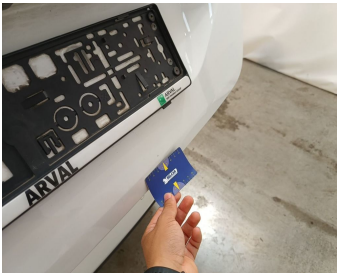
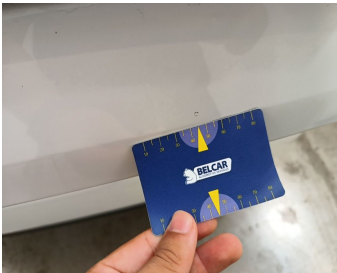
| Damages | Type | Acceptable |
|---|---|---|
| 153 | Rear Bonnet // Painting | Y |

Rear Bonnet // Painting-scratch

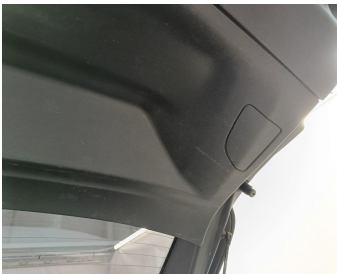
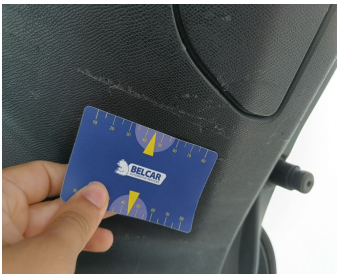
| Damages | Type | Acceptable |
|---|---|---|
| 594 | Trunk Lid Interior Coating / Complete Panel / Replace | Y |

Trunk Lid Interior Coating / Complete Panel / Replace-scratch

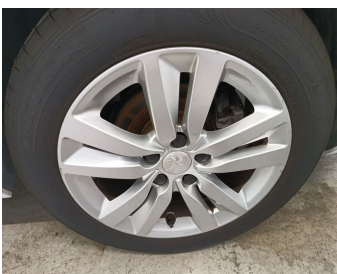
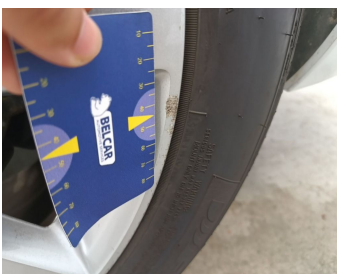
| Damages | Type | Acceptable |
|---|---|---|
| 321 | Wheel Alloy Rear Left // Repair | Y |

Wheel Alloy Rear Left // Repair-scratch

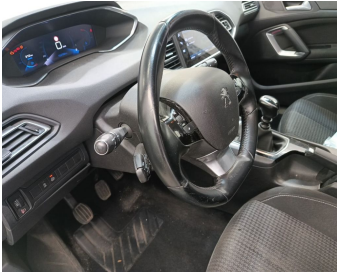
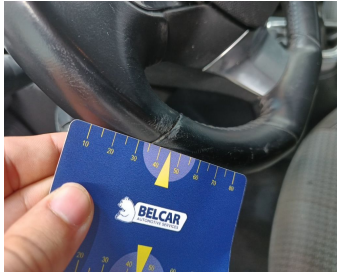
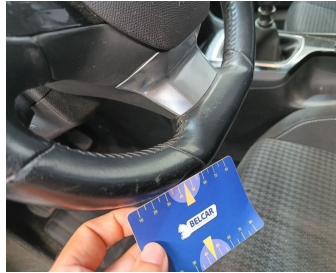
| Damages | Type | Acceptable |
|---|---|---|
| 569 | Dashboard / Steering Wheel / Replace | Y |

Dashboard / Steering Wheel / Replace-scratch

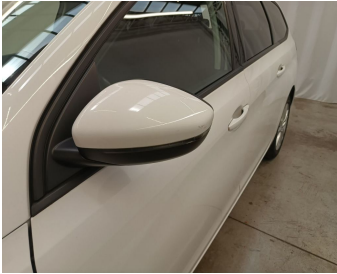
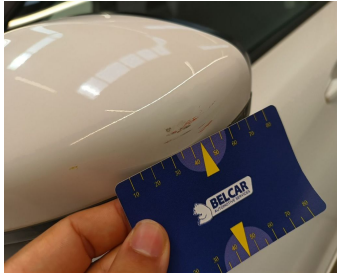
| Damages | Type | Acceptable |
|---|---|---|
| 72 | Side View Mirror Left // Painting | N |

Side View Mirror Left // Painting-scratch

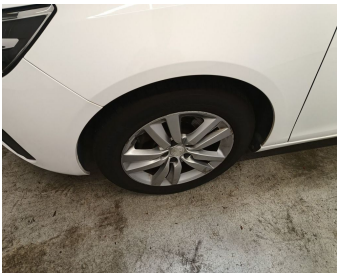
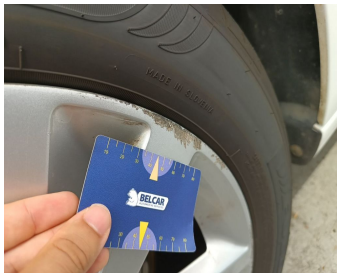
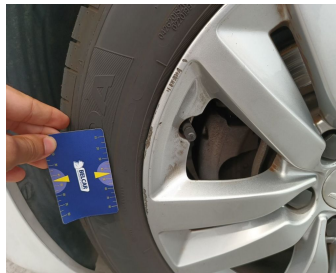
| Damages | Type | Acceptable |
|---|---|---|
| 311 | Wheel Alloy Front Left // Repair | N |

Wheel Alloy Front Left // Repair-scratch

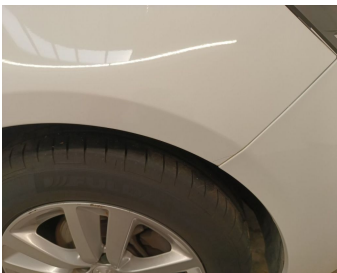
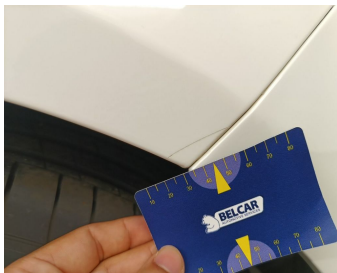
| Damages | Type | Acceptable |
|---|---|---|
| 233 | Wing Front right // Painting | Y |

Wing Front right // Painting-scratch

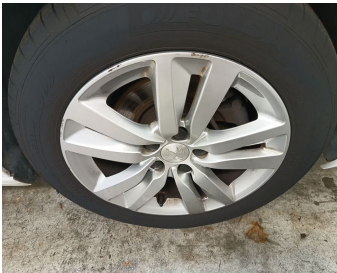
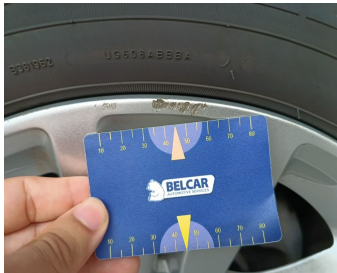
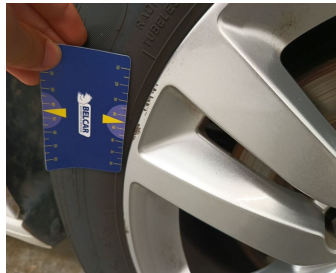
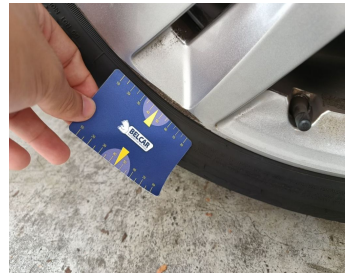
| Damages | Type | Acceptable |
|---|---|---|
| 341 | Wheel Alloy Front Right // Repair | N |

Wheel Alloy Front Right // Repair-scratch

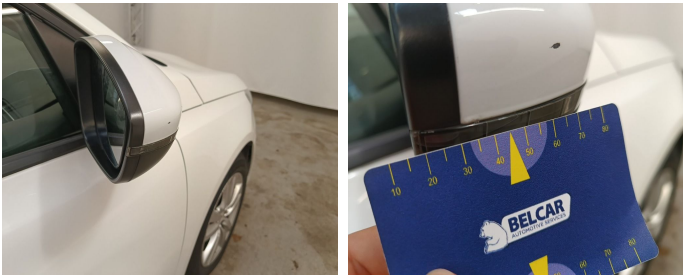
| Damages | Type | Acceptable |
|---|---|---|
| 228 | Side View Mirror Right / Direction Indicator / Replace | Y |

Side View Mirror Right / Direction Indicator / Replace-scratch

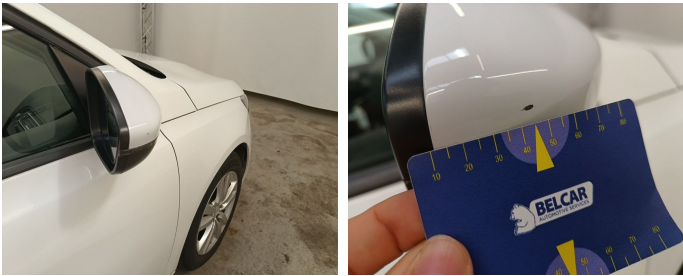
| Damages | Type | Acceptable |
|---|---|---|
| 222 | Side View Mirror Right // Painting | Y |

Side View Mirror Right // Painting-scratch

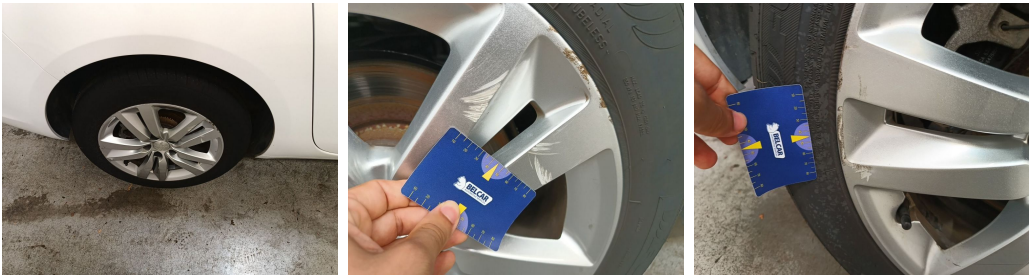
| Damages | Type | Acceptable |
|---|---|---|
| 331 | Wheel Alloy Rear Right // Repair | N |

Wheel Alloy Rear Right // Repair-scratch

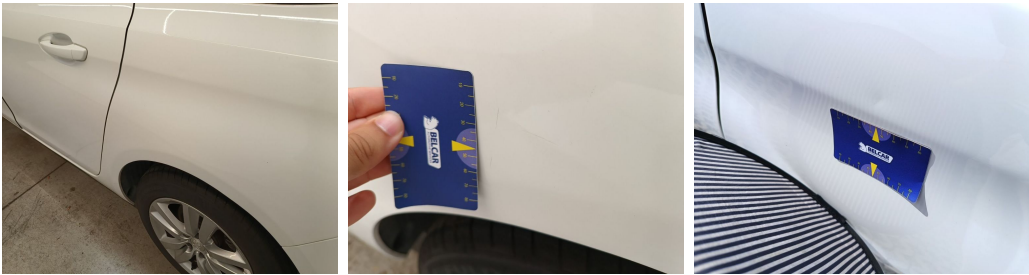
| Damages | Type | Acceptable |
|---|---|---|
| 110 | Wing Rear Left // Smart Repair Small | Y |

Wing Rear Left // Smart Repair Small-dent

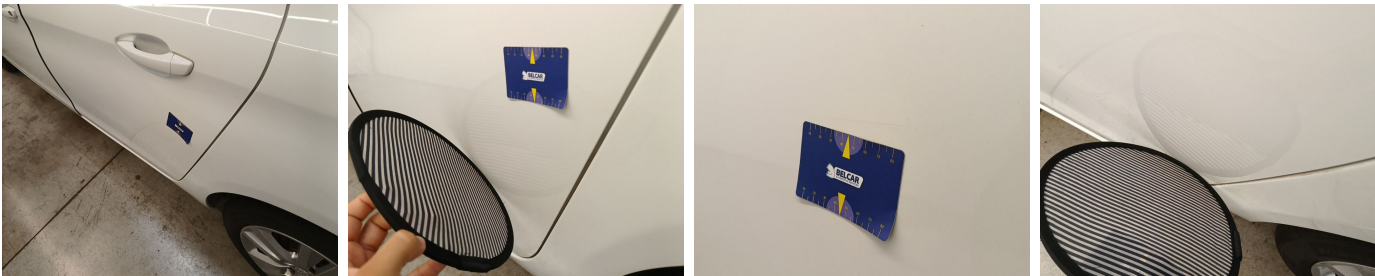
| Damages | Type | Acceptable |
|---|---|---|
| 100 | Door Rear Left // Smart Repair Small | N |

Door Rear Left // Smart Repair Small-dent

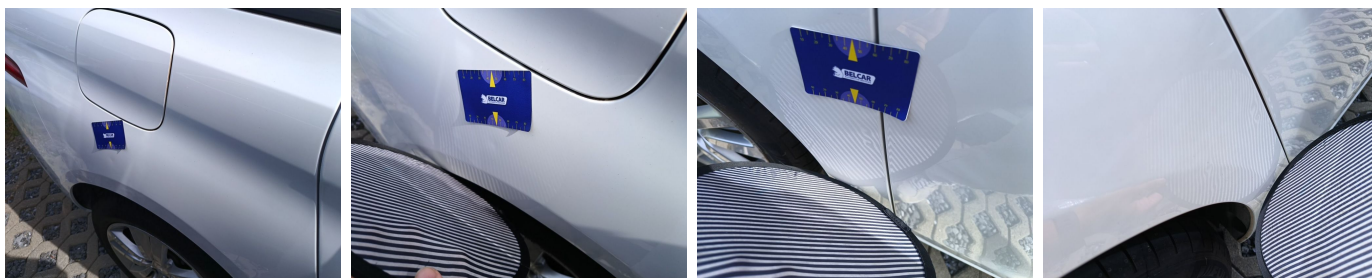
| Damages | Type | Acceptable |
|---|---|---|
| 180 | Wing Rear Right // Smart Repair Small | N |

Wing Rear Right // Smart Repair Small-dent

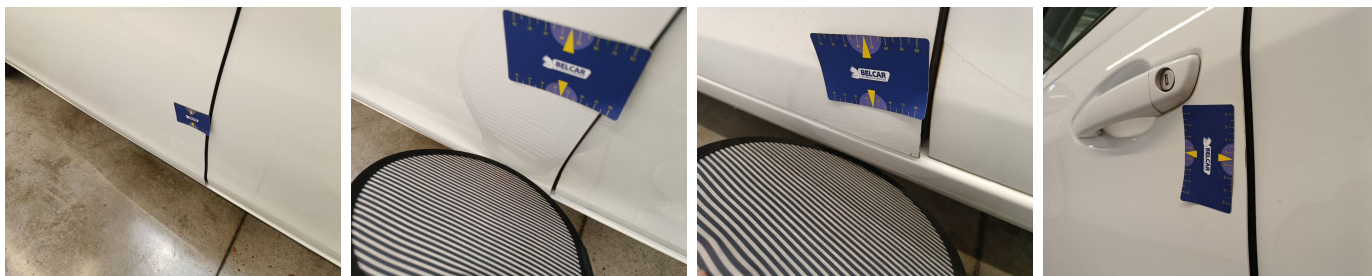
| Damages | Type | Acceptable |
|---|---|---|
| 84 | Door Front Left // Repair & Painting | N |

Door Front Left // Repair & Painting-dent

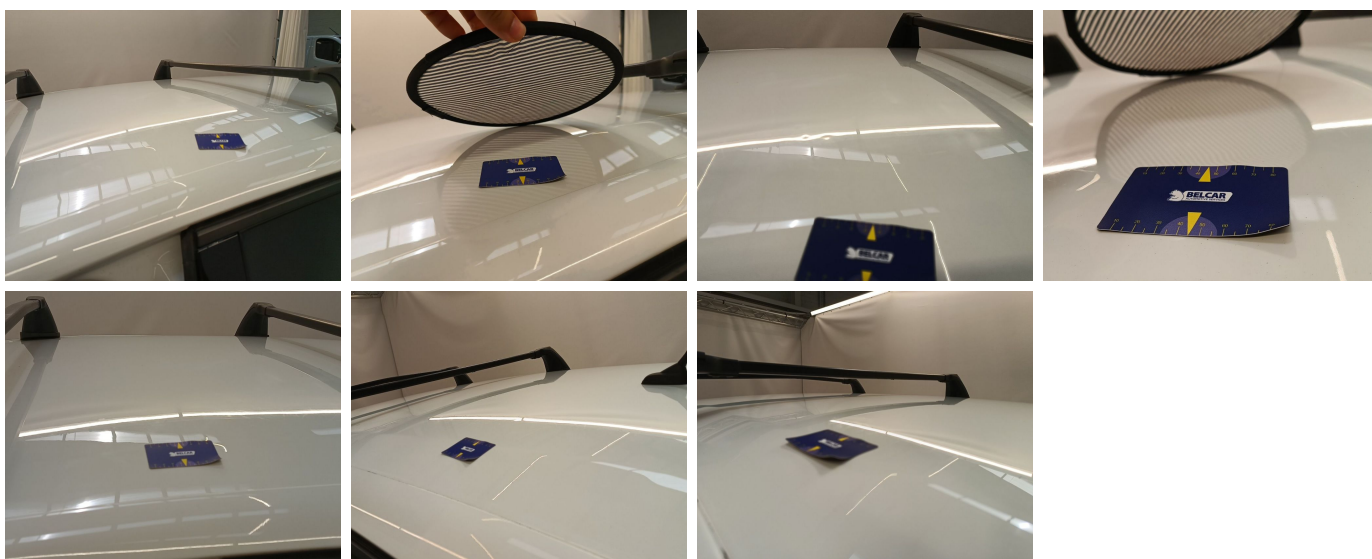
| Damages | Type | Acceptable |
|---|---|---|
| 163 | Roof // Repair & Painting | Y |

Roof // Repair & Painting-scratch + dent

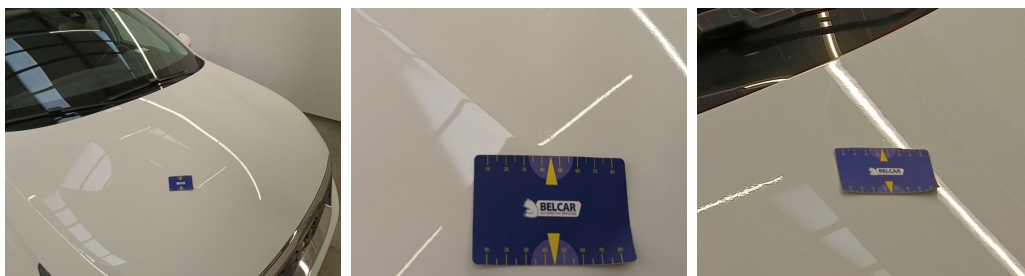
| Damages | Type | Acceptable |
|---|---|---|
| 32 | Front Bonnet // Painting | N |

Front Bonnet // Painting-bad repair

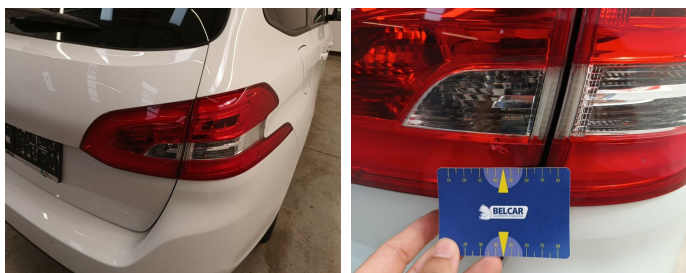
| Damages | Type | Acceptable |
|---|---|---|
| 175 | Light / Rear Right On Rear Bonnet / Replace | N |

Light / Rear Right On Rear Bonnet / Replace-cracked

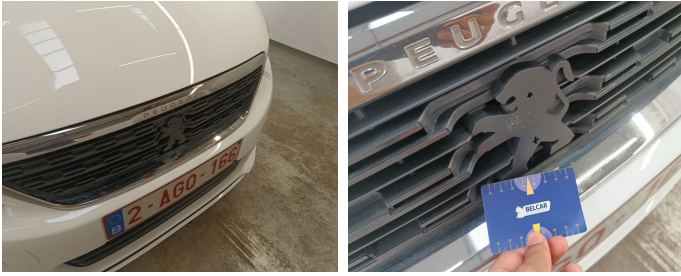
| Damages | Type | Acceptable |
|---|---|---|
| 27 | Front / Logo / Replace | N |

Front / Logo / Replace-missing

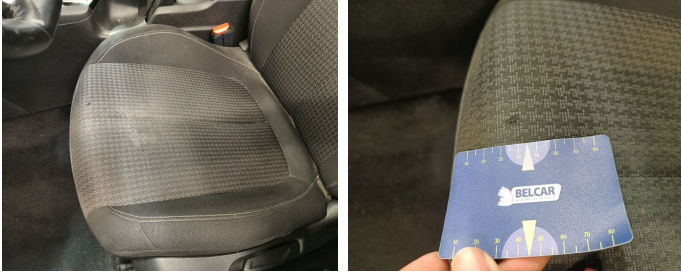
| Damages | Type | Acceptable |
|---|---|---|
| 412 | Seat Front Left / Bottom Coating / Replace | N |

Seat Front Left / Bottom Coating / Replace-hole

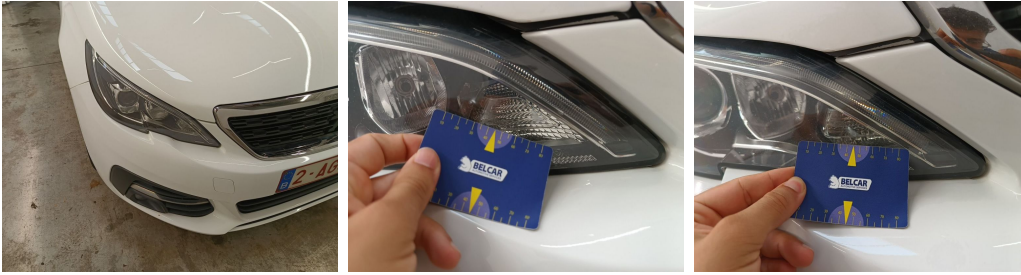
| Damages | Type | Acceptable |
|---|---|---|
| 244 | Light / Front Right / Replace | N |

Light / Front Right / Replace-Splashes

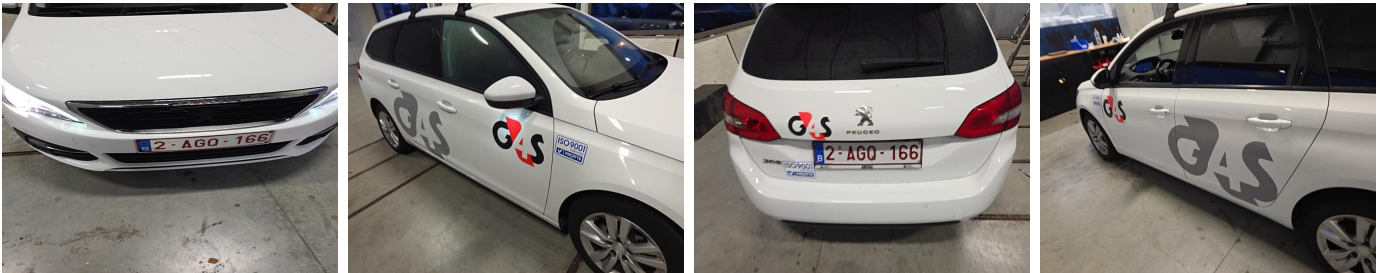
| Damages | Type | Acceptable |
|---|---|---|
| 891 | Lettering Removal 15min | N |

Lettering Removal 15min-
