# INSPECTION REPORT

End of contract

File	309084
License plate	2BEQ176
Vehicle identification number	KMHC851CGNU266846
Dossier	2021 161 089
Make	Hyundai Ioniq 1.6GDi Hybride F
Mileage	127373
First registration	22/10/2021
client availability date	27/03/2026
inspectionDate	02/04/2026

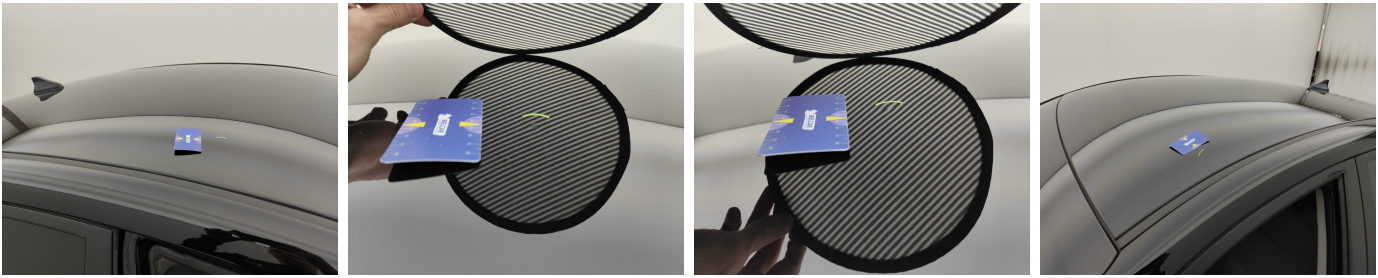
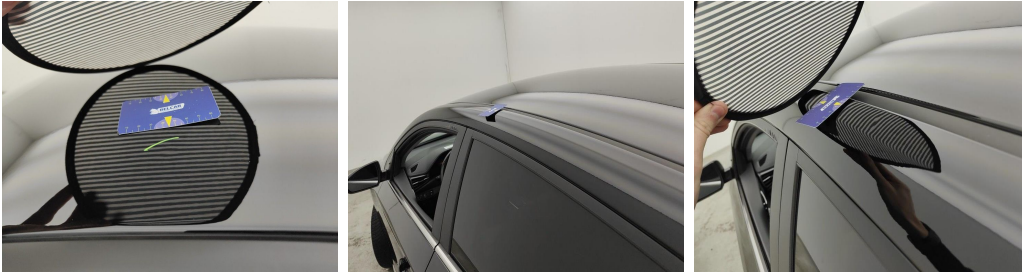
See External Expertise-

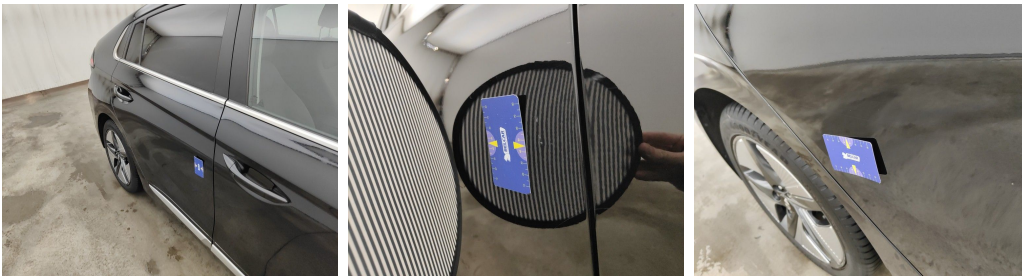
Door Rear Right // Repair & Painting-scratch + dent

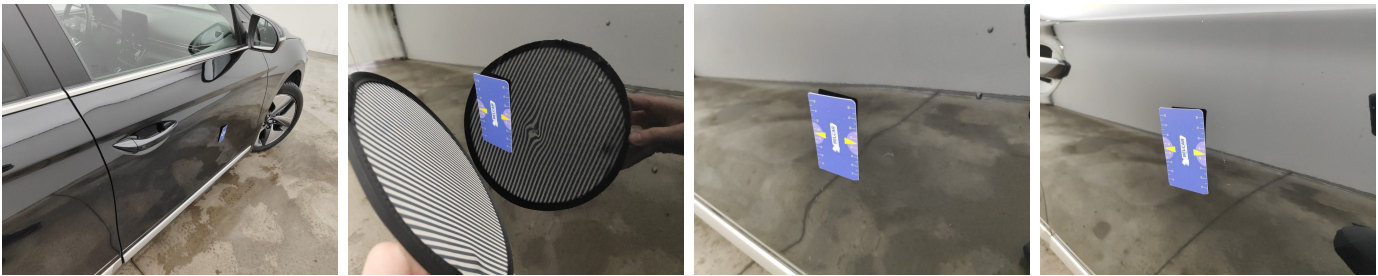
Door Front Right // Repair & Painting-scratch + dent

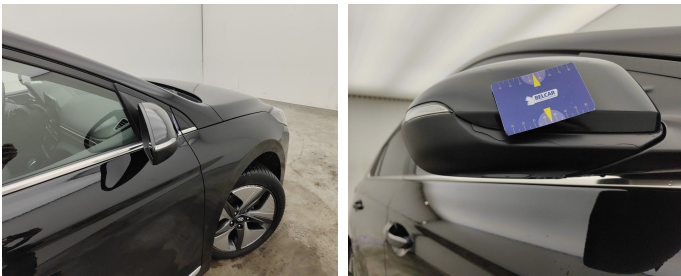
Side View Mirror Right / Shell / Replace Not Painted-cracked

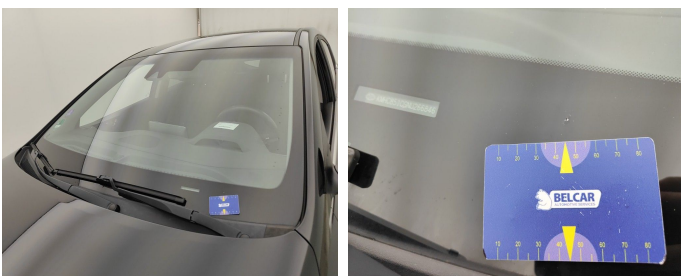
Windshield // Replace-cracked

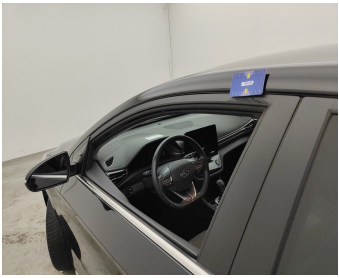
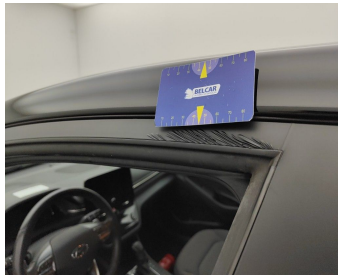
Door Front Left / Trim / Replace-Chemical reaction

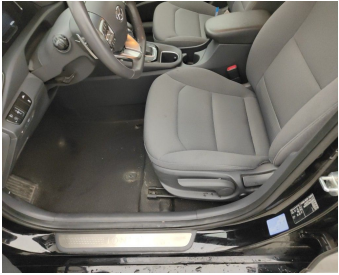
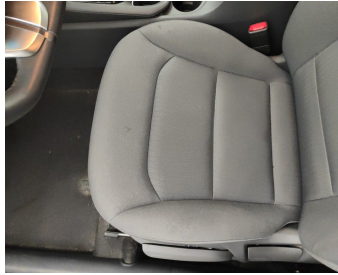
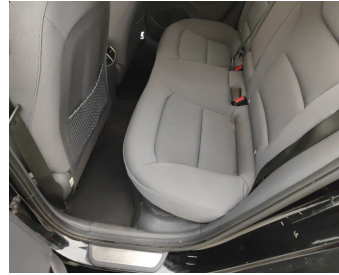
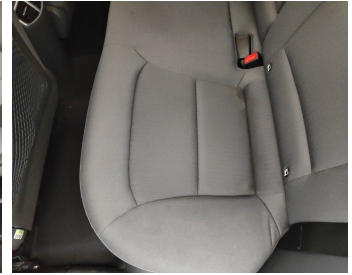
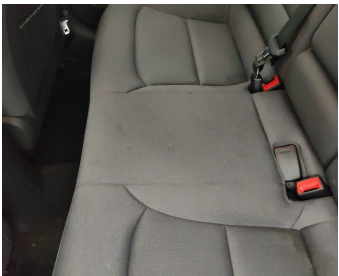
Interior Cleaning // Small-stain

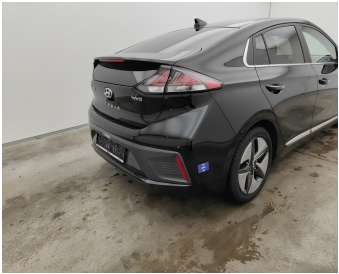
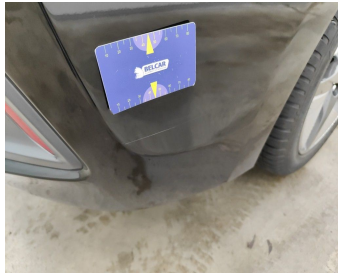
Bumper Rear // Smart Repair Medium-scratch

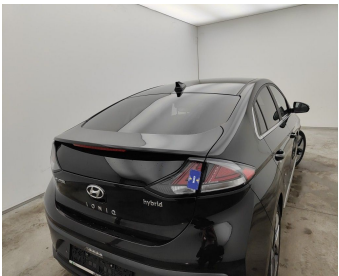
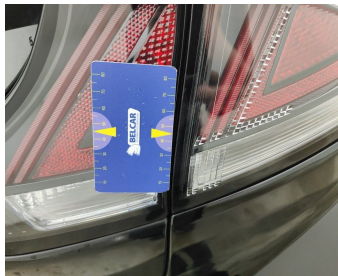
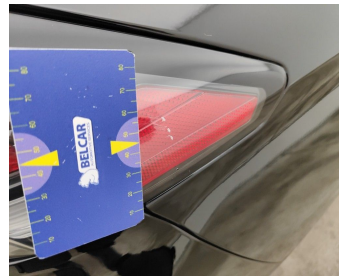
Light / Rear Right / Replace-scratch

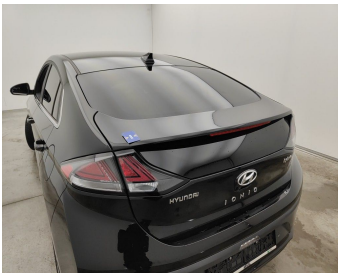
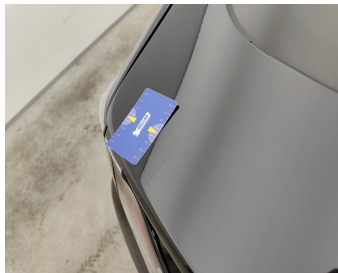
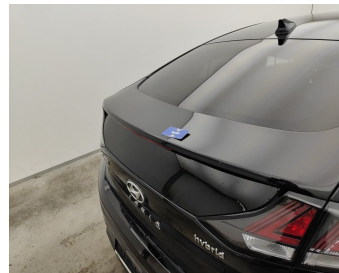
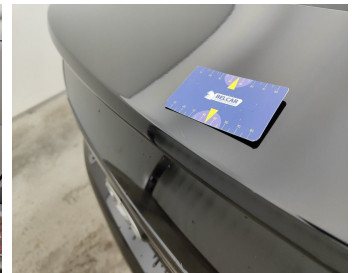
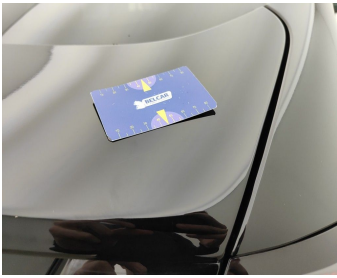
Rear Bonnet / Spoiler / Replace & Painting-scratch

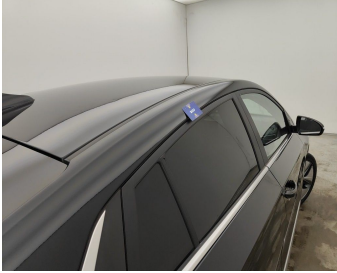
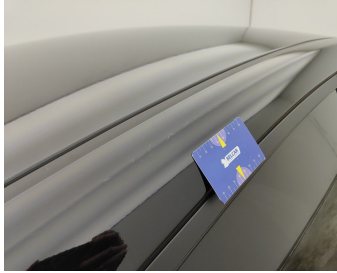
Roof // Smart Repair Medium-scratch

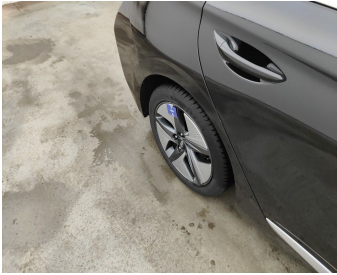
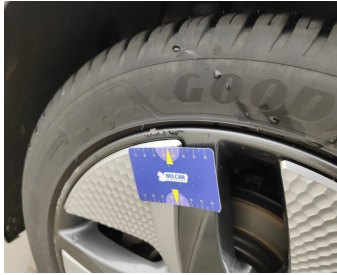
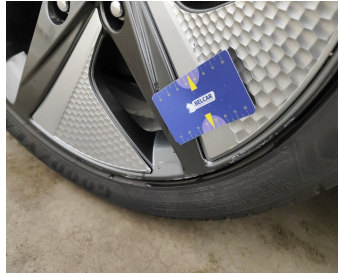
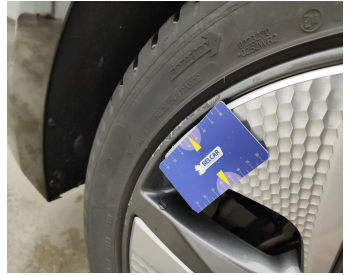
Wheel Alloy Rear Right // Repair-scratch

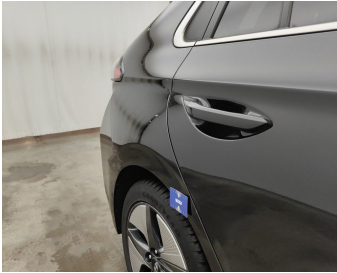
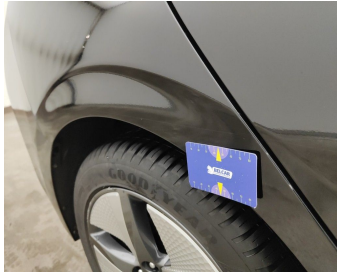
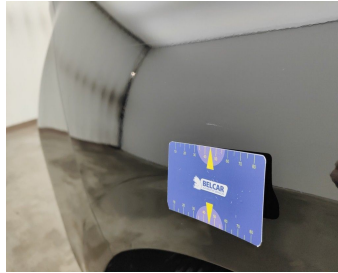
Wing Rear Right // Polish-scratch

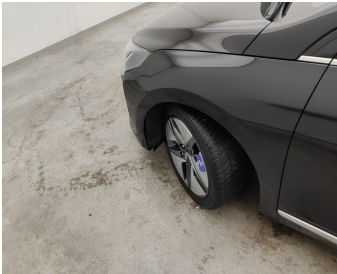
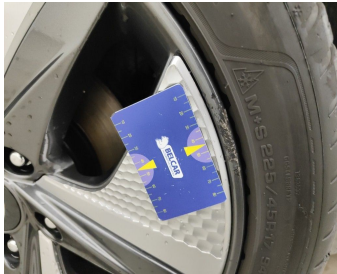
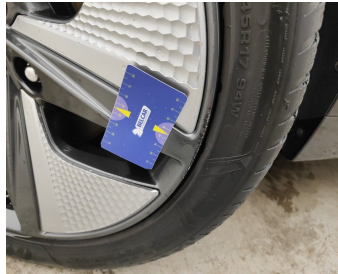
Wheel Alloy Front Left // Repair-scratch

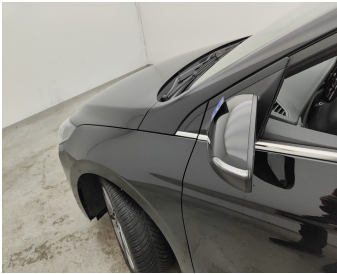
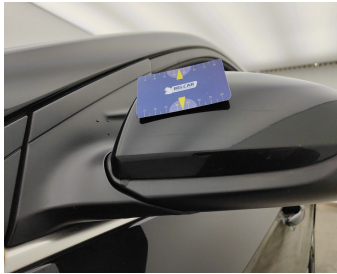
Side View Mirror Left // Painting-scratch

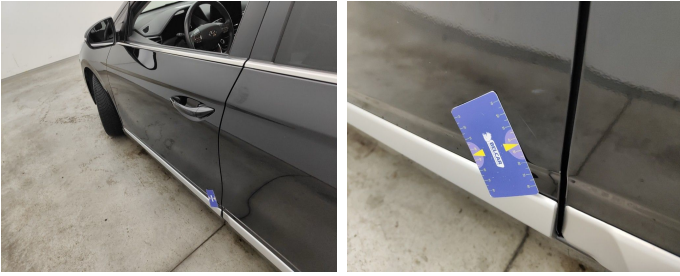
Door Front Left // Polish-scratch

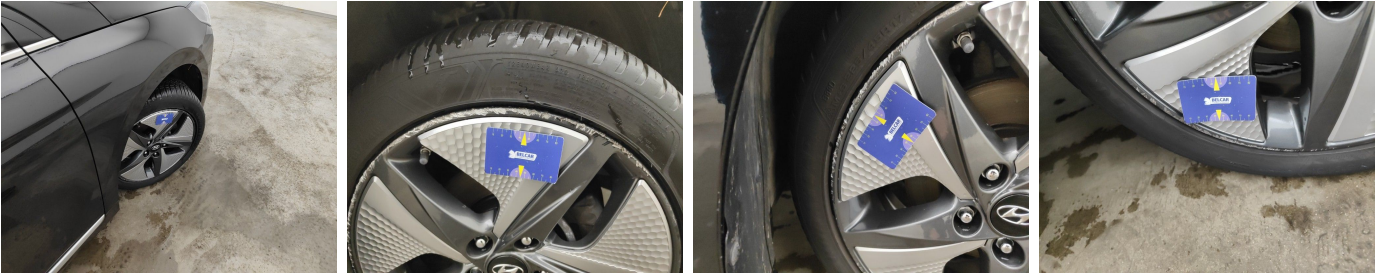
Wheel Alloy Front Right // Repair-scratch

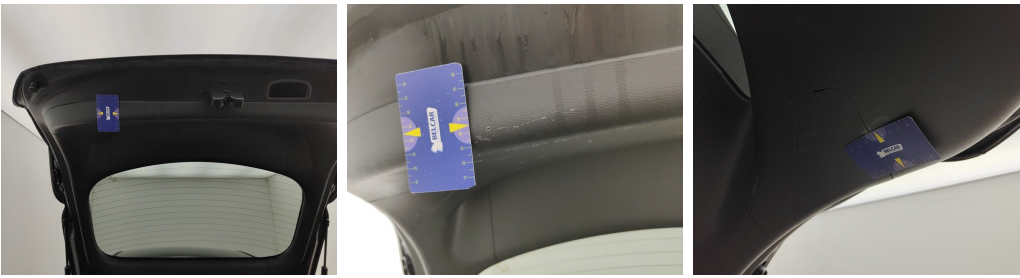
Trunk Lid Interior Coating / Complete Panel / Replace-scratch

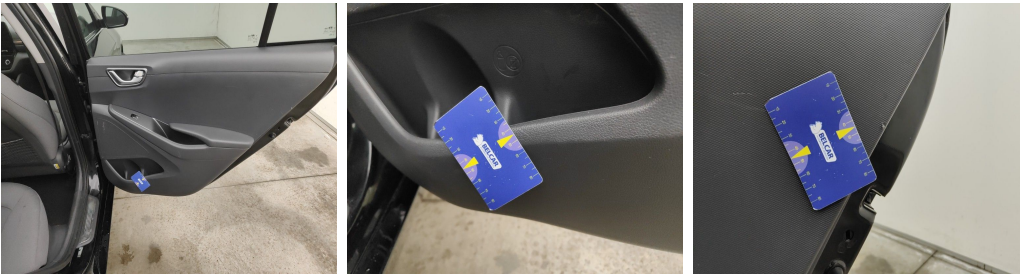
Rear Right Door Interior Coating // Repair-scratch

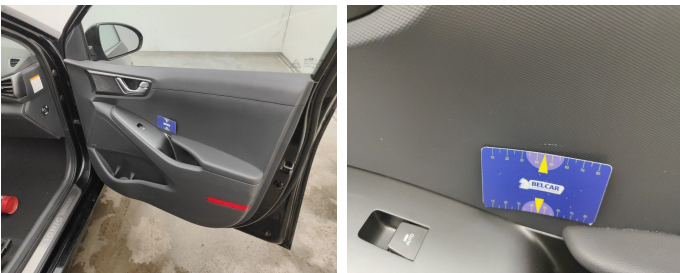
Front Right Door Interior Coating // Replace Completely-scratch

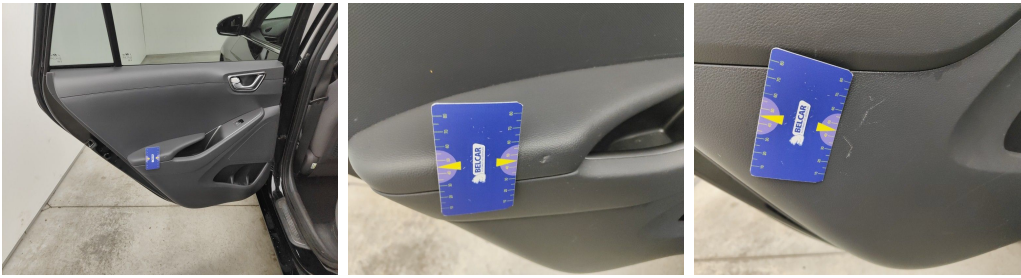
Rear Left Door Interior Coating // Repair-scratch

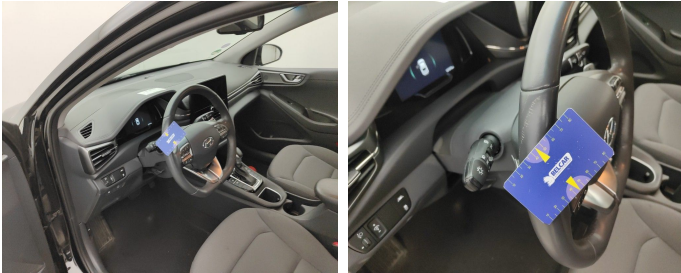
Dashboard / Steering Wheel / Replace-scratch

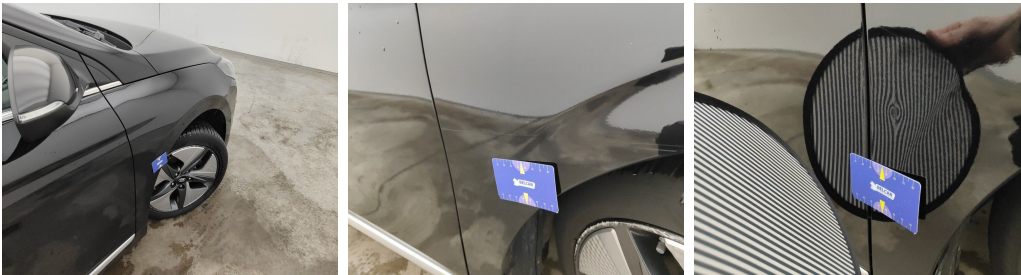
Wing Front right // Repair & Painting-scratch + dent

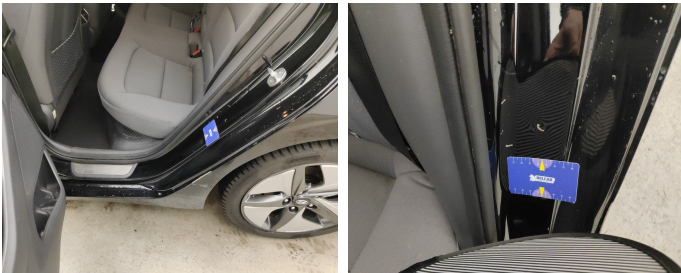
Rocker Panel Left // Smart Repair Medium-scratch + dent

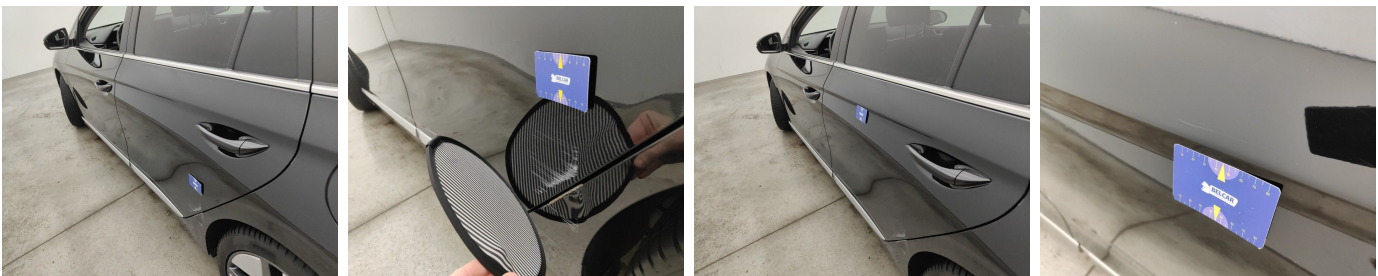
Door Rear Left // Repair & Painting-scratch + dent

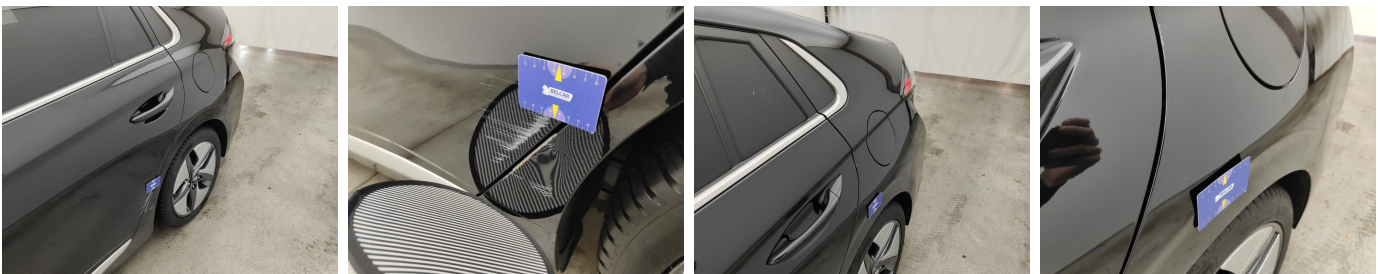
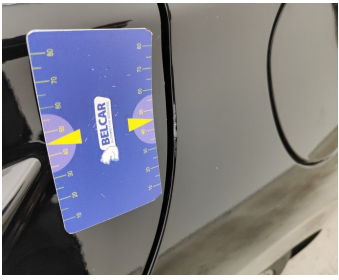
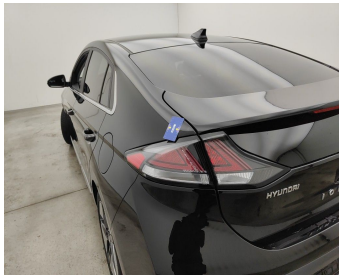
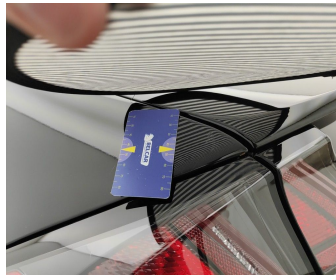
Wing Rear Left // Repair & Painting-scratch + dent
