# INSPECTION REPORT

End of contract

| License plate | 2CCB326 |
| Make | Seat Ateca 1.5TSI 150 Move DSG |

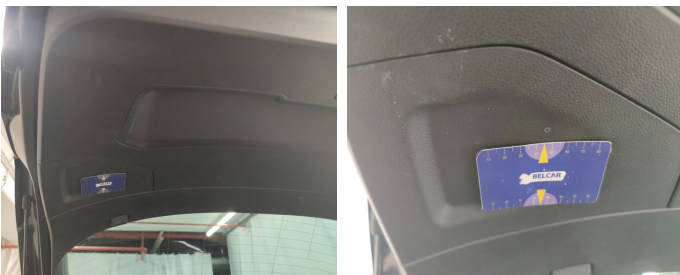
| Damages | Type | Acceptable |
|---|---|---|
| 594 | Trunk Lid Interior Coating / Complete Panel / Replace | Y |

Trunk Lid Interior Coating / Complete Panel / Replace-scratch

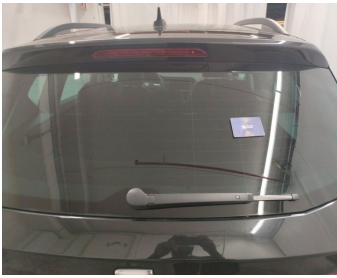
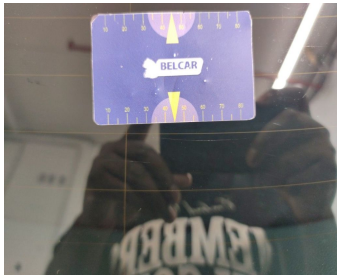
| Damages | Type | Acceptable |
|---|---|---|
| 159 | Rear Bonnet / Rear Window / Replace | Y |

Rear Bonnet / Rear Window / Replace-scratch

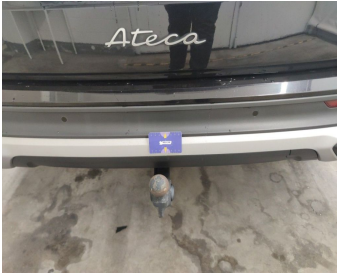
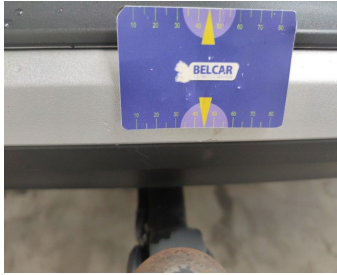
| Damages | Type | Acceptable |
|---|---|---|
| 139 | Bumper Rear / Spoiler / Replace | Y |

Bumper Rear / Spoiler / Replace-scratch

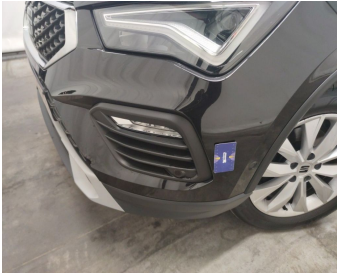
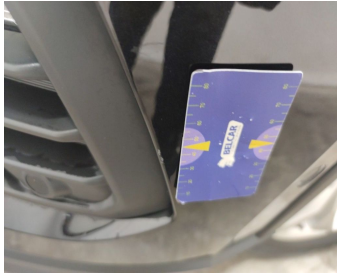
| Damages | Type | Acceptable |
|---|---|---|
| 13 | Bumper Front // Painting | Y |

Bumper Front // Painting-scratch

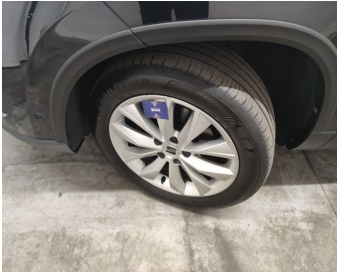
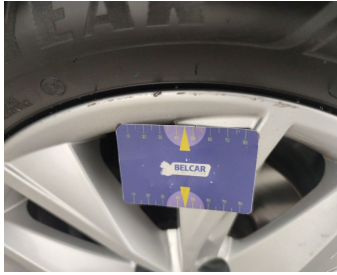
| Damages | Type | Acceptable |
|---|---|---|
| 311 | Wheel Alloy Front Left // Repair | N |

Wheel Alloy Front Left // Repair-scratch

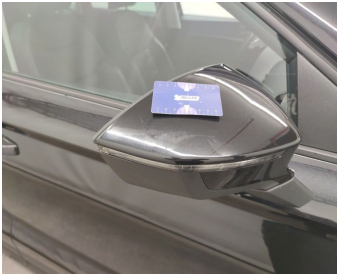
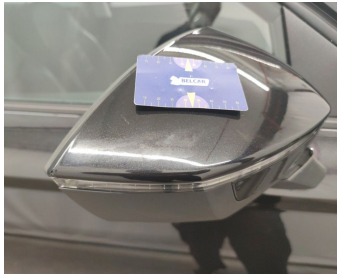
| Damages | Type | Acceptable |
|---|---|---|
| 225 | Side View Mirror Right // Polish | Y |

Side View Mirror Right // Polish-scratch

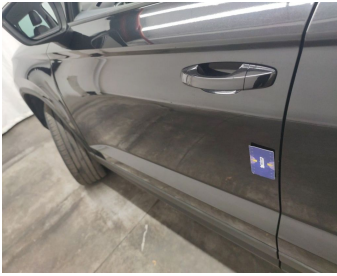
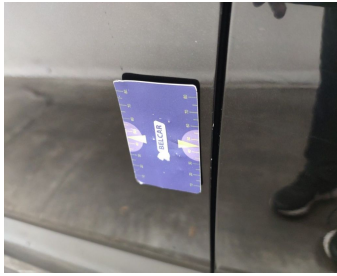
| Damages | Type | Acceptable |
|---|---|---|
| 81 | Door Front Left // Smart Repair Medium | Y |

Door Front Left // Smart Repair Medium-scratch

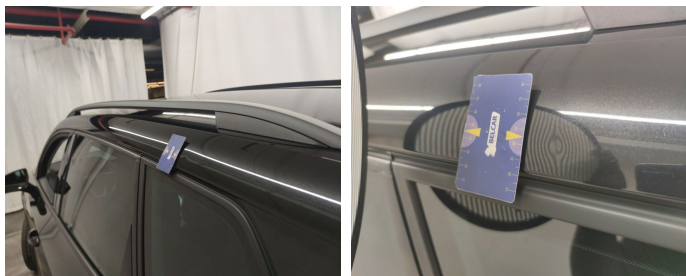
| Damages | Type | Acceptable |
|---|---|---|
| 161 | Roof // Smart Repair Medium | Y |

Roof // Smart Repair Medium-dent

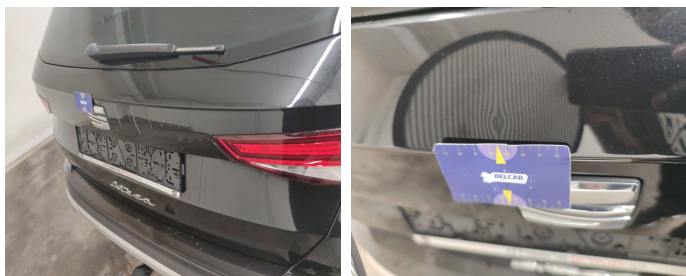
| Damages | Type | Acceptable |
|---|---|---|
| 150 | Rear Bonnet // Smart Repair Small | Y |

Rear Bonnet // Smart Repair Small-dent

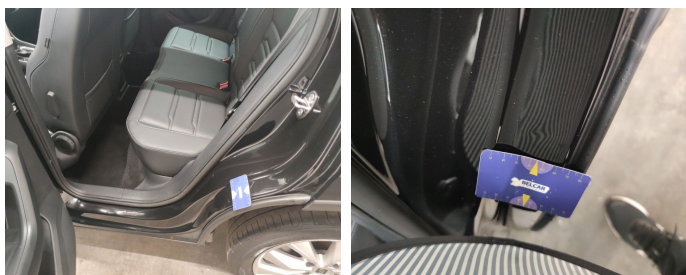
| Damages | Type | Acceptable |
|---|---|---|
| 91 | Rocker Panel Left // Smart Repair Medium | Y |

Rocker Panel Left // Smart Repair Medium-dent

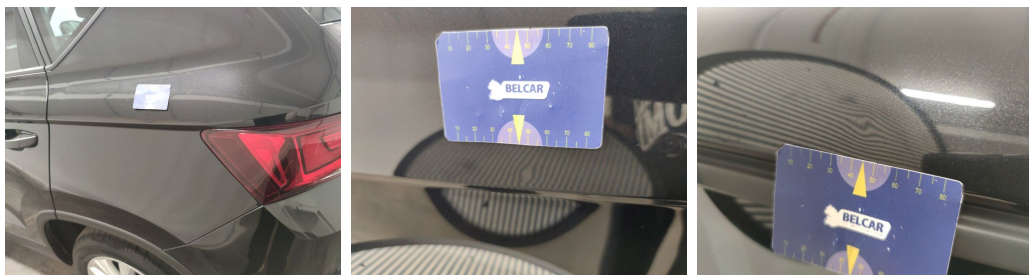
| Damages | Type | Acceptable |
|---|---|---|
| 110 | Wing Rear Left // Smart Repair Small | Y |

Wing Rear Left // Smart Repair Small-dent

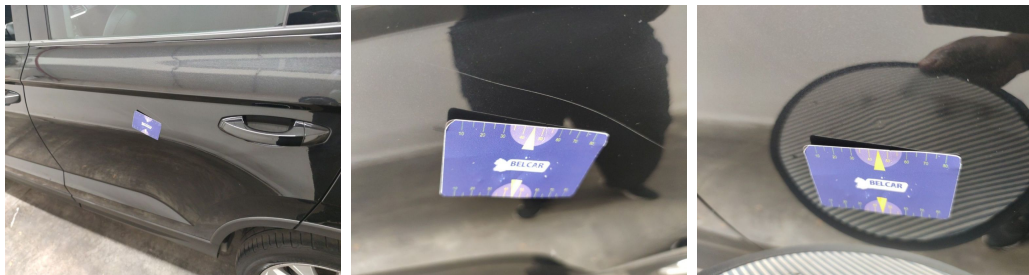
| Damages | Type | Acceptable |
|---|---|---|
| 104 | Door Rear Left // Repair & Painting | N |

Door Rear Left // Repair & Painting-scratch + dent

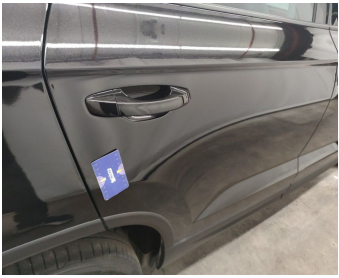
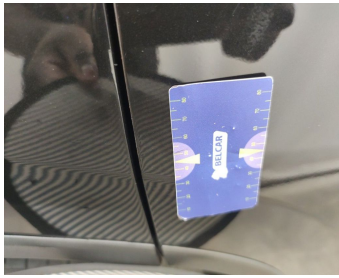
| Damages | Type | Acceptable |
|---|---|---|
| 193 | Door Rear Right // Painting | Y |

Door Rear Right // Painting-bad repair

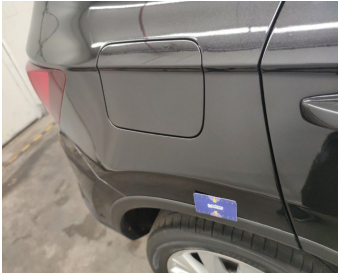
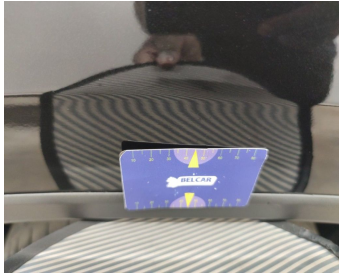
| Damages | Type | Acceptable |
|---|---|---|
| 183 | Wing Rear Right // Painting | Y |

Wing Rear Right // Painting-bad repair

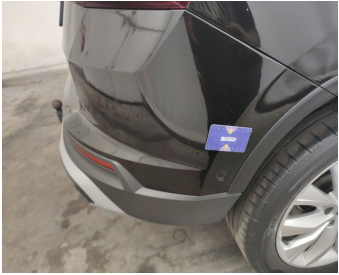
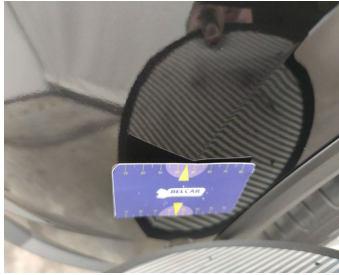
| Damages | Type | Acceptable |
|---|---|---|
| 133 | Bumper Rear // Painting | Y |

Bumper Rear // Painting-bad repair

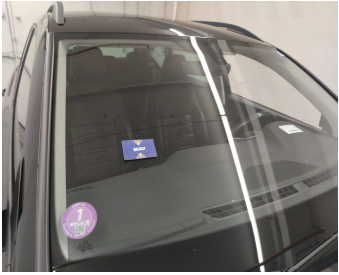
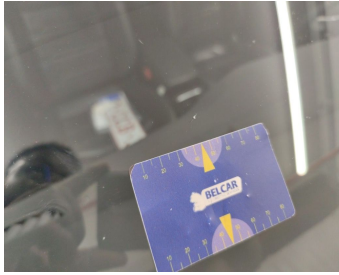
| Damages | Type | Acceptable |
|---|---|---|
| 40 | Windshield // Repair | Y |

Windshield // Repair-cracked

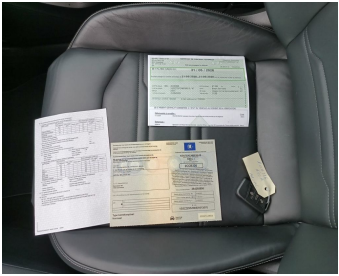
| Damages | Type | Acceptable |
|---|---|---|
| 881 | Key Price Range 1 // | N |

Key Price Range 1 //-missing

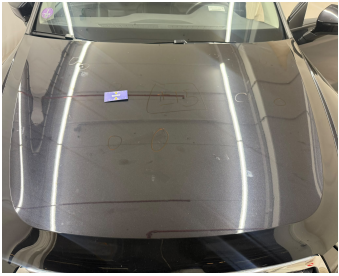
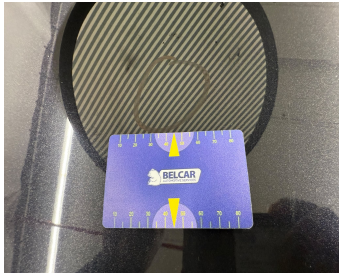
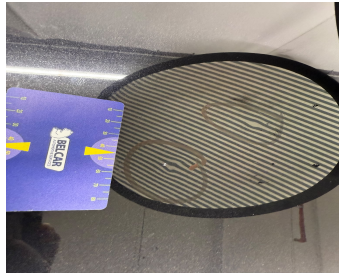
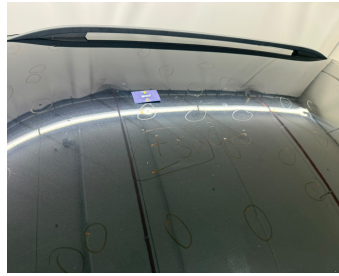
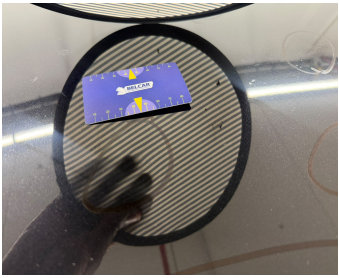
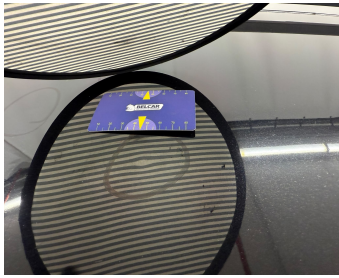
| Damages | Type | Acceptable |
|---|---|---|
| 801 | See External Expertise | N |

See External Expertise-Splashes
