# INSPECTION REPORT

**End of contract**

| License plate | 2AUF746 |
| Make | Peugeot 3008 1.5BHDi 96kW Allu |

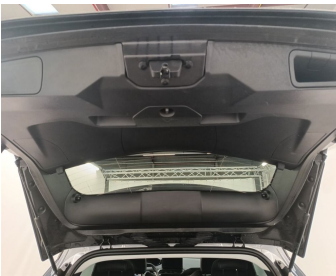
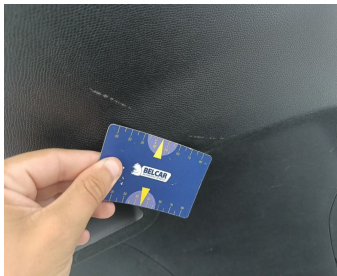
| Damages | Type | Acceptable |
|---|---|---|
| 594 | Trunk Lid Interior Coating / Complete Panel / Replace | Y |

Trunk Lid Interior Coating / Complete Panel / Replace-scratch

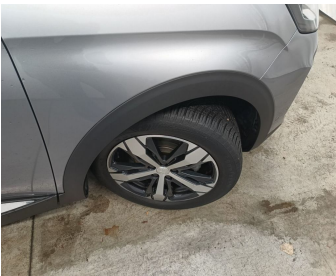
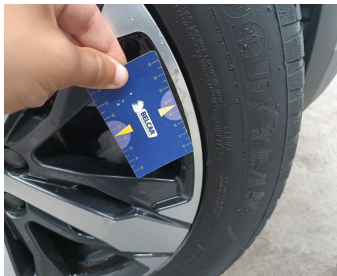
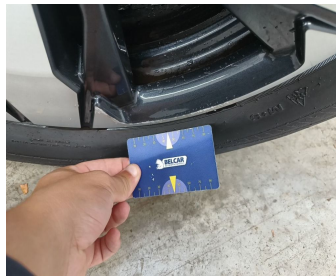
| Damages | Type | Acceptable |
|---|---|---|
| 340 | Wheel Two Tone Front Right // Repair | Y |

Wheel Two Tone Front Right // Repair-scratch

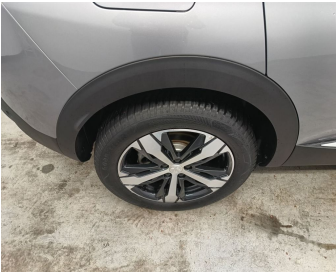
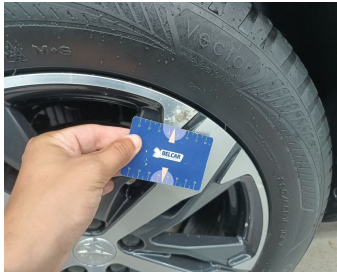
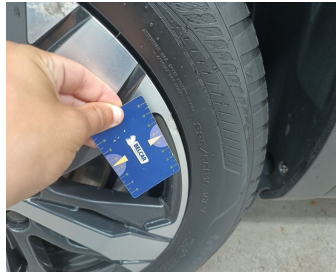
| Damages | Type | Acceptable |
|---|---|---|
| 330 | Wheel Two Tone Rear Right // Repair | Y |

Wheel Two Tone Rear Right // Repair-Chemical reaction

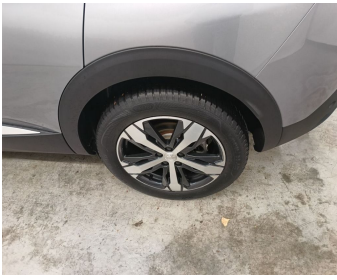
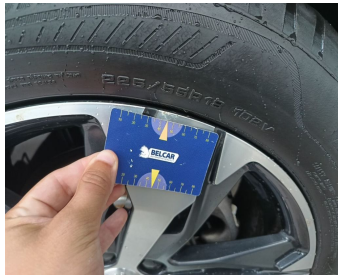
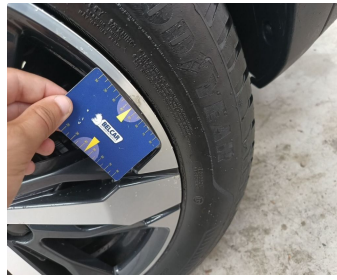
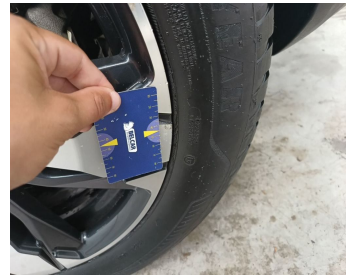
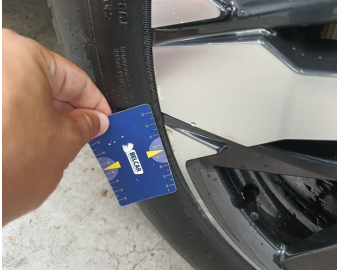
| Damages | Type | Acceptable |
|---|---|---|
| 320 | Wheel Two Tone Rear Left // Repair | Y |

Wheel Two Tone Rear Left // Repair-Chemical reaction

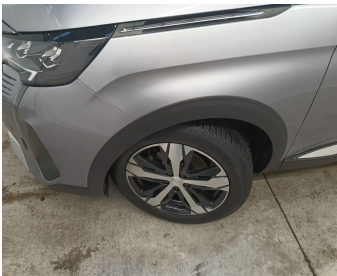
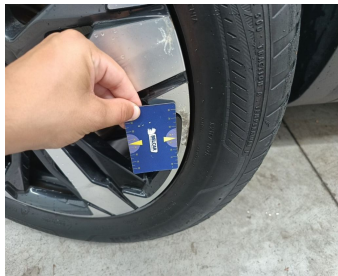
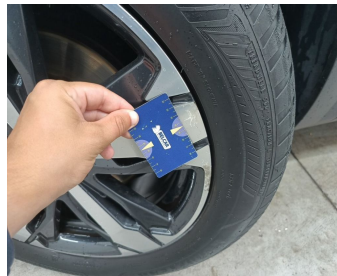
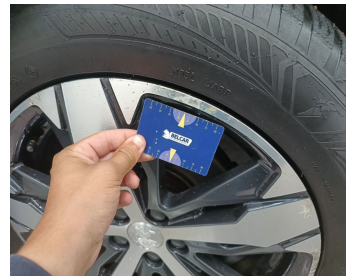
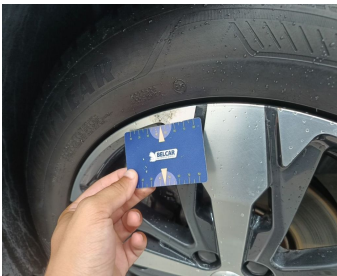
| Damages | Type | Acceptable |
|---|---|---|
| 310 | Wheel Two Tone Front Left // Repair | Y |

Wheel Two Tone Front Left // Repair-Chemical reaction

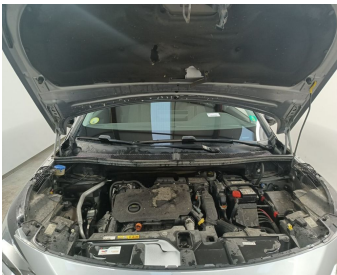
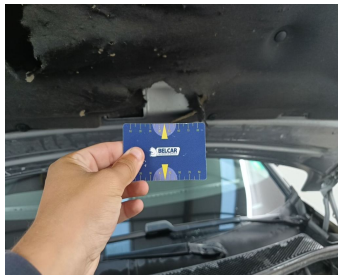
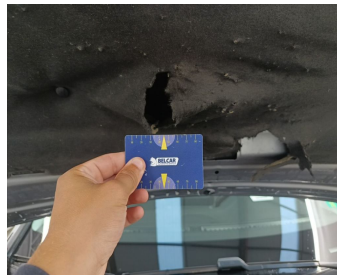
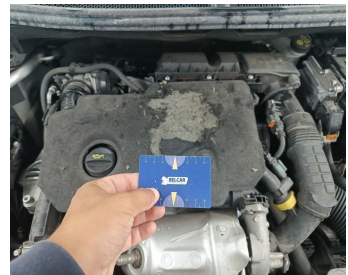
| Damages | Type | Acceptable |
|---|---|---|
| 38 | Front Bonnet / Insulation / Replace | N |

Front Bonnet / Insulation / Replace-tear

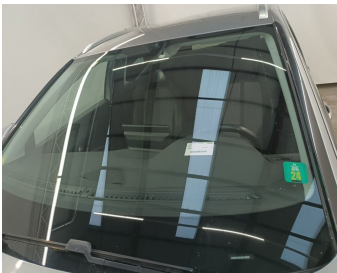
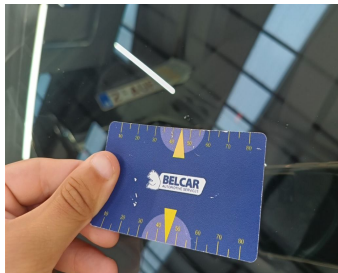
| Damages | Type | Acceptable |
|---|---|---|
| 40 | Windshield // Repair | Y |

Windshield // Repair-stone chipping
