INSPECTION REPORT

End of contract

| License plate | 2DVK334 |
| Make | Mercedes C 300e 230kW Luxury L |

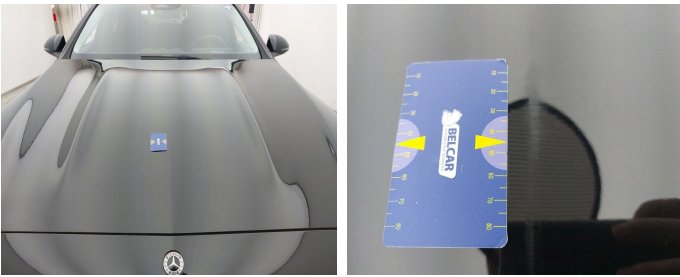
| Damages | Type | Acceptable |
|---|---|---|
| 35 | Front Bonnet // Polish | Y |

Front Bonnet // Polish-scratch

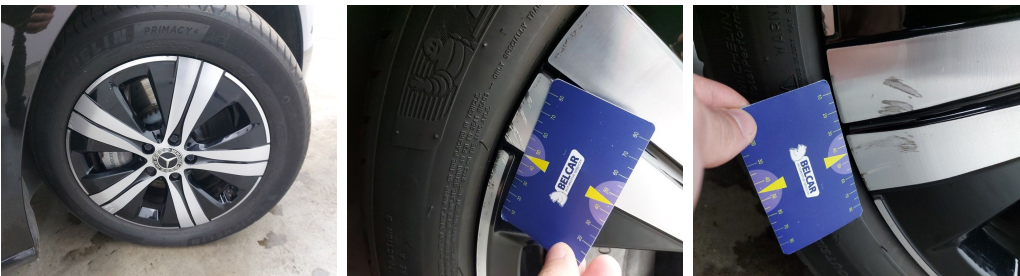
| Damages | Type | Acceptable |
|---|---|---|
| 340 | Wheel Two Tone Front Right // Repair | N |

Wheel Two Tone Front Right // Repair-scratch

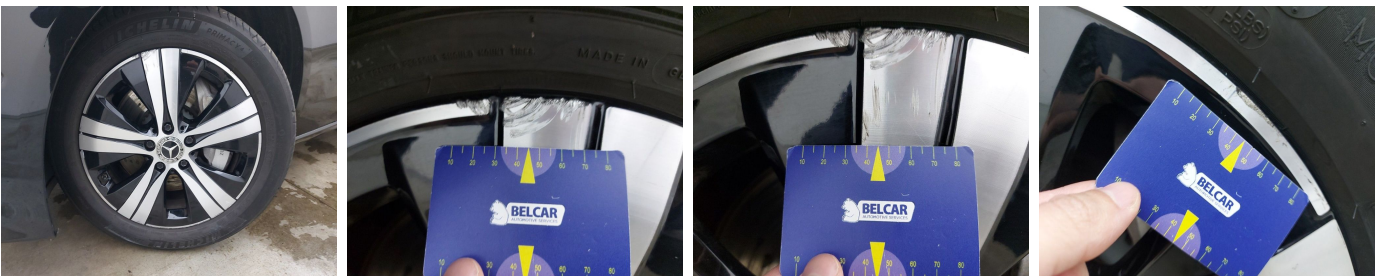
| Damages | Type | Acceptable |
|---|---|---|
| 310 | Wheel Two Tone Front Left // Repair | N |

Wheel Two Tone Front Left // Repair-scratch

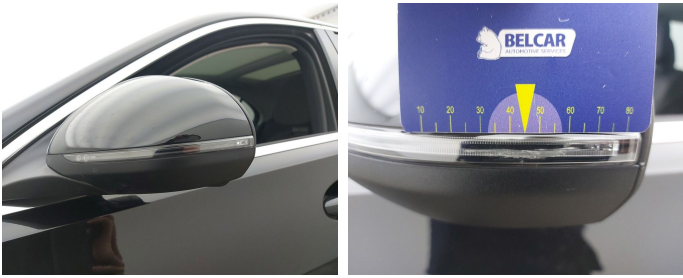
| Damages | Type | Acceptable |
|---|---|---|
| 78 | Side View Mirror Left / Direction Indicator / Replace | N |

Side View Mirror Left / Direction Indicator / Replace-scratch

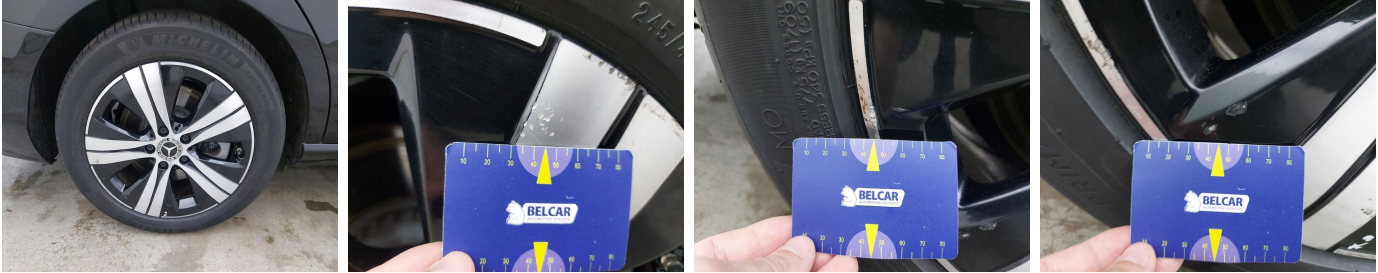
| Damages | Type | Acceptable |
|---|---|---|
| 330 | Wheel Two Tone Rear Right // Repair | N |

Wheel Two Tone Rear Right // Repair-scratch

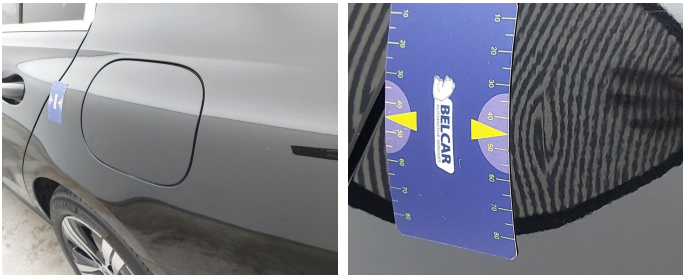
| Damages | Type | Acceptable |
|---|---|---|
| 110 | Wing Rear Left // Smart Repair Small | Y |

Wing Rear Left // Smart Repair Small-dent

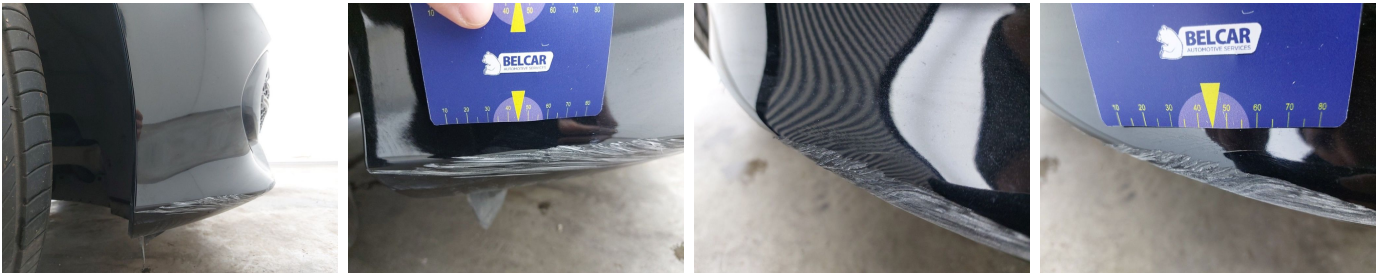
| Damages | Type | Acceptable |
|---|---|---|
| 14 | Bumper Front // Repair & Painting | N |

Bumper Front // Repair & Painting-scratch + dent

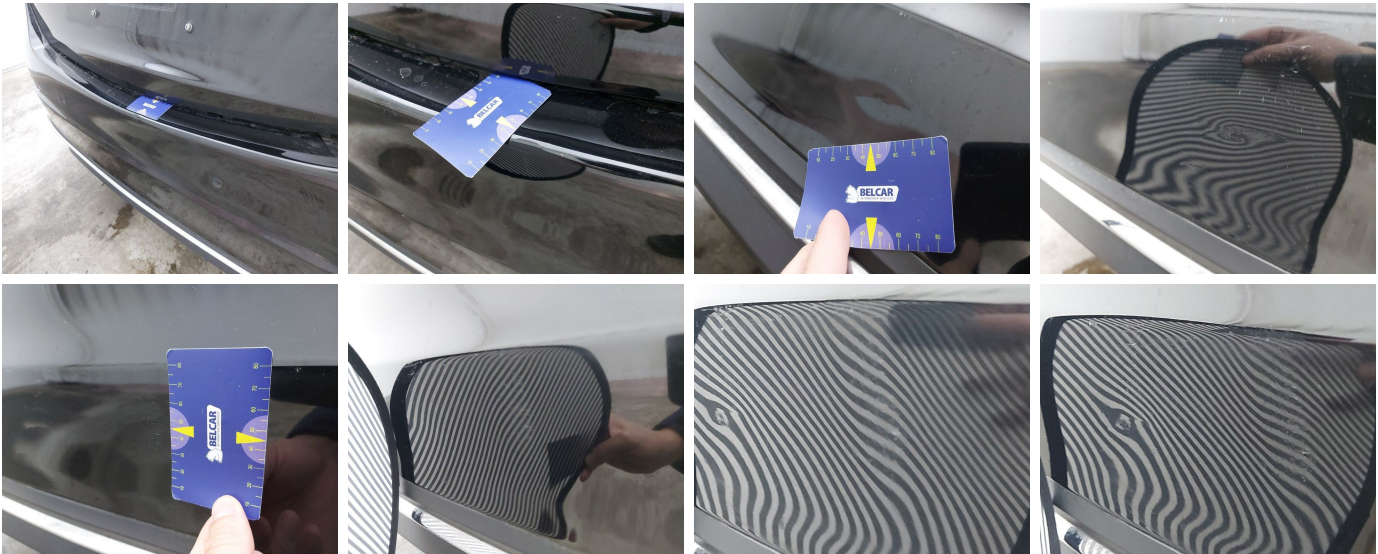
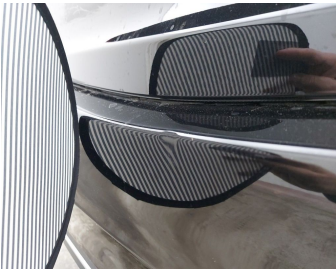
| Damages | Type | Acceptable |
|---|---|---|
| 134 | Bumper Rear // Repair & Painting | N |

Bumper Rear // Repair & Painting-scratch + dent
