# INSPECTION REPORT

**End of contract**

| License plate | 2AJH228 |
| Make | Skoda Sup.Comb.TSI 150 Amb.DSG |

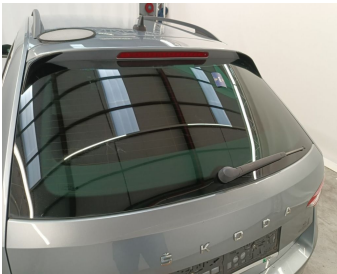
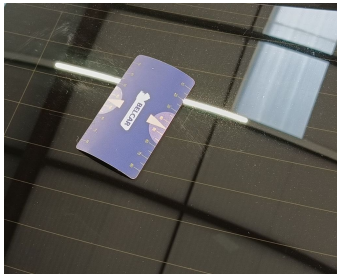
Rear Bonnet / Rear Window / Replace-scratch

| Damages | Type | Acceptable |
|---|---|---|
| 159 | Rear Bonnet / Rear Window / Replace | N |

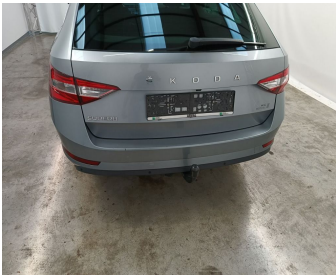
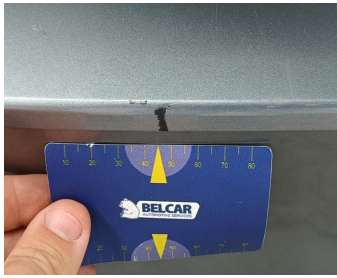
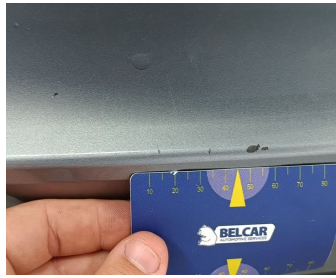
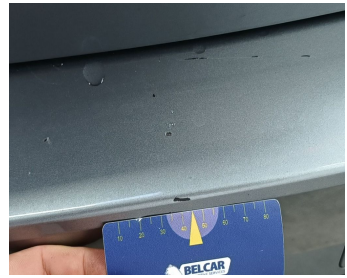
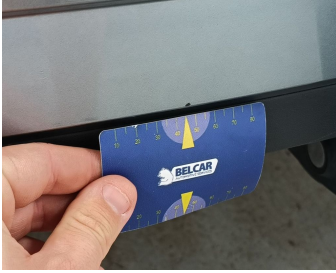
Bumper Rear // Painting-scratch

| Damages | Type | Acceptable |
|---|---|---|
| 133 | Bumper Rear // Painting | Y |

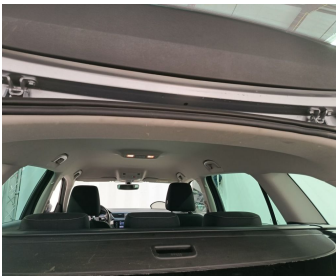
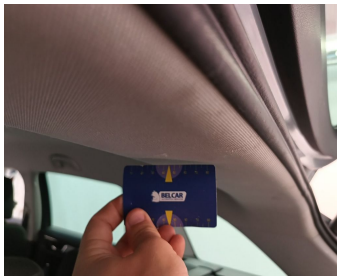
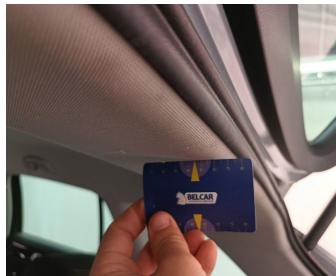
Trunk Compartment / Back Coating / Replace-scratch

| Damages | Type | Acceptable |
|---|---|---|
| 539 | Trunk Compartment / Back Coating / Replace | Y |

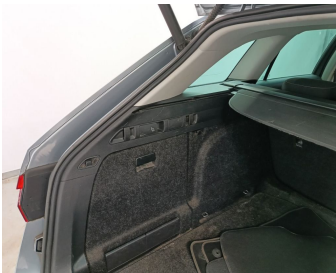
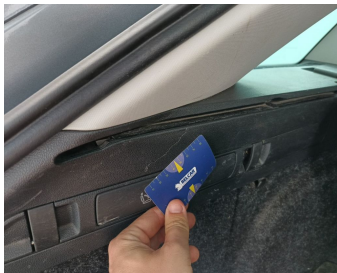
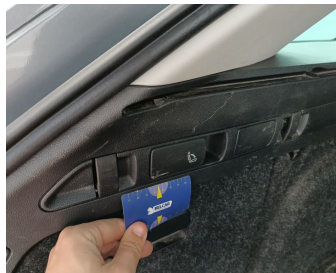
Trunk Compartment / Side Cover Left / Replace-scratch

| Damages | Type | Acceptable |
|---|---|---|
| 532 | Trunk Compartment / Side Cover Left / Replace | Y |

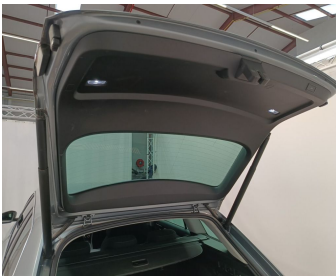
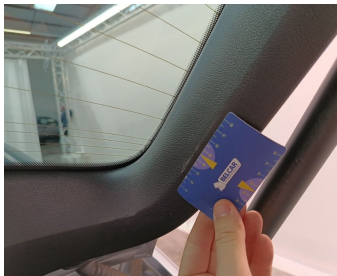
Trunk Lid Interior Coating / Complete Panel / Replace-scratch

| Damages | Type | Acceptable |
|---|---|---|
| 594 | Trunk Lid Interior Coating / Complete Panel / Replace | Y |

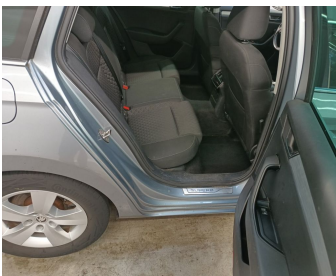
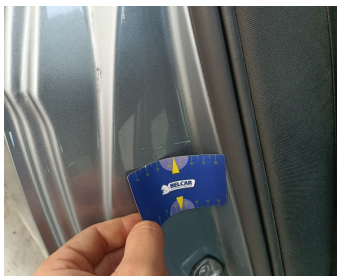
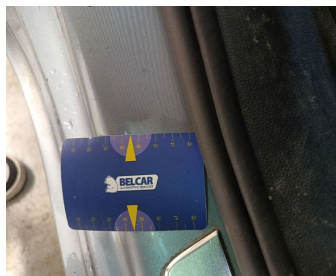
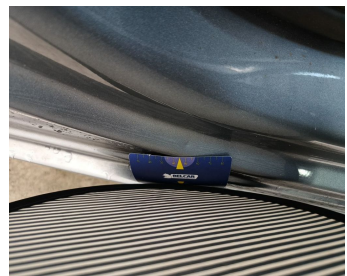
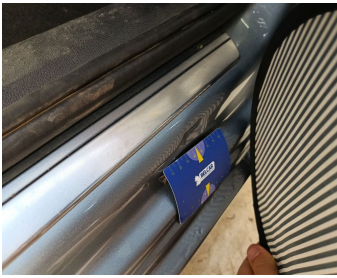
Rocker Panel Right // Smart Repair Medium-dent

| Damages | Type | Acceptable |
|---|---|---|
| 201 | Rocker Panel Right // Smart Repair Medium | N |

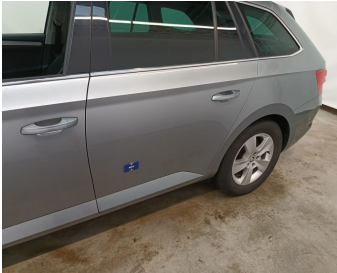
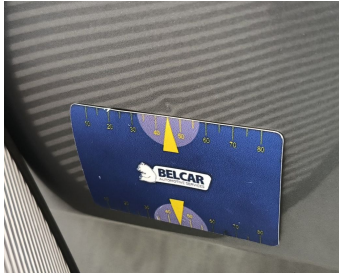
Door Rear Left // Smart Repair Small-dent

| Damages | Type | Acceptable |
|---|---|---|
| 100 | Door Rear Left // Smart Repair Small | Y |

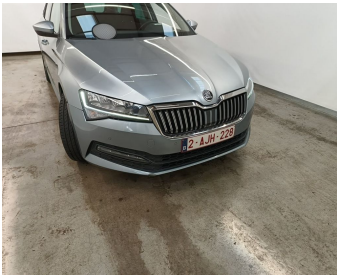
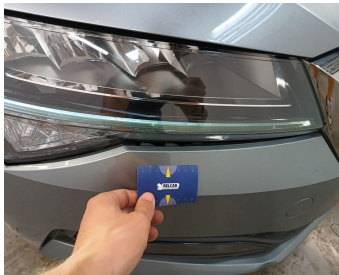
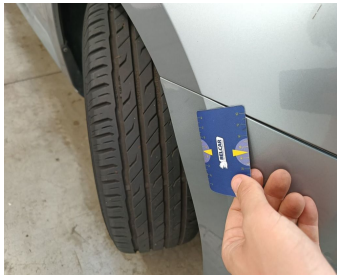
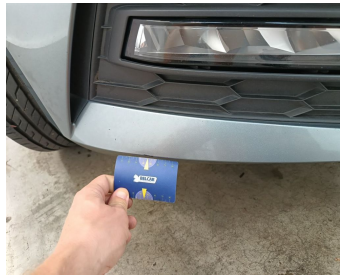
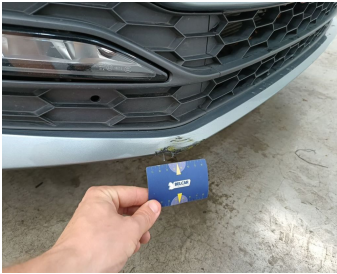
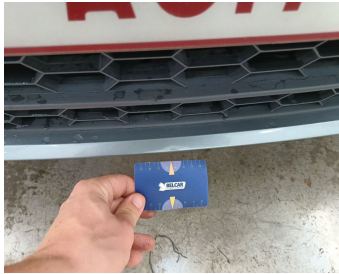
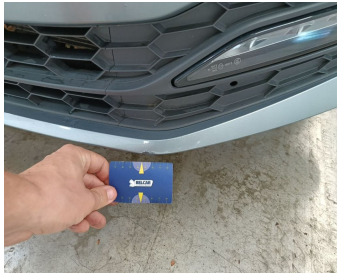
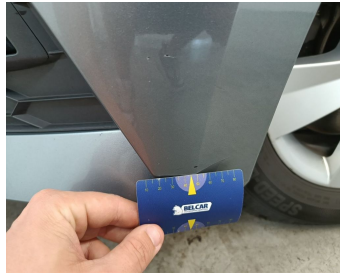
Bumper Front // Replace & Painting-scratch + dent

| Damages | Type | Acceptable |
|---|---|---|
| 15 | Bumper Front // Replace & Painting | N |

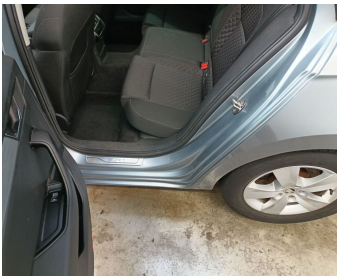
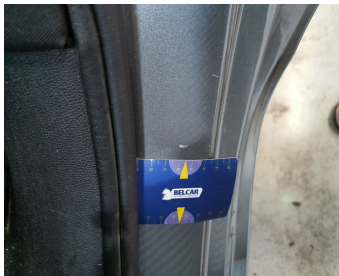
Rocker Panel Left // Smart Repair Medium-scratch + dent

| Damages | Type | Acceptable |
|---|---|---|
| 91 | Rocker Panel Left // Smart Repair Medium | Y |

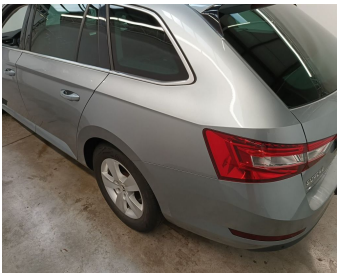
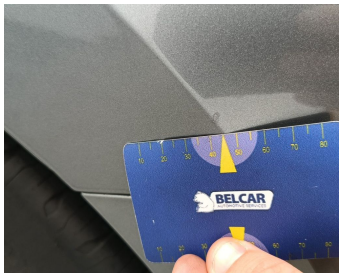
Wing Rear Left // Painting-bad repair

| Damages | Type | Acceptable |
|---|---|---|
| 113 | Wing Rear Left // Painting | Y |

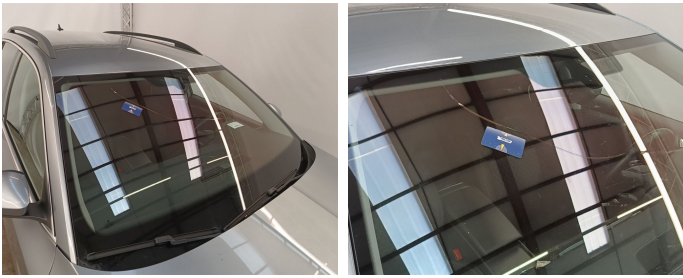
Windshield // Replace-cracked

| Damages | Type | Acceptable |
|---|---|---|
| 41 | Windshield // Replace | N |

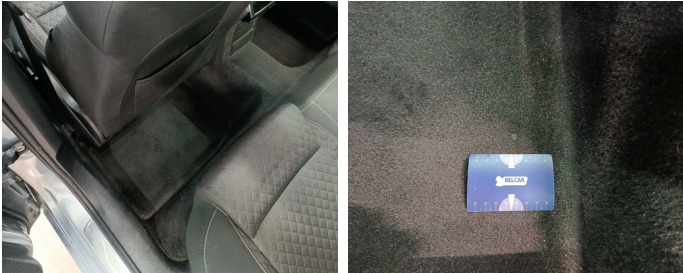
Interior // Repair 2-Incinerated

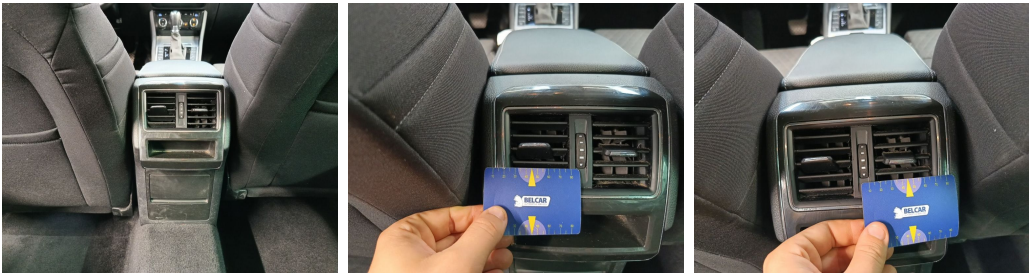
Interior // Repair 2-N comf / out of order

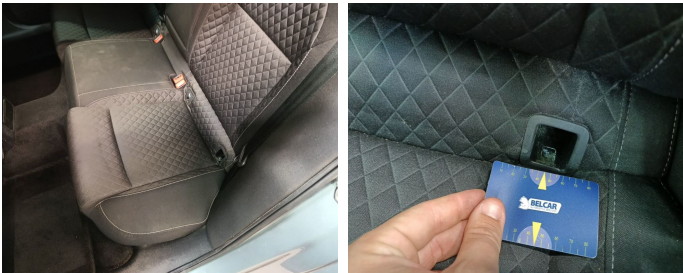
Seat Rear Left / Bottom Coating / Replace-Incinerated

| Damages | Type | Acceptable |
|---|---|---|
| 432 | Seat Rear Left / Bottom Coating / Replace | Y |

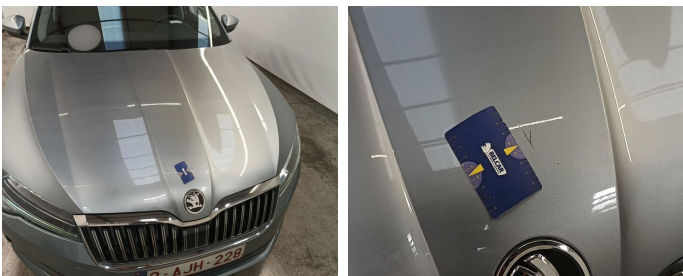
Front Bonnet // Polish-Chemical reaction

| Damages | Type | Acceptable |
|---|---|---|
| 35 | Front Bonnet // Polish | Y |

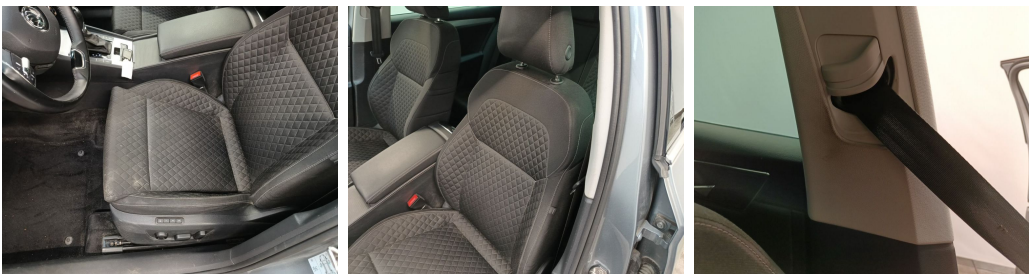
Interior Cleaning // Small-dirty

| Damages | Type | Acceptable |
|---|---|---|
| 860 | Interior Cleaning // Small | N |

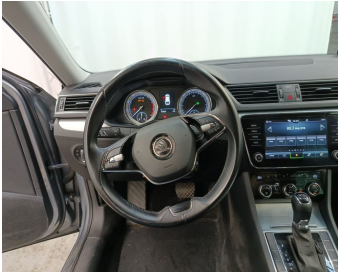
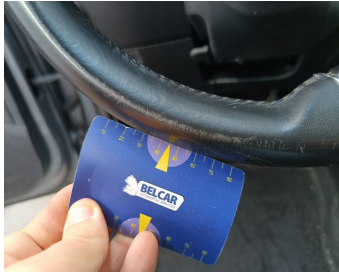
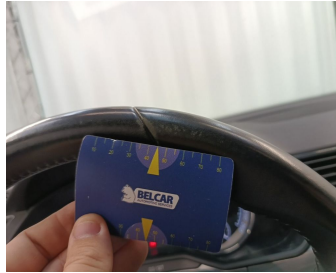
Dashboard / Steering Wheel / Replace-worn

| Damages | Type | Acceptable |
|---|---|---|
| 569 | Dashboard / Steering Wheel / Replace | Y |

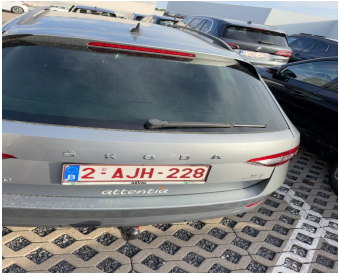
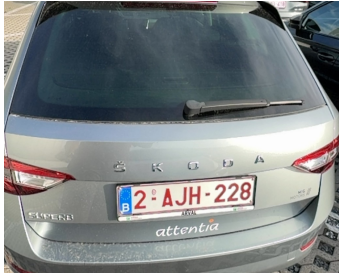
Lettering Removal 15min-

| Damages | Type | Acceptable |
|---|---|---|
| 891 | Lettering Removal 15min | N |
