INSPECTION REPORT

End of contract

File	308619
License plate	1XSU617
Vehicle identification number	W1K2052001G013661
Dossier	2020015024
Make	Mercedes C Break 180d 90kW Aut
Mileage	105225
First registration	08/05/2020
client availability date	02/04/2026
inspectionDate	08/04/2026

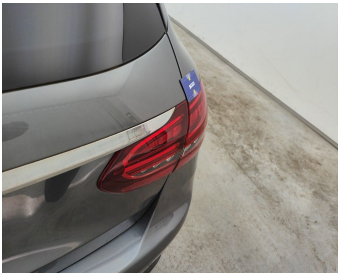
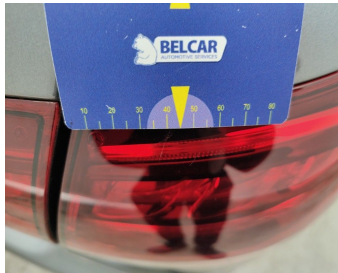
Rear Bonnet / Rear Window / Replace-scratch

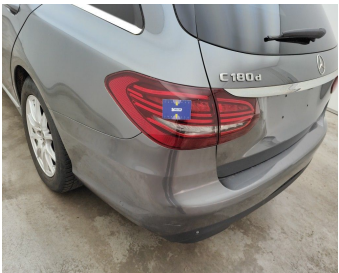
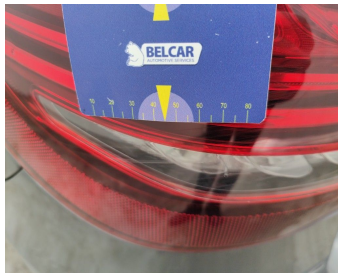
Light / Rear Right / Replace-scratch
