INSPECTION REPORT

End of contract

| License plate | 1XHY362 |
| Make | Mercedes Citan 109CDI L2 Perf. |

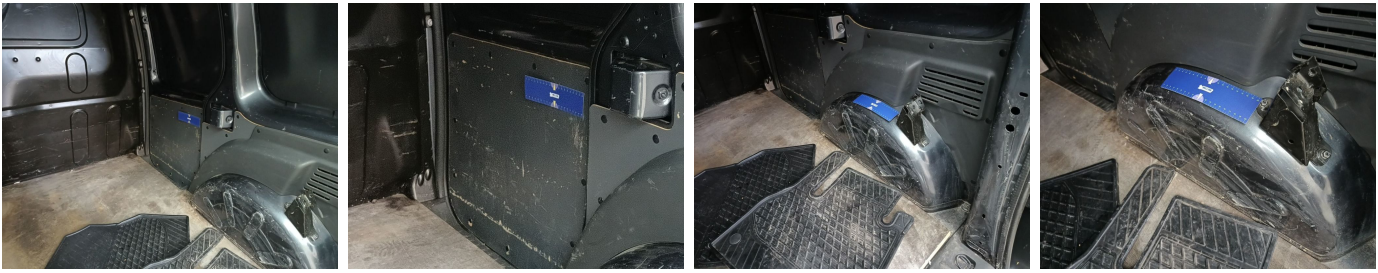
Damage within Renta-norm-scratch

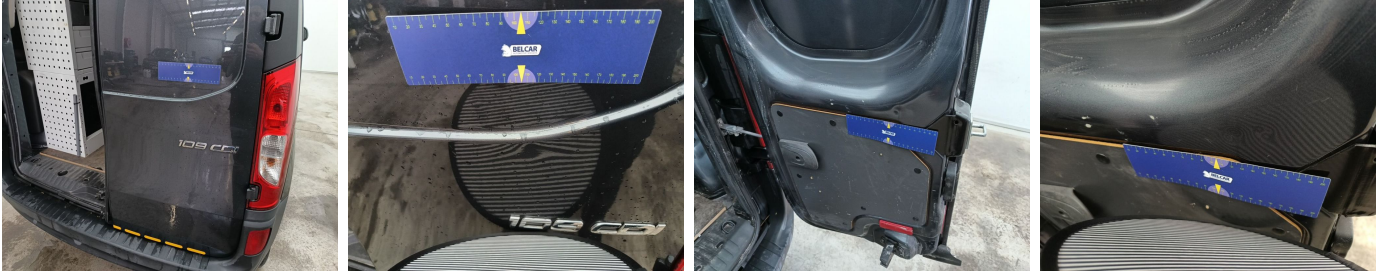
| Damages | Type | Acceptable |
|---|--|---|
| 304 | Rear Loading Door Right // Repair & Painting | Y |

Rear Loading Door Right // Repair & Painting-dent

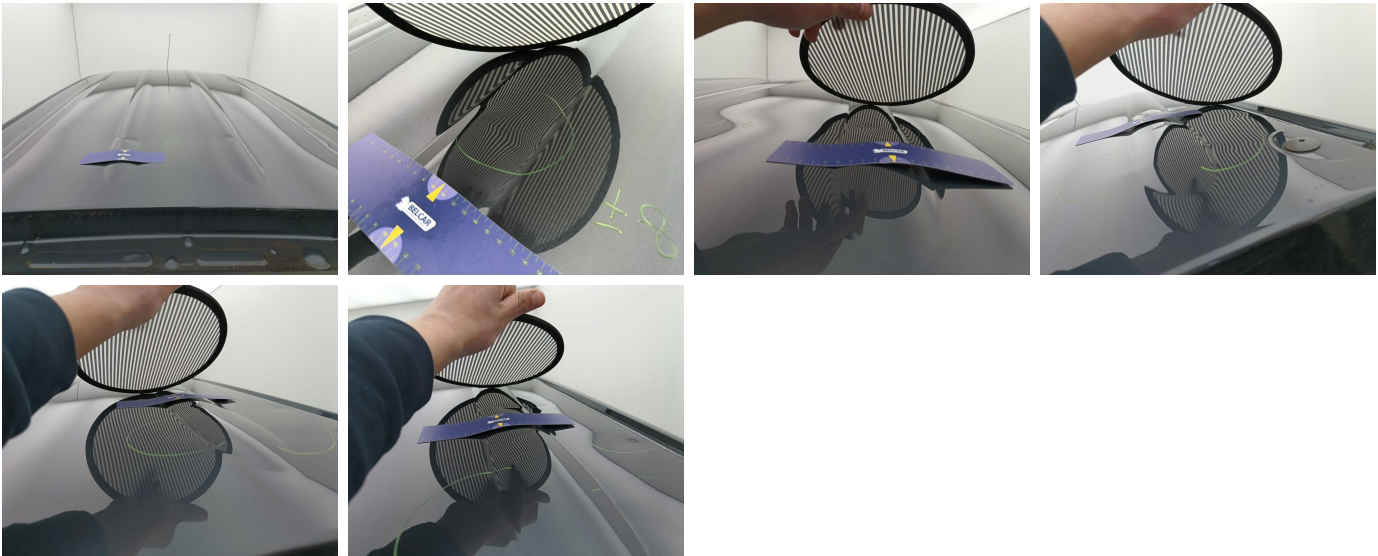
| Damages | Type | Acceptable |
|---|--|---|
| 163 | Roof // Repair & Painting | N |

Roof // Repair & Painting-scratch + dent

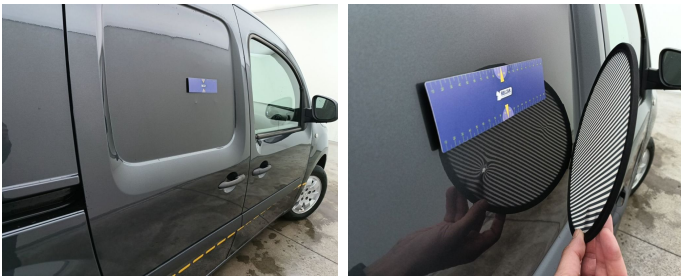
| Damages | Type | Acceptable |
|---|--|---|
| 194 | Door Rear Right // Repair & Painting | N |

Door Rear Right // Repair & Painting-scratch + dent

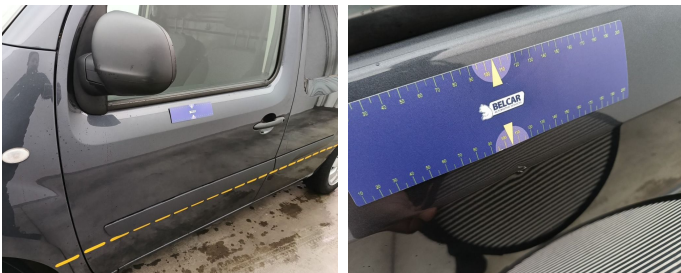
| Damages | Type | Acceptable |
|---|--|---|
| 84 | Door Front Left // Repair & Painting | Y |

Door Front Left // Repair & Painting-scratch + dent

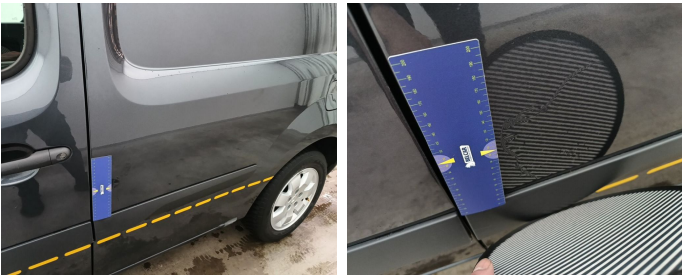
| Damages | Type | Acceptable |
|---|--|---|
| 113 | Wing Rear Left // Painting | Y |

Wing Rear Left // Painting-bad repair

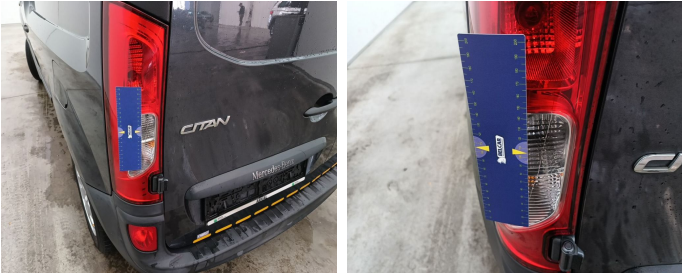
| Damages | Type | Acceptable |
|---|--|---|
| 124 | Light / Rear left / Replace | N |

Light / Rear left / Replace-cracked

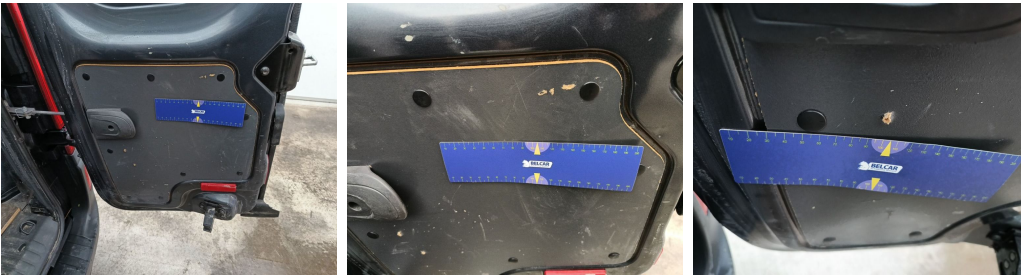
| Damages | Type | Acceptable |
|---|--|---|
| 533 | Trunk Compartment / Side Cover Right / Replace | N |

Trunk Compartment / Side Cover Right / Replace-cracked

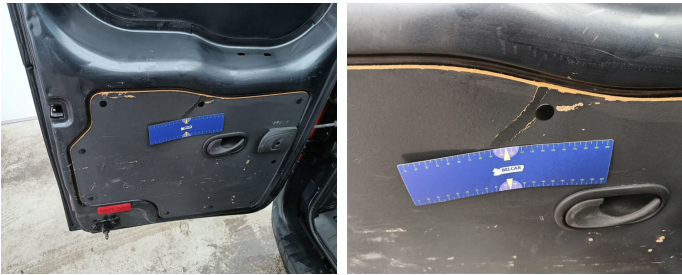
| Damages | Type | Acceptable |
|---|--|---|
| 532 | Trunk Compartment / Side Cover Left / Replace | N |

Trunk Compartment / Side Cover Left / Replace-cracked

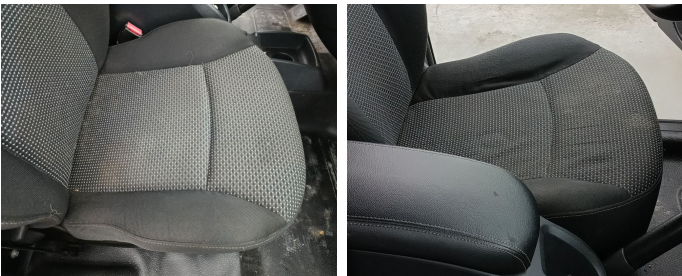
| Damages | Type | Acceptable |
|---|--|---|
| 840 | Interior Cleaning // Large | Y |

Interior Cleaning // Large-stain
