INSPECTION REPORT

End of contract

| License plate | 1XNV675 |
| Make | Peugeot 3008 1.5BHdi 96kW Allu |

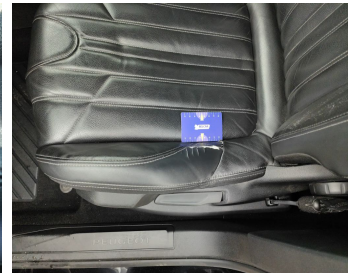
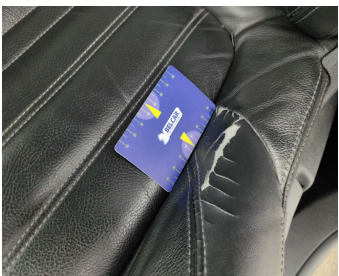
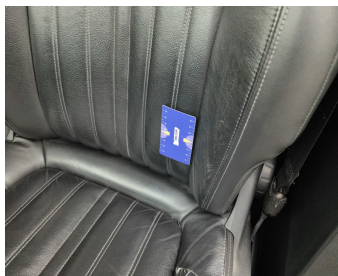
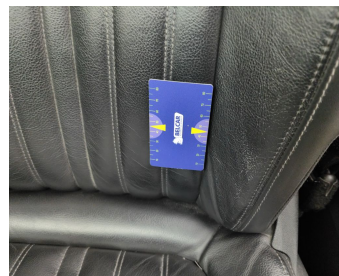
| Damages | Type | Acceptable |
|---|---|---|
| 540 | Interior // Repair 1 | N |

Interior // Repair 1-tear

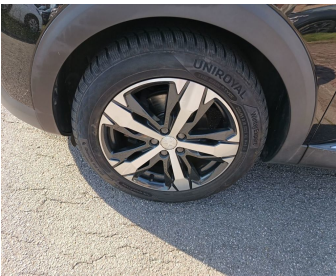
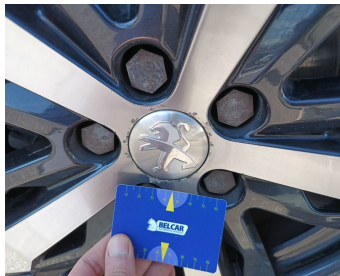
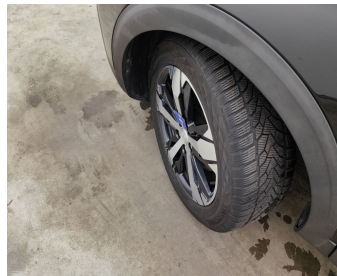
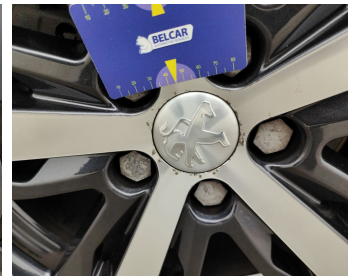
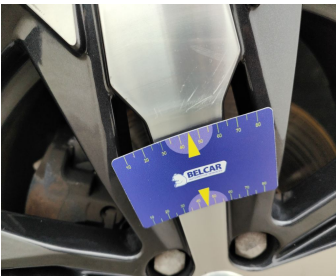
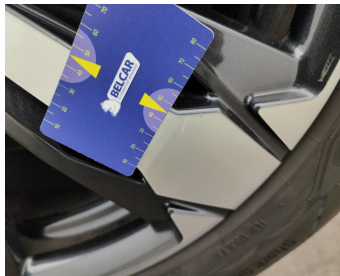
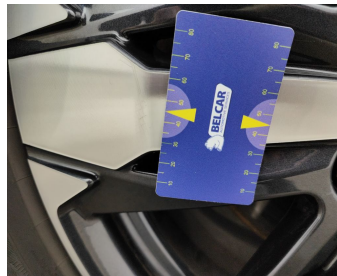
| Damages | Type | Acceptable |
|---|---|---|
| 340 | Wheel Two Tone Front Right // Repair | N |

Wheel Two Tone Front Right // Repair-scratch

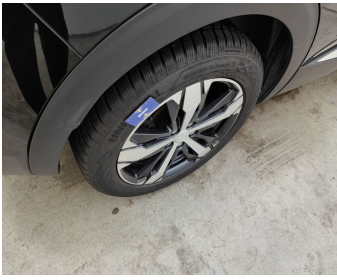
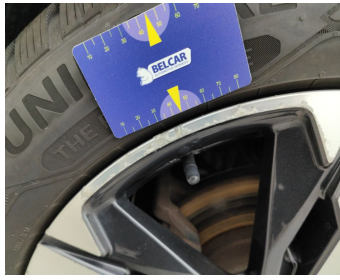
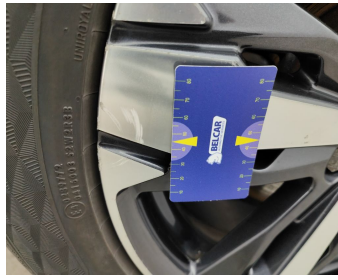
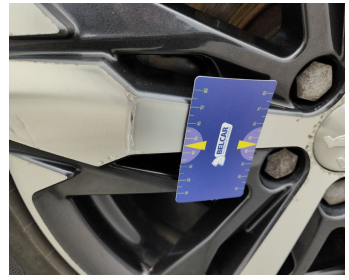
| Damages | Type | Acceptable |
|---|---|---|
| 330 | Wheel Two Tone Rear Right // Repair | N |

Wheel Two Tone Rear Right // Repair-scratch

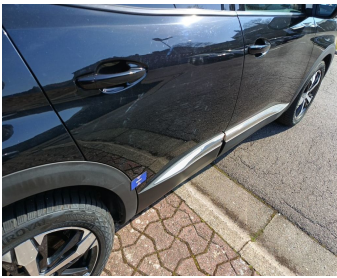
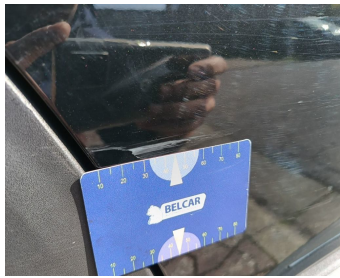
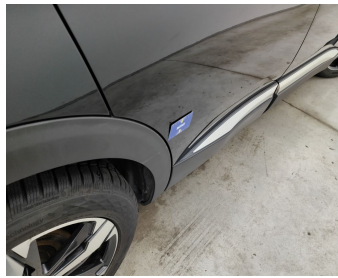
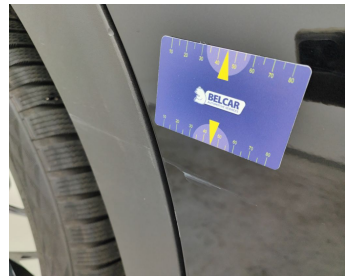
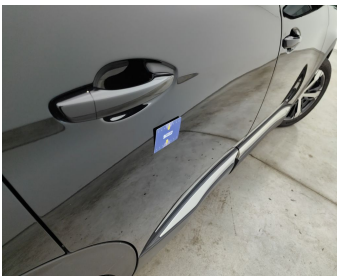
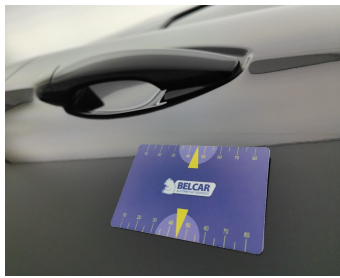
| Damages | Type | Acceptable |
|---|---|---|
| 196 | Door Rear Right // Polish | N |

Door Rear Right // Polish-scratch

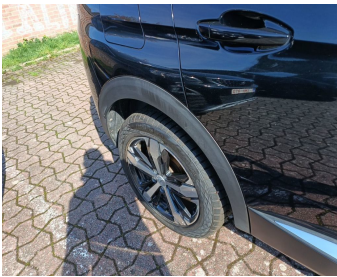
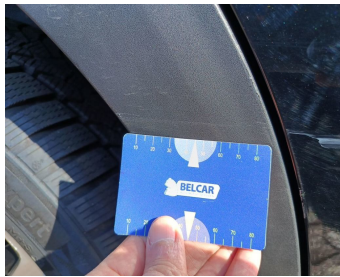
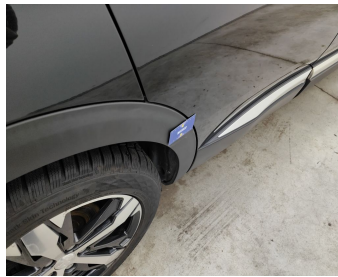
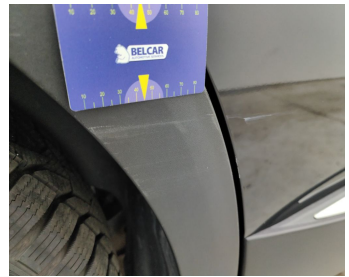
| Damages | Type | Acceptable |
|---|---|---|
| 187 | Wing Rear Right / Trim / Replace | N |

Wing Rear Right / Trim / Replace-scratch
