# INSPECTION REPORT

**End of contract**

| License plate | PR9020 |
| Make | Peugeot 5008 1.5Hdi 130 GT Pac |

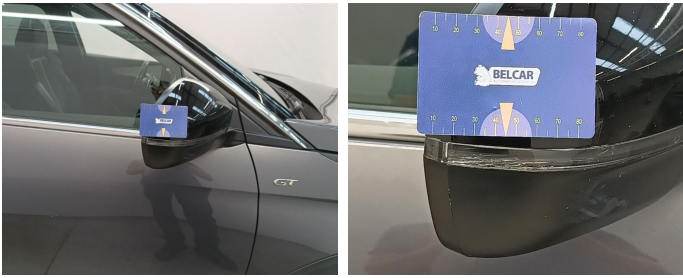
| Damages | Type | Acceptable |
|---|---|---|
| 228 | Side View Mirror Right / Direction Indicator / Replace | N |

Side View Mirror Right / Direction Indicator / Replace-scratch

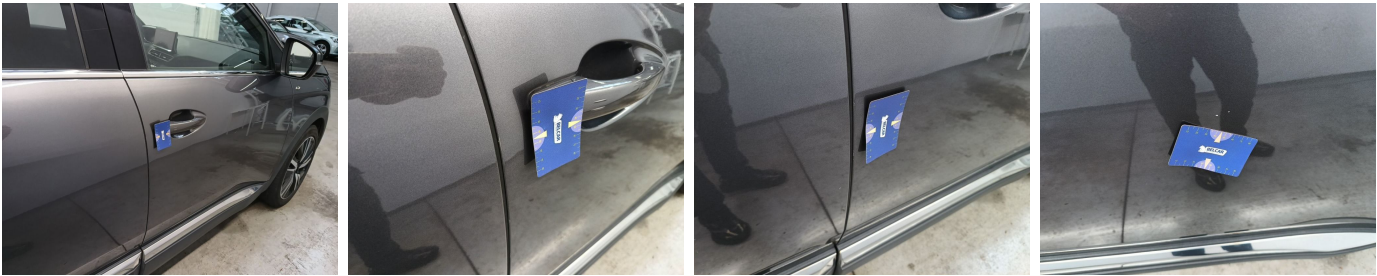
| Damages | Type | Acceptable |
|---|---|---|
| 213 | Door Front Right // Painting | Y |

Door Front Right // Painting-scratch

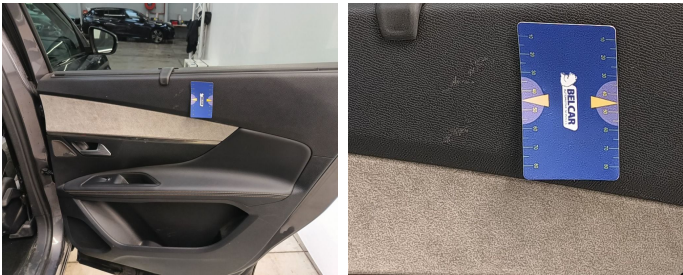
| Damages | Type | Acceptable |
|---|---|---|
| 644 | Rear Right Door Interior Coating // Replace Completely | Y |

Rear Right Door Interior Coating // Replace Completely-scratch

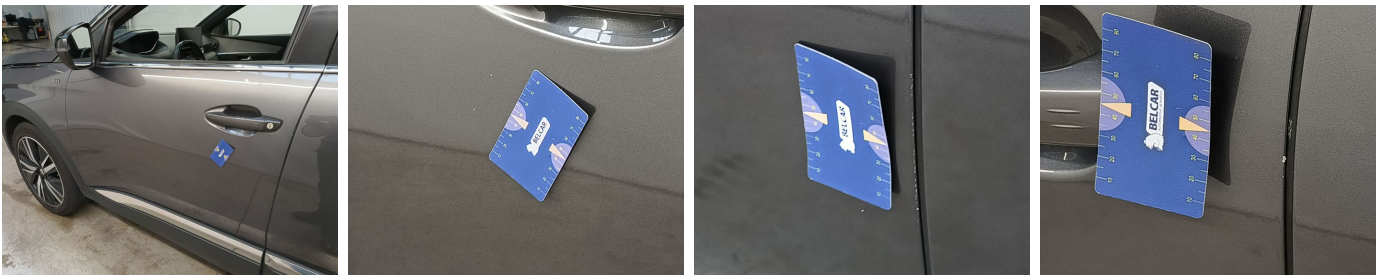
| Damages | Type | Acceptable |
|---|---|---|
| 83 | Door Front Left // Painting | Y |

Door Front Left // Painting-scratch

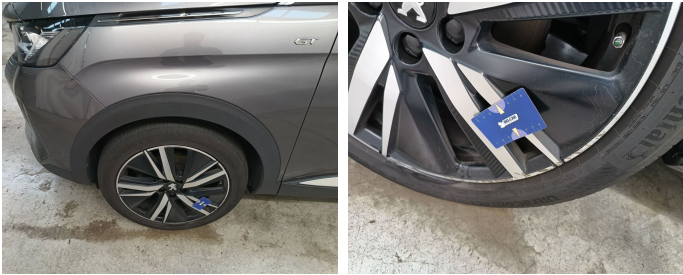
| Damages | Type | Acceptable |
|---|---|---|
| 310 | Wheel Two Tone Front Left // Repair | N |

Wheel Two Tone Front Left // Repair-scratch

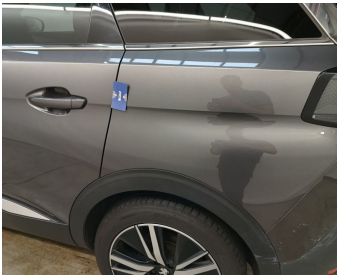
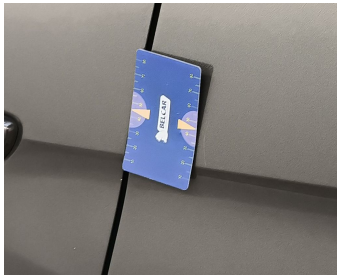
| Damages | Type | Acceptable |
|---|---|---|
| 113 | Wing Rear Left // Painting | Y |

Wing Rear Left // Painting-scratch

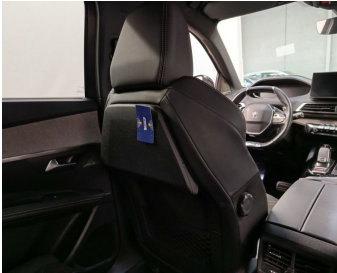
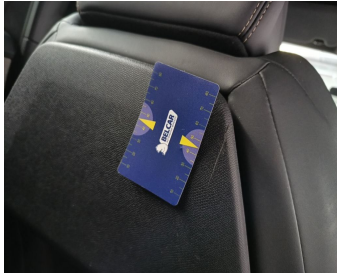
| Damages | Type | Acceptable |
|---|---|---|
| 411 | Seat Front Left // Repair | Y |

Seat Front Left // Repair-scratch

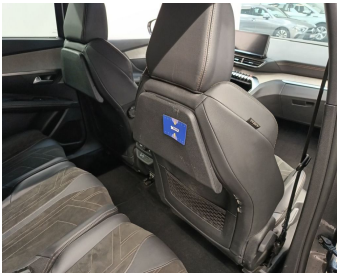
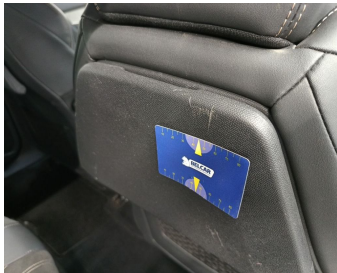
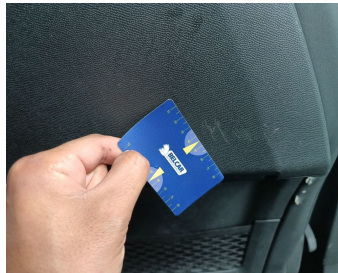
| Damages | Type | Acceptable |
|---|---|---|
| 421 | Seat Front Right // Repair | Y |

Seat Front Right // Repair-scratch

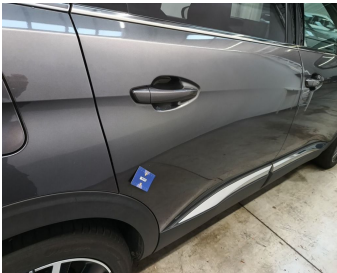
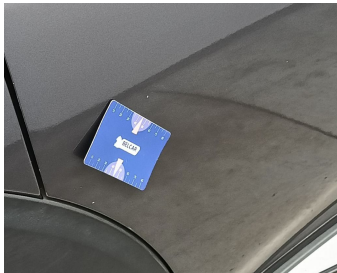
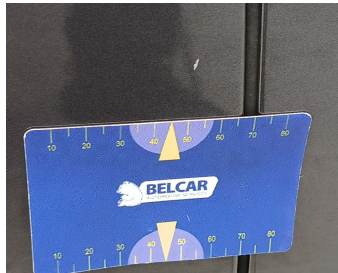
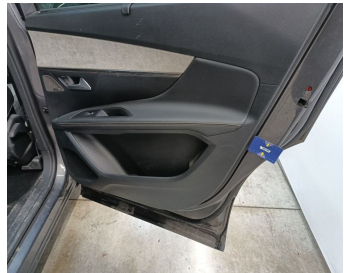
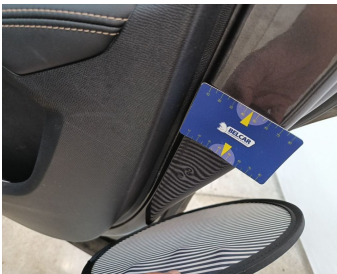
| Damages | Type | Acceptable |
|---|---|---|
| 194 | Door Rear Right // Repair & Painting | Y |

Door Rear Right // Repair & Painting-dent

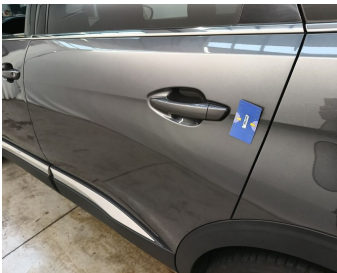
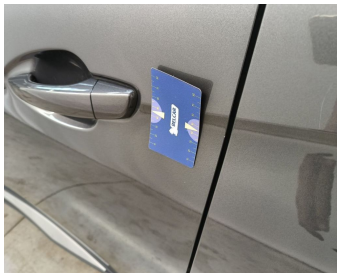
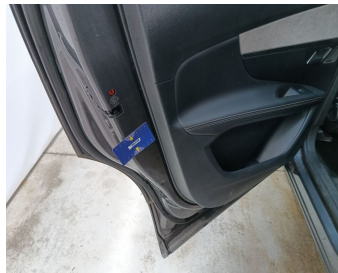
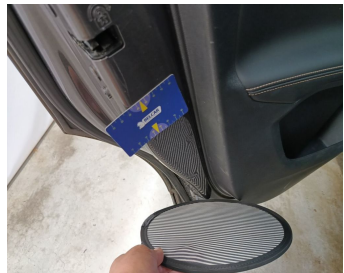
| Damages | Type | Acceptable |
|---|---|---|
| 104 | Door Rear Left // Repair & Painting | Y |

Door Rear Left // Repair & Painting-dent

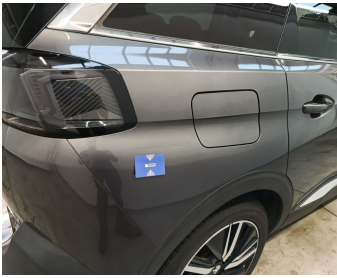
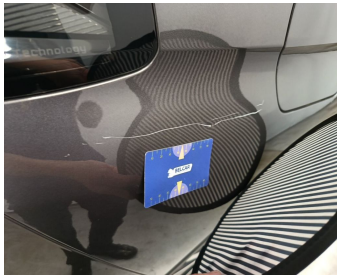
| Damages | Type | Acceptable |
|---|---|---|
| 184 | Wing Rear Right // Repair & Painting | N |

Wing Rear Right // Repair & Painting-scratch + dent

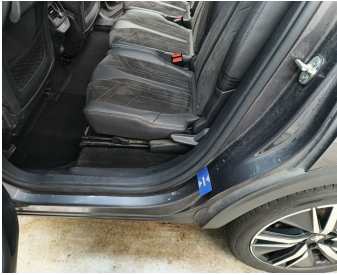
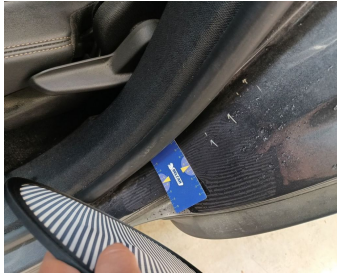
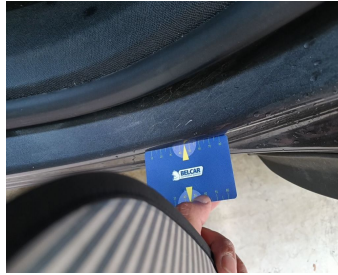
| Damages | Type | Acceptable |
|---|---|---|
| 91 | Rocker Panel Left // Smart Repair Medium | N |

Rocker Panel Left // Smart Repair Medium-scratch + dent

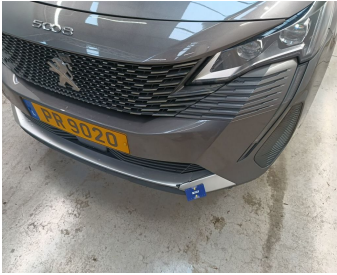
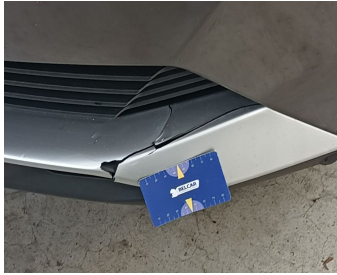
| Damages | Type | Acceptable |
|---|---|---|
| 18 | Bumper Front / Spoiler / Replace | N |

Bumper Front / Spoiler / Replace-cracked

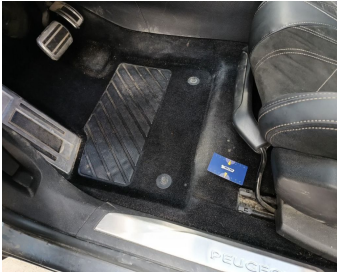
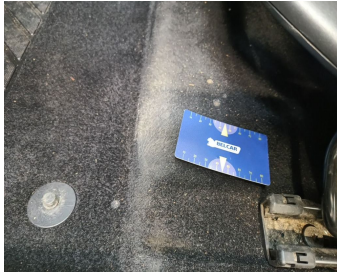
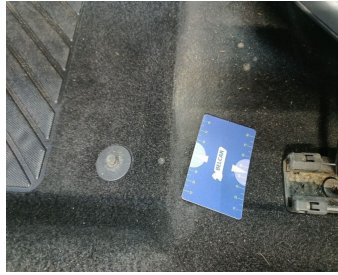
| Damages | Type | Acceptable |
|---|---|---|
| 540 | Interior // Repair 1 | N |

Interior // Repair 1-Incinerated

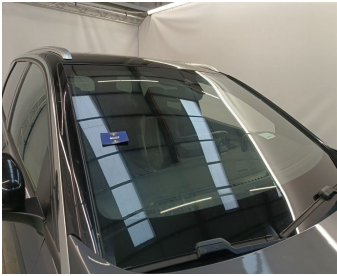
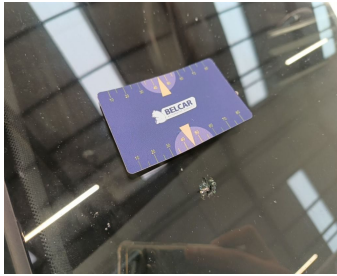
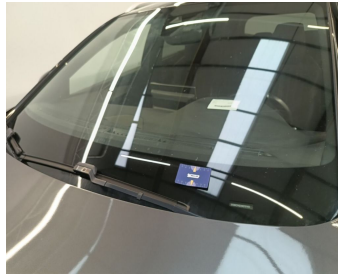
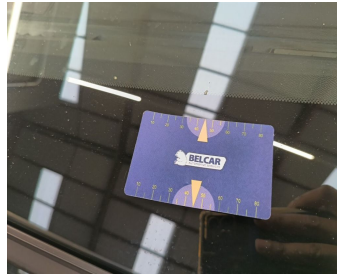
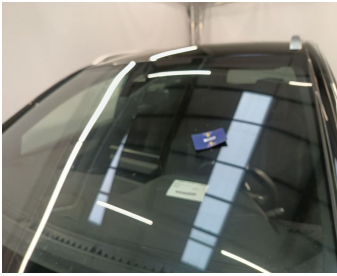
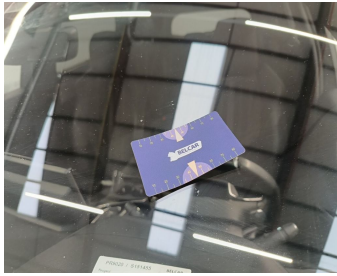
| Damages | Type | Acceptable |
|---|---|---|
| 41 | Windshield // Replace | N |

Windshield // Replace-glass damage

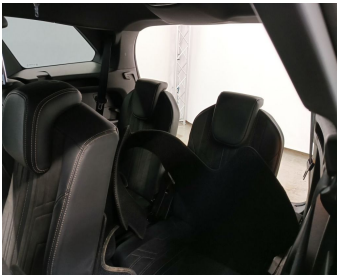
| Damages | Type | Acceptable |
|---|---|---|
| 538 | Trunk Compartment / Boot Cover / Replace | N |

Trunk Compartment / Boot Cover / Replace-missing

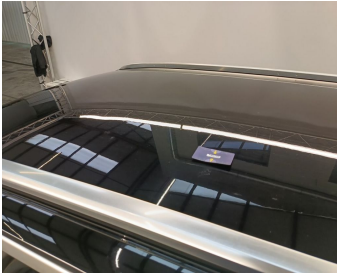
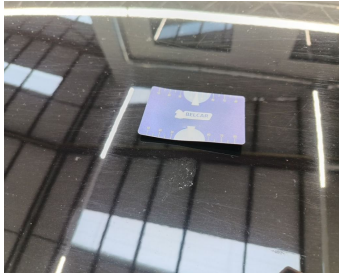
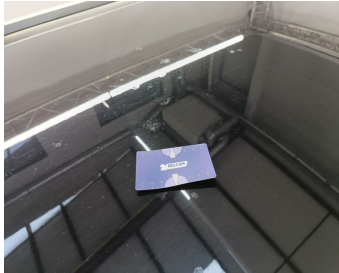
| Damages | Type | Acceptable |
|---|---|---|
| 162 | Roof // Painting | N |

Roof // Painting-Chemical reaction

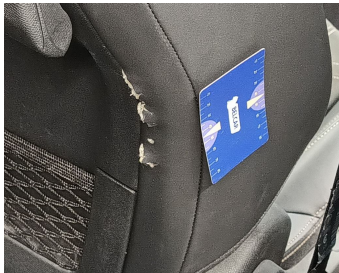
| Damages | Type | Acceptable |
|---|---|---|
| 423 | Seat Front Right / Rear Coating / Replace | N |

Seat Front Right / Rear Coating / Replace-tear

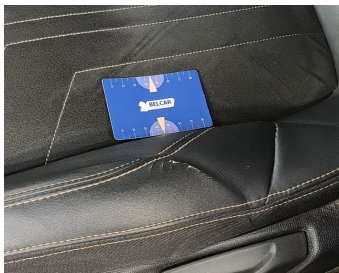
| Damages | Type | Acceptable |
|---|---|---|
| 412 | Seat Front Left / Bottom Coating / Replace | Y |

Seat Front Left / Bottom Coating / Replace-worn

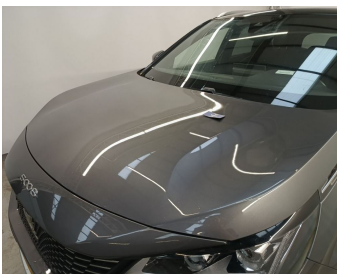
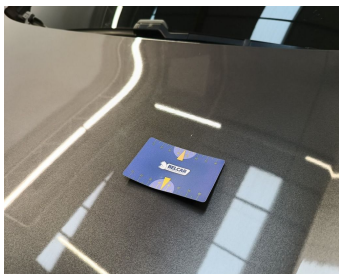
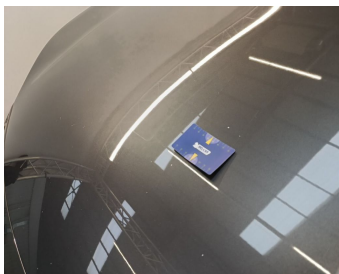
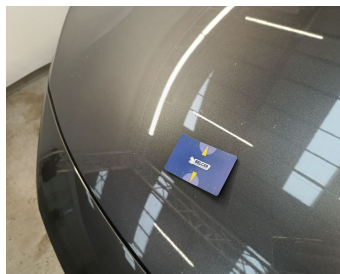
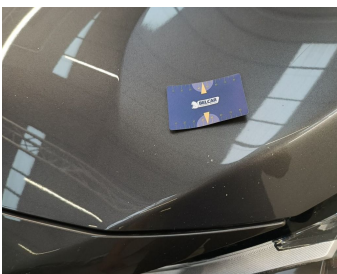
| Damages | Type | Acceptable |
|---|---|---|
| 32 | Front Bonnet // Painting | Y |

Front Bonnet // Painting-stone chipping

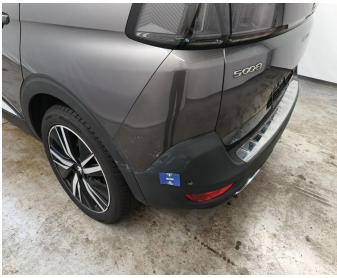
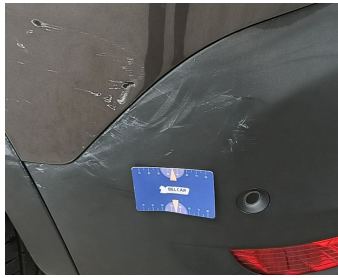
| Damages | Type | Acceptable |
|---|---|---|
| 138 | Bumper Rear / Lower Cover Not Painted / Replace | N |

Bumper Rear / Lower Cover Not Painted / Replace-scratch

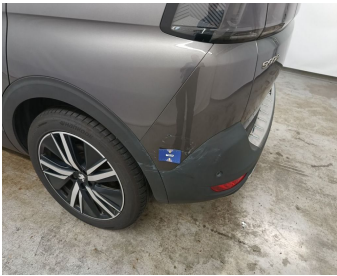
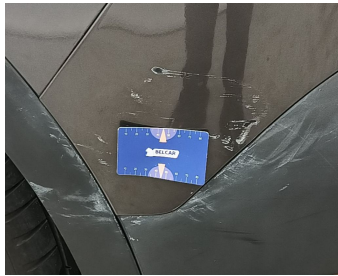
| Damages | Type | Acceptable |
|---|---|---|
| 132 | Bumper Rear // Smart Repair Large | N |

Bumper Rear // Smart Repair Large-scratch

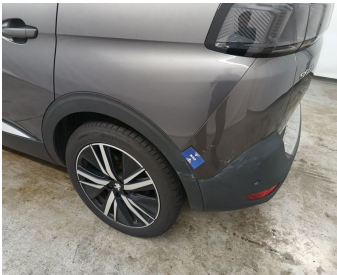
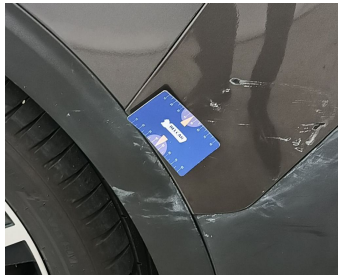
| Damages | Type | Acceptable |
|---|---|---|
| 117 | Wing Rear Left / Trim / Replace | N |

Wing Rear Left / Trim / Replace-scratch

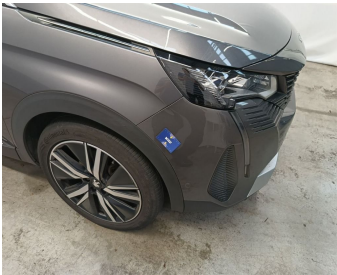
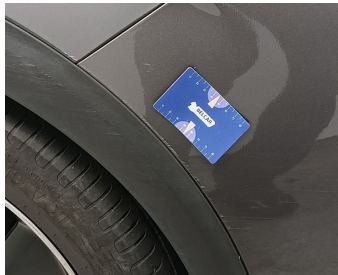
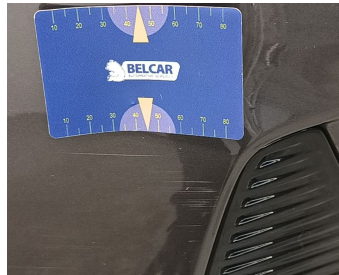
| Damages | Type | Acceptable |
|---|---|---|
| 13 | Bumper Front // Painting | N |

Bumper Front // Painting-scratch

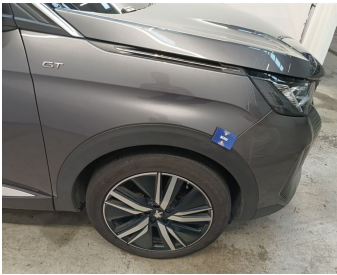
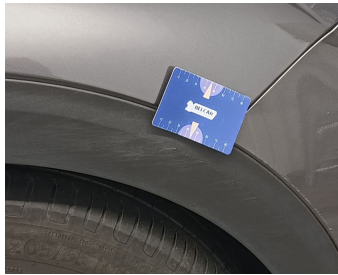
| Damages | Type | Acceptable |
|---|---|---|
| 237 | Wing Front right / Trim / Replace | N |

Wing Front right / Trim / Replace-scratch

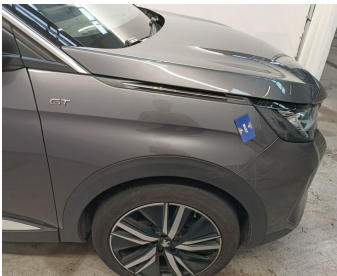
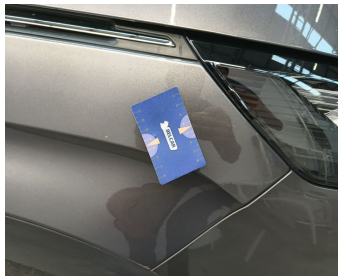
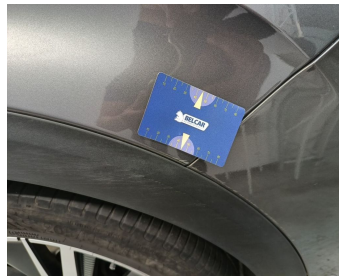
| Damages | Type | Acceptable |
|---|---|---|
| 11 | Bumper Front // Smart Repair Medium | N |

Bumper Front // Smart Repair Medium-scratch
