# INSPECTION REPORT

End of contract

File	311301
License plate	2BJY679
Vehicle identification number	W1K1770101N268422
Dossier	2021 046 109
Make	Mercedes A 180 d Bus.Sol.Aut.
Mileage	30015
First registration	14/12/2021
client availability date	04/05/2026
inspectionDate	07/05/2026

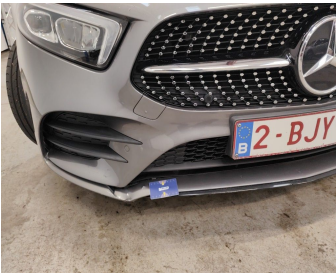
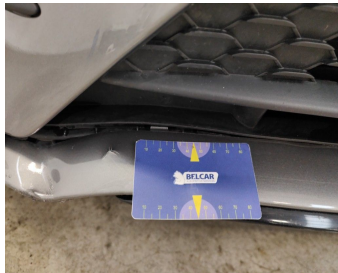
Damages	Type	Acceptable
15	Bumper Front // Replace & Painting	N
272	Bumper Front / Trim Right / Replace	N
274	Bumper Front / Grid Central / Replace	Y

Damage within Renta-norm-

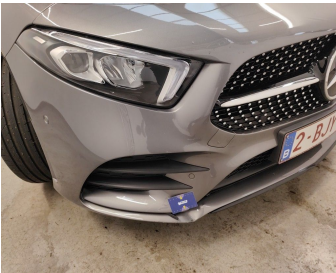
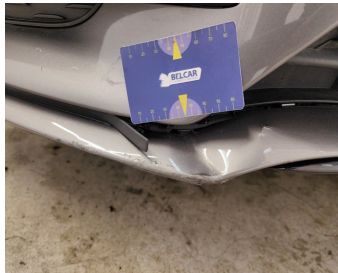
Bumper Front / Grid Central / Replace-cracked

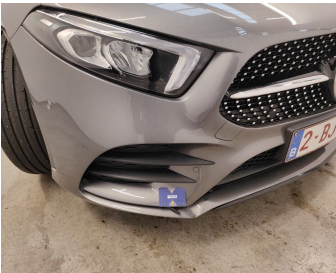
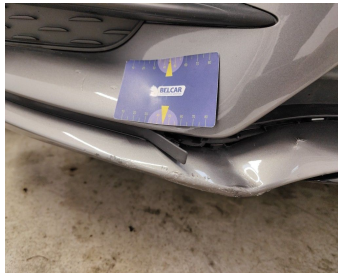
Bumper Front // Replace & Painting-scratch + dent
