# INSPECTION REPORT

**End of contract**

| License plate | 2BRG344 |
| Make | Mercedes GLC 300de 4M Bus.Sol. |

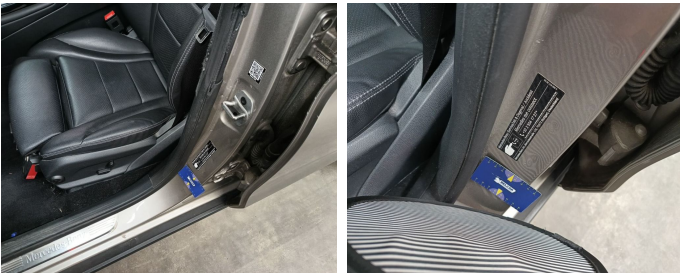
| Damages | Type | Acceptable |
|---|---|---|
| 91 | Rocker Panel Left // Smart Repair Medium | N |

Rocker Panel Left // Smart Repair Medium-scratch + dent

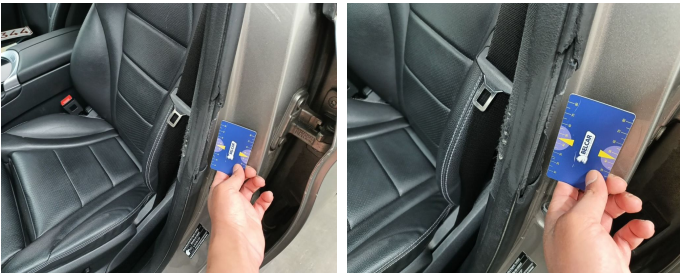
| Damages | Type | Acceptable |
|---|---|---|
| 773 | Interior / A Pillar Lower Cover / Replace | N |

Interior / A Pillar Lower Cover / Replace-tear

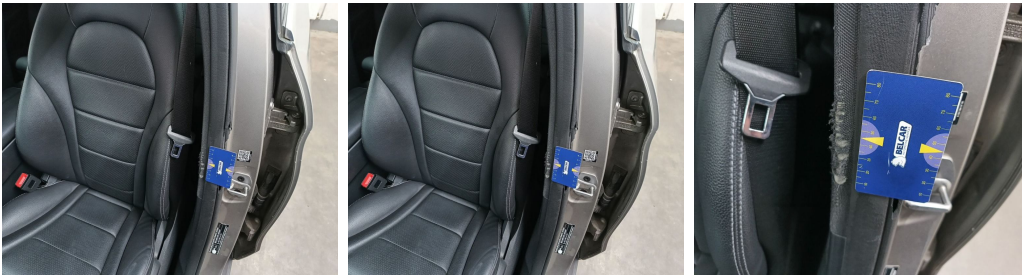
| Damages | Type | Acceptable |
|---|---|---|
| 772 | Interior / A Pillar Upper Cover / Replace | N |

Interior / A Pillar Upper Cover / Replace-tear

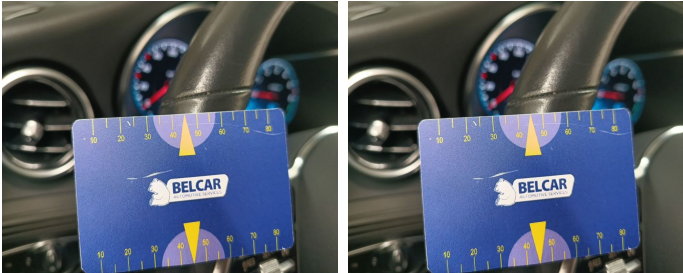
| Damages | Type | Acceptable |
|---|---|---|
| 569 | Dashboard / Steering Wheel / Replace | Y |

Dashboard / Steering Wheel / Replace-worn

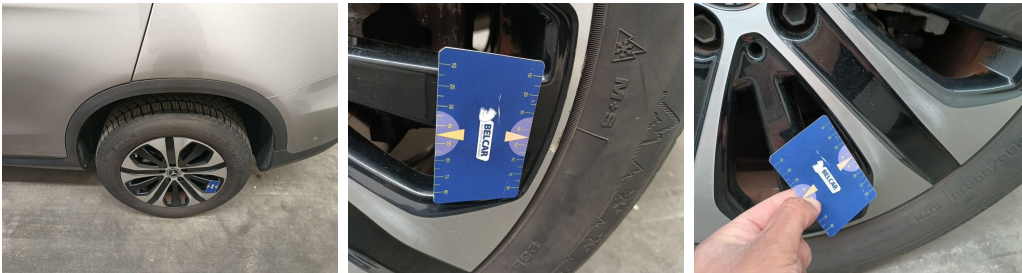
| Damages | Type | Acceptable |
|---|---|---|
| 320 | Wheel Two Tone Rear Left // Repair | N |

Wheel Two Tone Rear Left // Repair-scratch

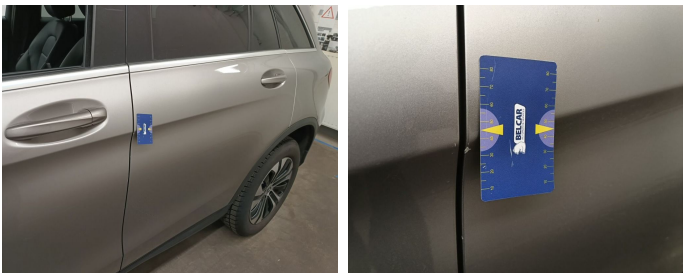
| Damages | Type | Acceptable |
|---|---|---|
| 100 | Door Rear Left // Smart Repair Small | Y |

Door Rear Left // Smart Repair Small-scratch

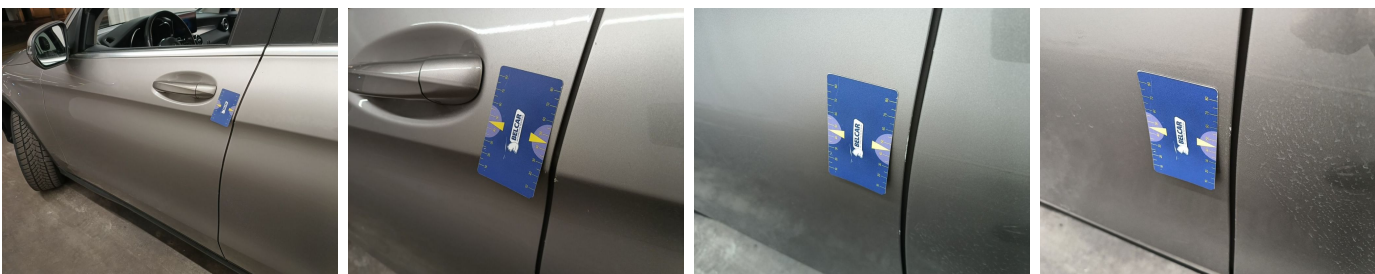
| Damages | Type | Acceptable |
|---|---|---|
| 80 | Door Front Left // Smart Repair Small | Y |

Door Front Left // Smart Repair Small-scratch

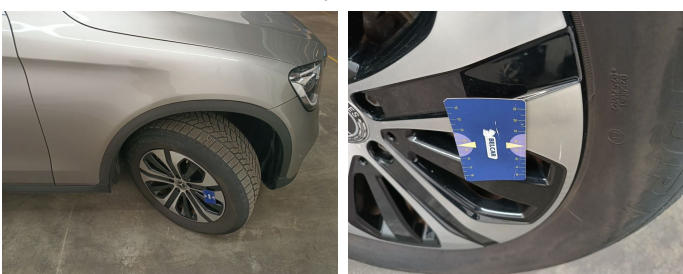
| Damages | Type | Acceptable |
|---|---|---|
| 340 | Wheel Two Tone Front Right // Repair | Y |

Wheel Two Tone Front Right // Repair-scratch

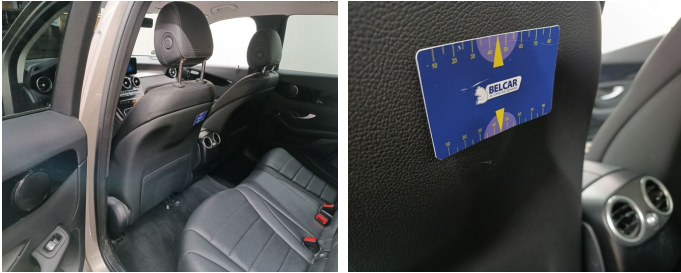
| Damages | Type | Acceptable |
|---|---|---|
| 411 | Seat Front Left // Repair | N |

Seat Front Left // Repair-scratch

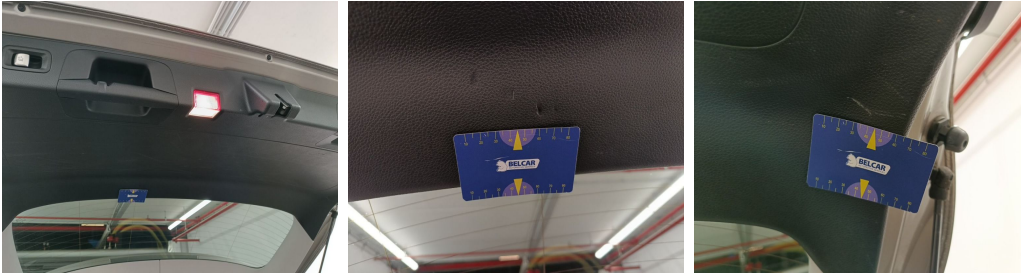
| Damages | Type | Acceptable |
|---|---|---|
| 594 | Trunk Lid Interior Coating / Complete Panel / Replace | Y |

Trunk Lid Interior Coating / Complete Panel / Replace-scratch

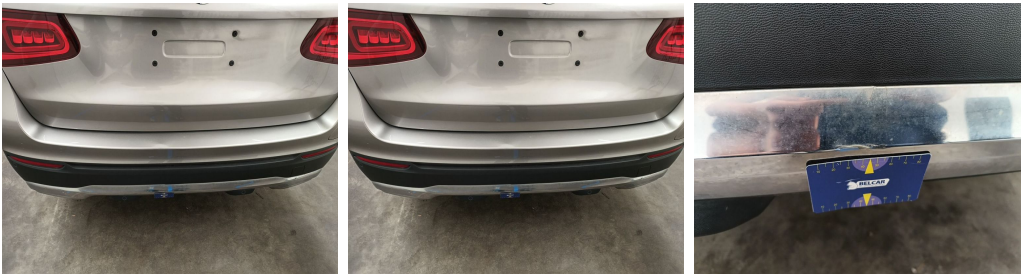
| Damages | Type | Acceptable |
|---|---|---|
| 139 | Bumper Rear / Spoiler / Replace | N |

Bumper Rear / Spoiler / Replace-cracked

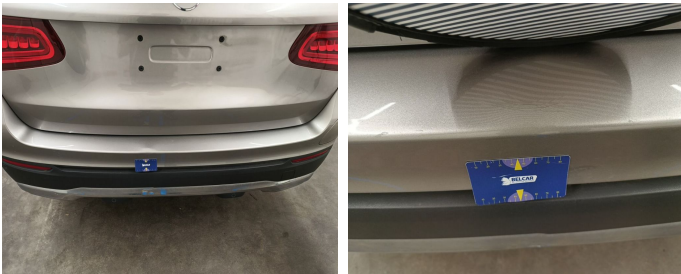
| Damages | Type | Acceptable |
|---|---|---|
| 134 | Bumper Rear // Repair & Painting | N |

Bumper Rear // Repair & Painting-scratch + dent
