INSPECTION REPORT

End of contract

File	308832
License plate	2BRQ377
Vehicle identification number	W0VEFYHT2MJ956810
Dossier	2021154068
Make	Opel Comb.1.5D 55kW 2.0T L1H1
Mileage	197073
First registration	25/02/2022
client availability date	23/03/2026
inspectionDate	02/04/2026

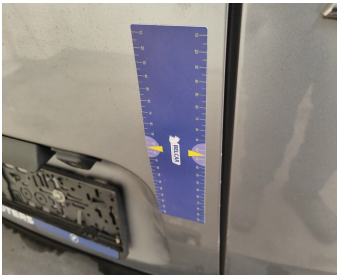
Rear Loading Door Left // Painting-scratch

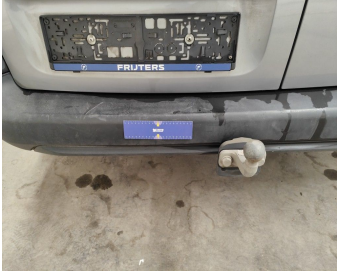
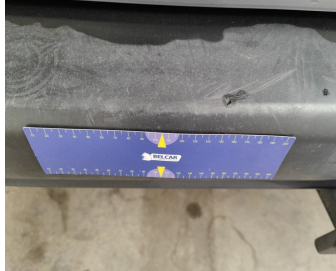
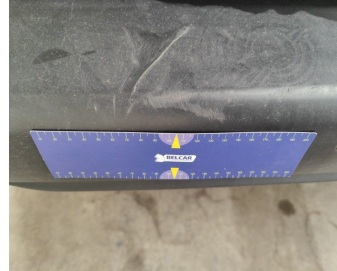
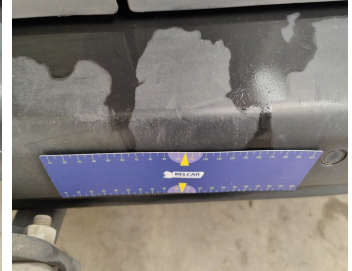
Bumper Rear / Lower Cover Not Painted / Replace-scratch

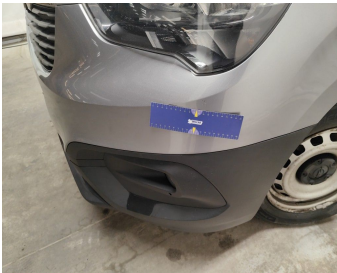
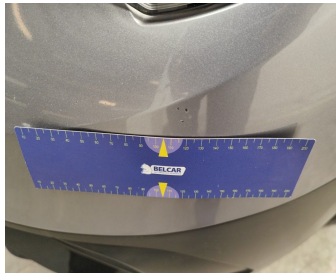
Bumper Front // Painting-scratch

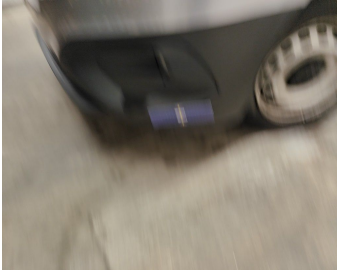
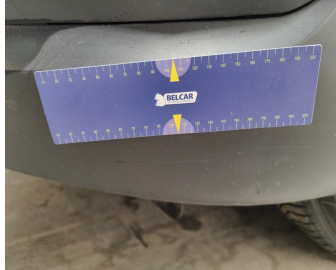
Bumper Front / Lower Cover Not Painted / Replace-scratch

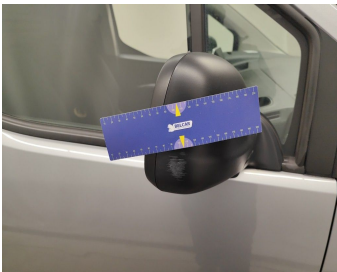
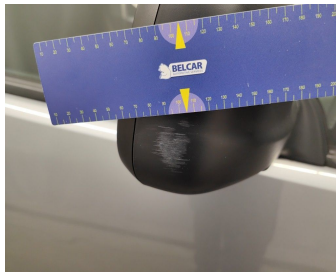
Side View Mirror Right / Shell / Replace Not Painted-scratch

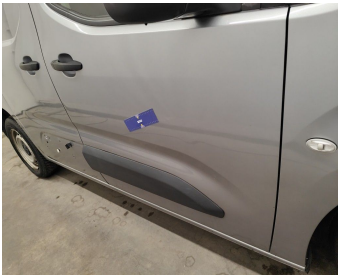
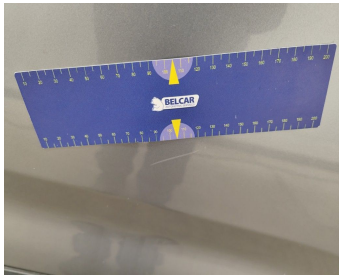
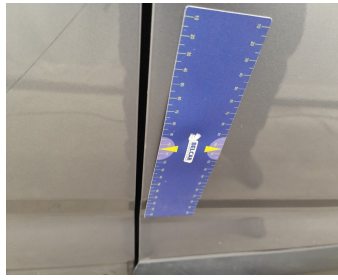
Door Front Right // Painting-scratch

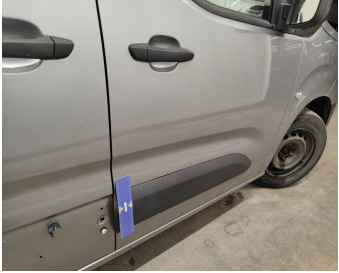
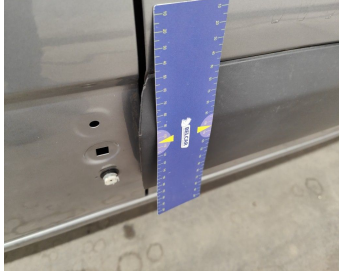
Door Front Right / Trim / Replace-scratch

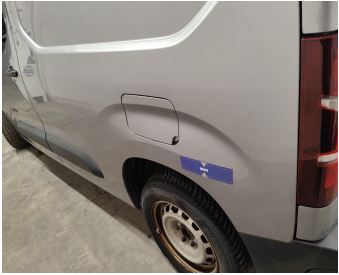
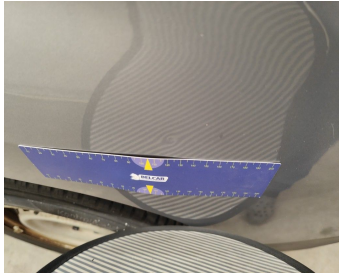
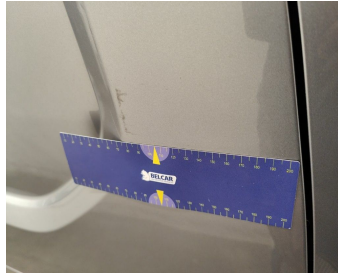
Wing Rear Left // Smart Repair Small-dent

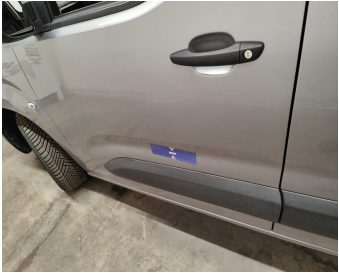
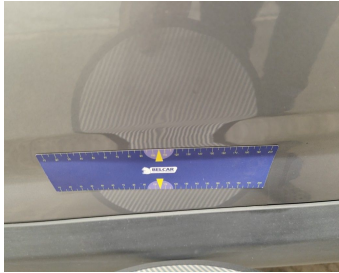
Door Front Left // Smart Repair Small-dent

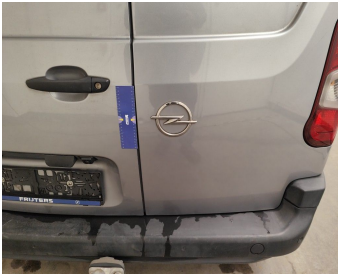
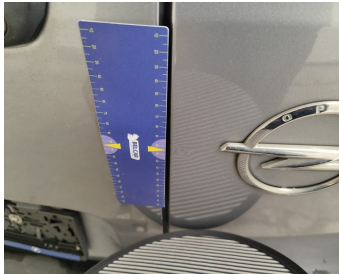
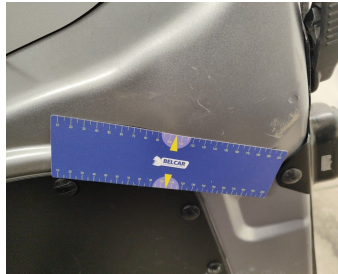
Rear Loading Door Right // Repair & Painting-scratch + dent

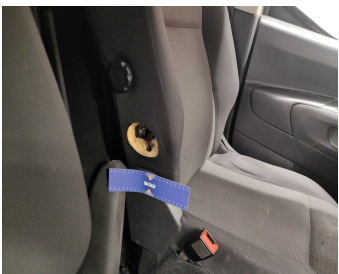
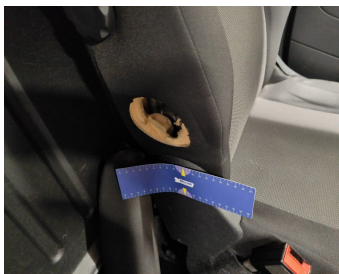
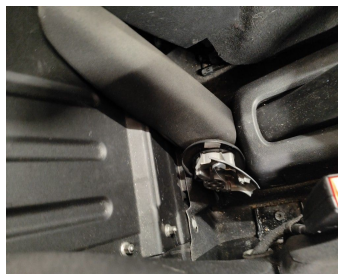
Seat Front Left / Armrest / Replace-cracked

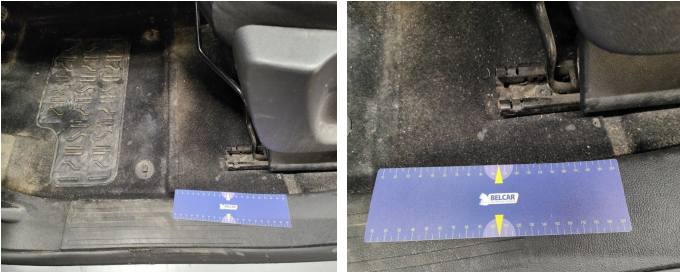
Interior // Repair 1-Incinerated

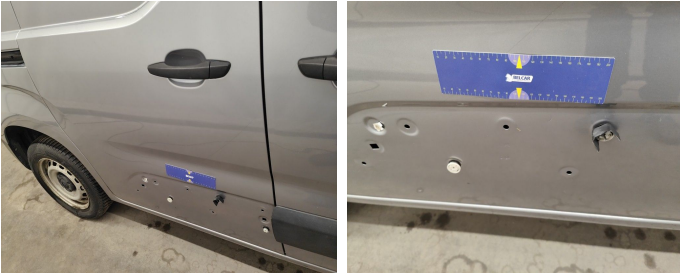
Door Rear Right / Trim / Replace-missing

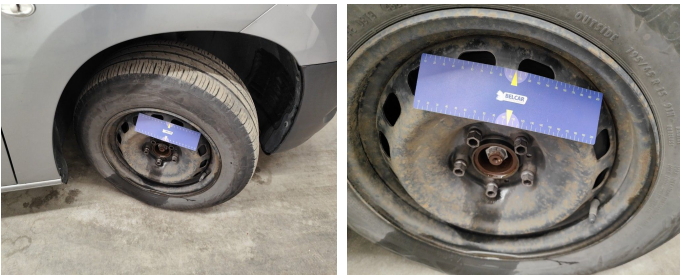
Wheel Front Right / Wheel Cover / Replace-missing

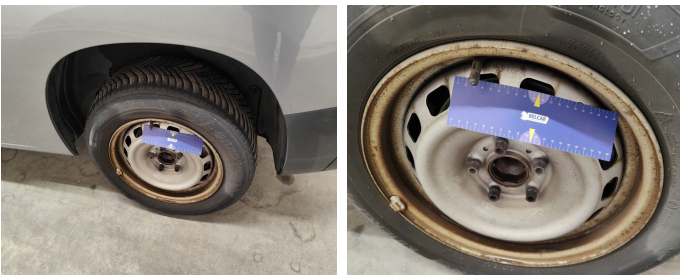
Wheel Rear Left / Wheel Cover / Replace-missing

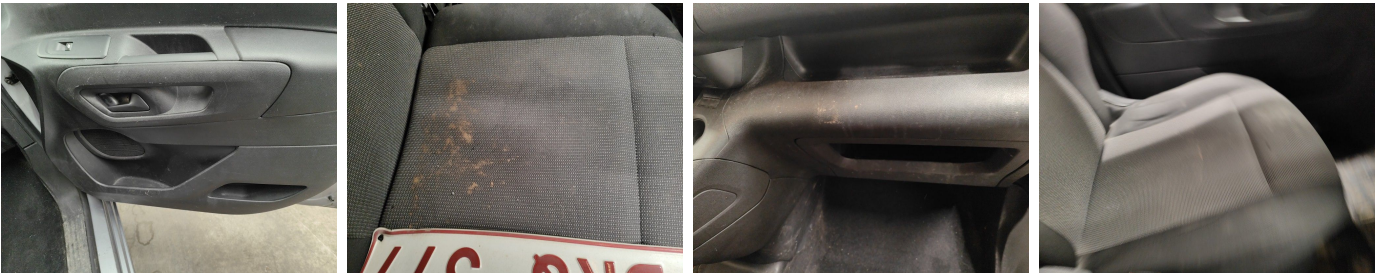
Interior Cleaning // Small-dirty

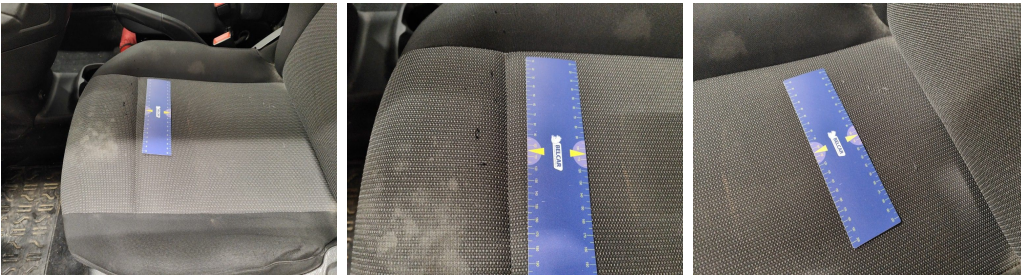
Seat Front Left / Bottom Coating / Replace-worn

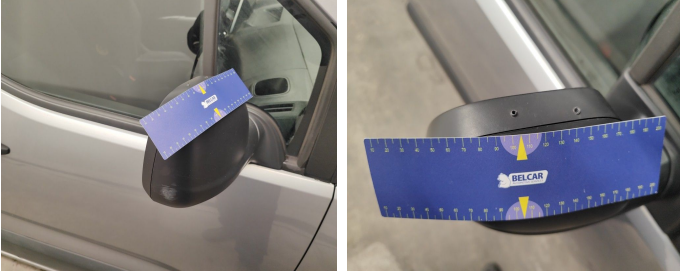
Side View Mirror Right // Replace Not Painted-hole

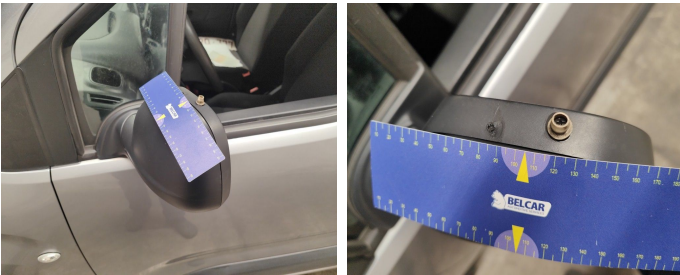
Side View Mirror Left // Replace Not Painted-hole
