INSPECTION REPORT

End of contract

File	309094
License plate	2BDW509
Vehicle identification number	VR3USHNKKMJ828774
Dossier	2021 103 009
Make	Peugeot 2008 1.2 74kW Allure P
Mileage	90091
First registration	15/10/2021
client availability date	25/03/2026
inspectionDate	31/03/2026

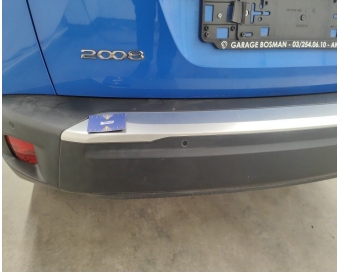
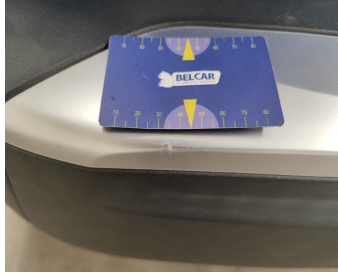
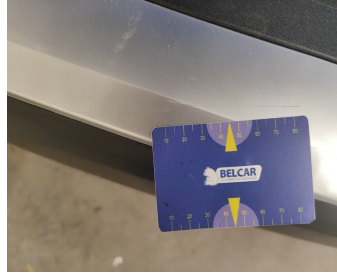
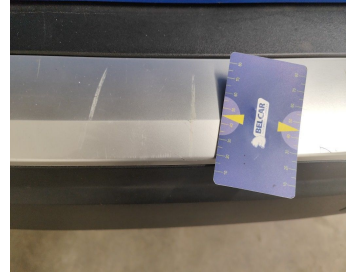
Bumper Rear / Lower Cover Not Painted / Replace-scratch

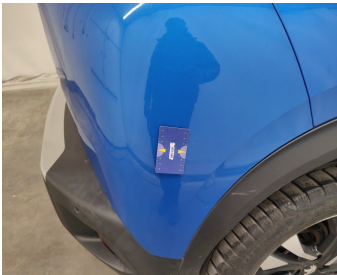
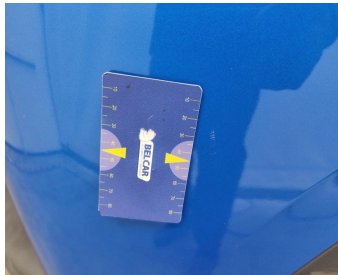
Bumper Rear / Spoiler / Replace-scratch

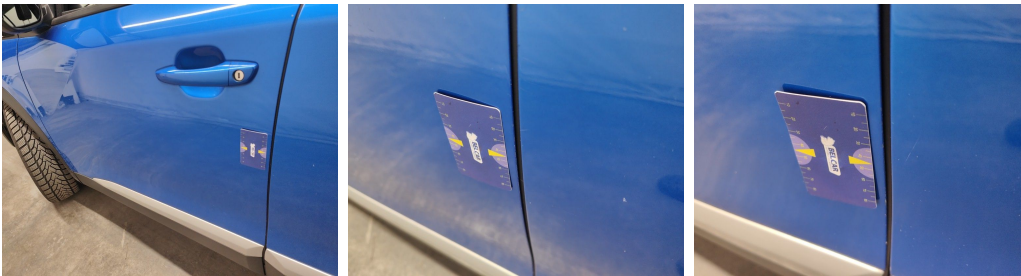
Door Rear Left // Painting-scratch

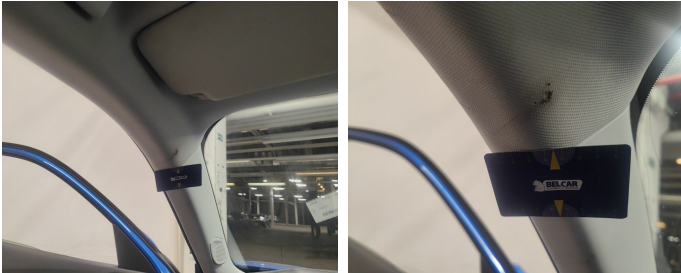
Interior / A Pillar Cover / Replace-Incinerated
