INSPECTION REPORT

End of contract

File	306857
License plate	1XHY632
Vehicle identification number	W1V4156031U280416
Dossier	2019331174
Make	Mercedes Citan 109CDI L2 Perf.
Mileage	125054
First registration	10/01/2020
client availability date	27/02/2026
inspectionDate	10/03/2026

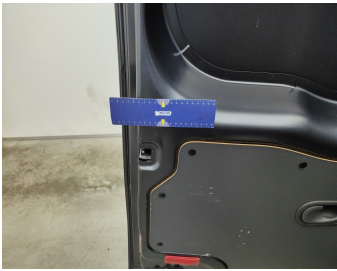
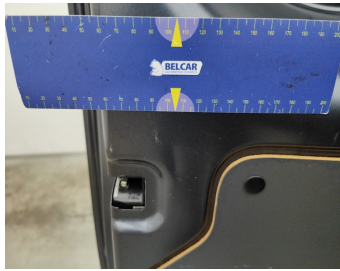
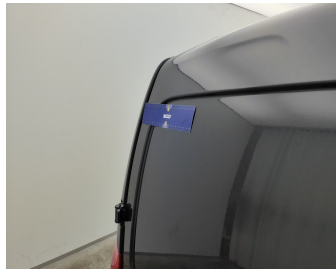
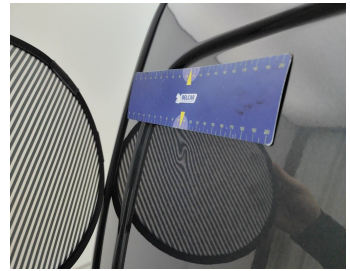
Damage within Renta-norm-scratch

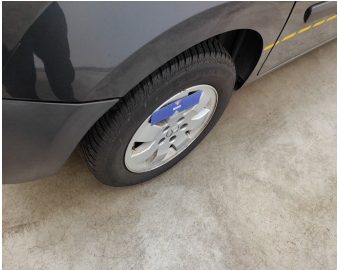
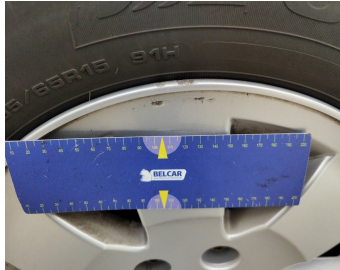
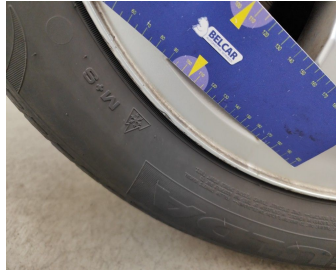
Wheel Alloy Rear Right // Repair-scratch

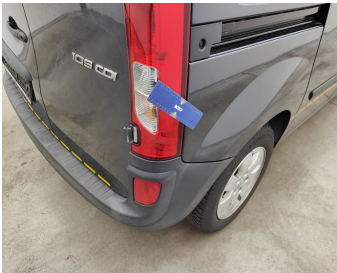
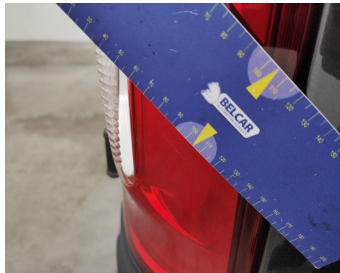
Light / Rear Right / Replace-scratch

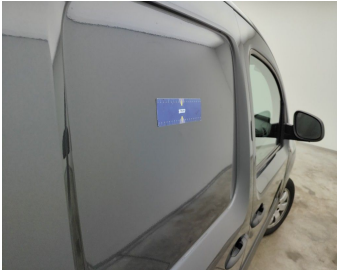
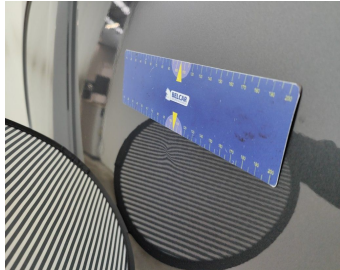
Door Rear Right // Repair & Painting-dent

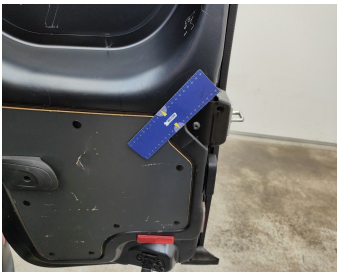
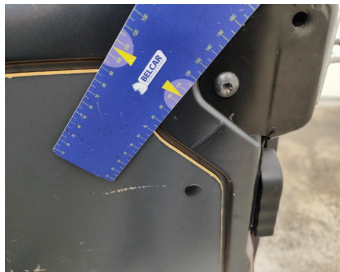
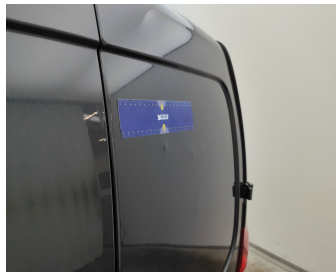
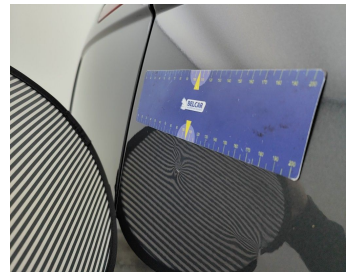
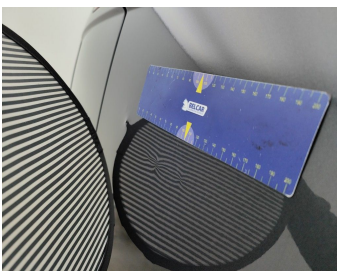
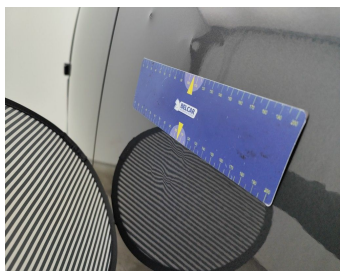
Rear Loading Door Right // Repair & Painting-scratch + dent

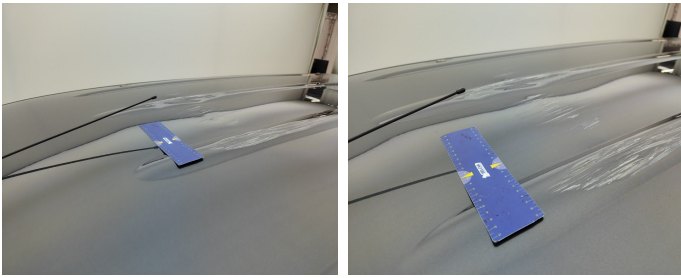
Roof // Repair & Painting-scratch + dent

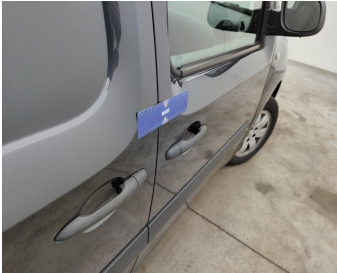
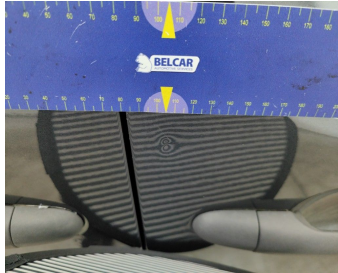
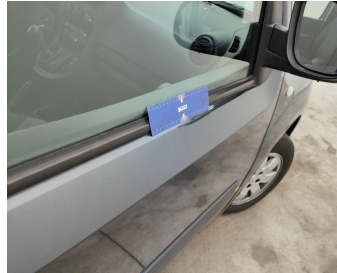
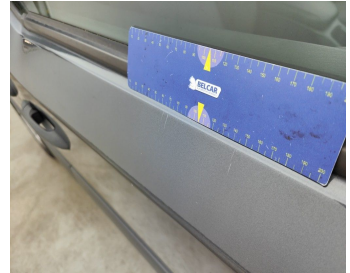
Door Front Right // Repair & Painting-scratch + dent

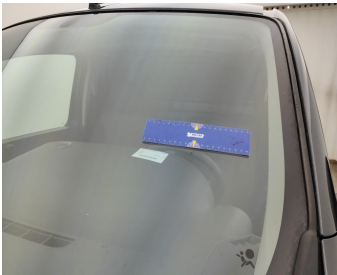
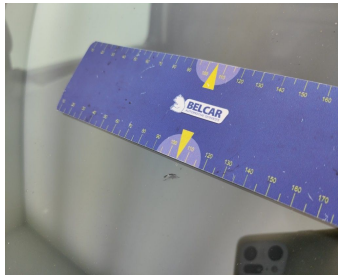
Windshield // Replace-cracked

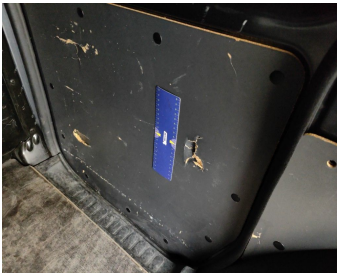
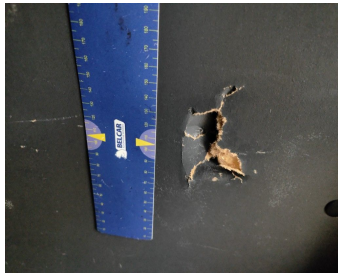
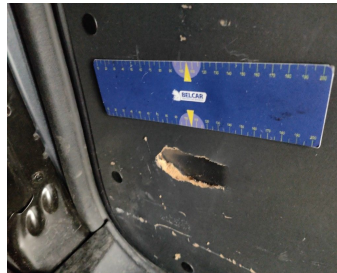
Rear Right Door Interior Coating // Replace Completely-cracked

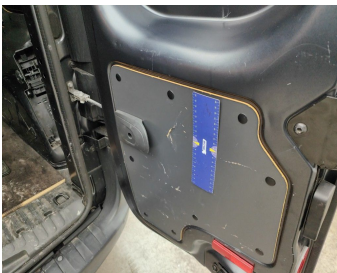
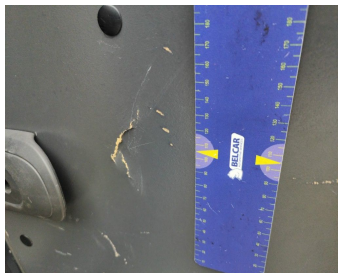
Trunk Lid Interior Coating / MDF Rear Right / Replace-cracked

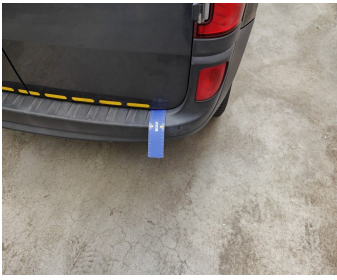
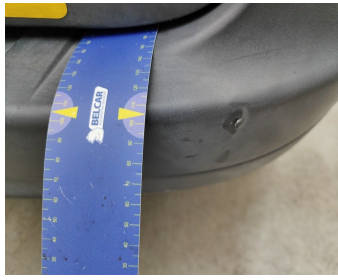
Bumper Rear // Replace without painting-cracked

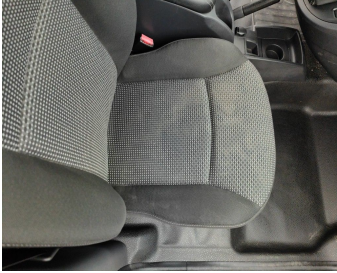
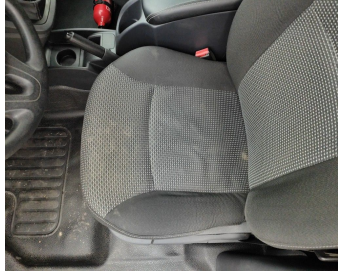
Interior Cleaning // Small-stain

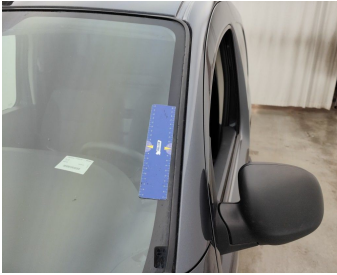
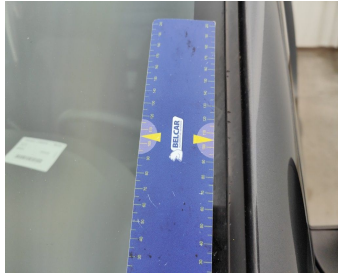
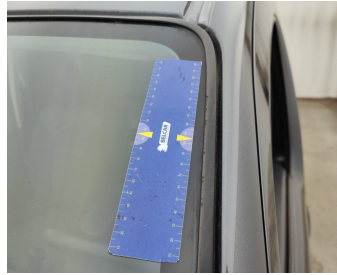
Windshield / Trim / Replace-scratch

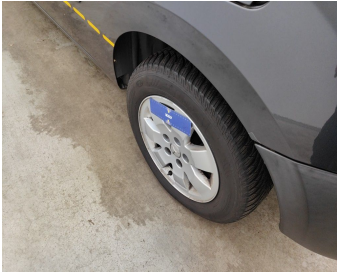
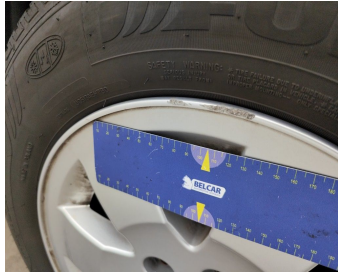
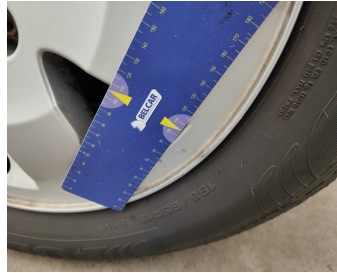
Wheel Alloy Rear Left // Repair-scratch
