# INSPECTION REPORT

End of contract

| License plate | 2BRZ973 |
| Make | Mercedes GLC 300de 4M Bus.Sol. |

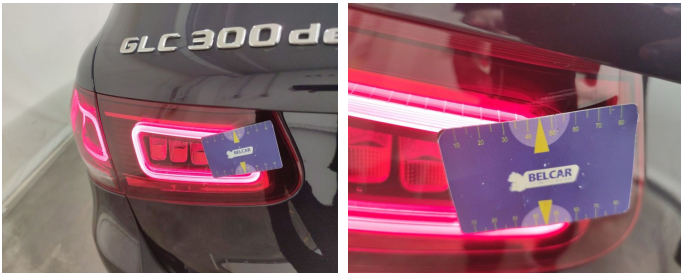
| Damages | Type | Acceptable |
|---|---|---|
| 125 | Light / Rear Left On Rear Bonnet / Replace | N |

Light / Rear Left On Rear Bonnet / Replace-scratch

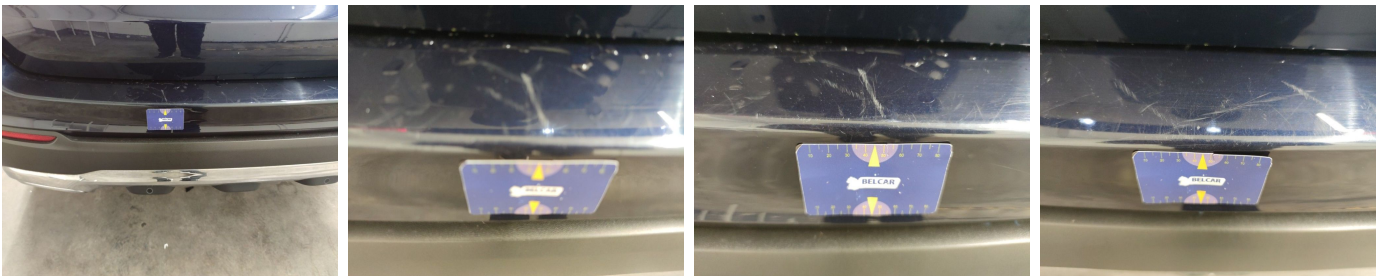
| Damages | Type | Acceptable |
|---|---|---|
| 133 | Bumper Rear // Painting | N |

Bumper Rear // Painting-scratch

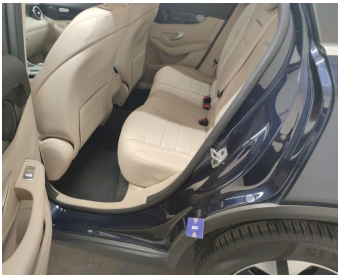
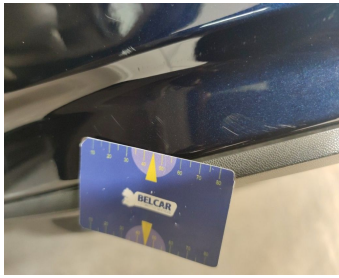
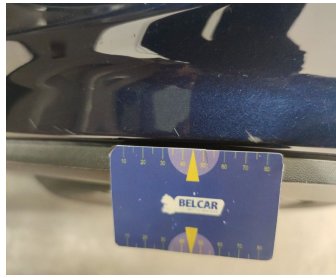
| Damages | Type | Acceptable |
|---|---|---|
| 91 | Rocker Panel Left // Smart Repair Medium | Y |

Rocker Panel Left // Smart Repair Medium-scratch

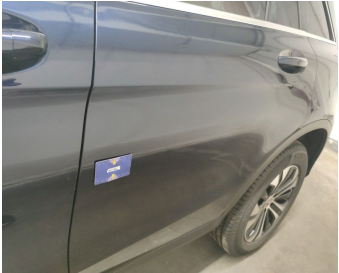
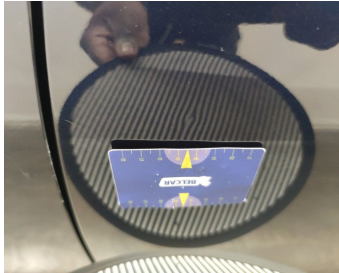
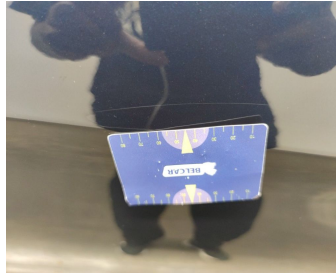
| Damages | Type | Acceptable |
|---|---|---|
| 106 | Door Rear Left // Polish | Y |

Door Rear Left // Polish-scratch

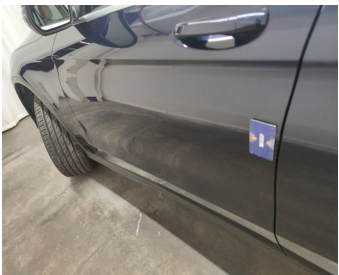
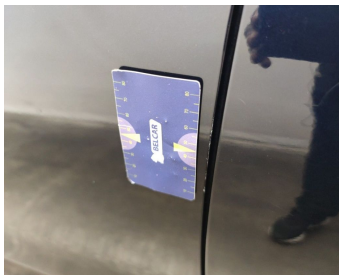
| Damages | Type | Acceptable |
|---|---|---|
| 81 | Door Front Left // Smart Repair Medium | Y |

Door Front Left // Smart Repair Medium-scratch

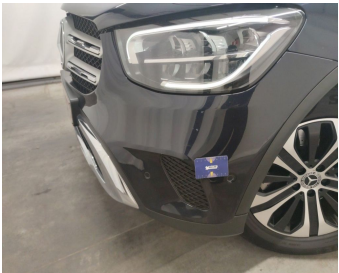
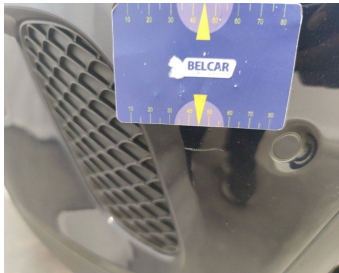
| Damages | Type | Acceptable |
|---|---|---|
| 13 | Bumper Front // Painting | Y |

Bumper Front // Painting-scratch

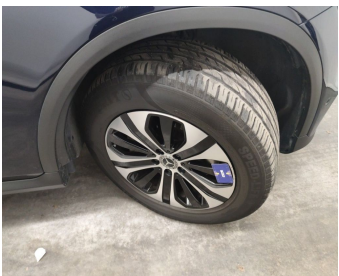
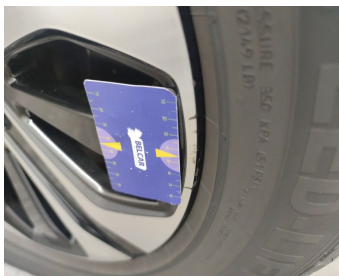
| Damages | Type | Acceptable |
|---|---|---|
| 340 | Wheel Two Tone Front Right // Repair | Y |

Wheel Two Tone Front Right // Repair-scratch

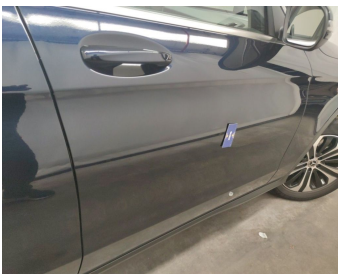
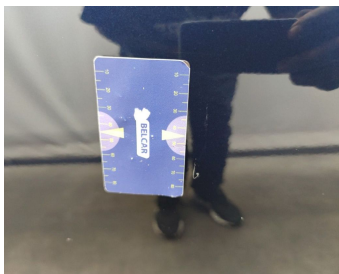
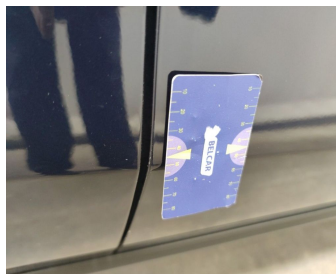
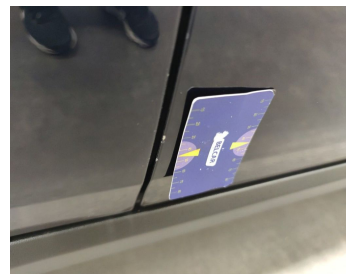
| Damages | Type | Acceptable |
|---|---|---|
| 213 | Door Front Right // Painting | Y |

Door Front Right // Painting-scratch

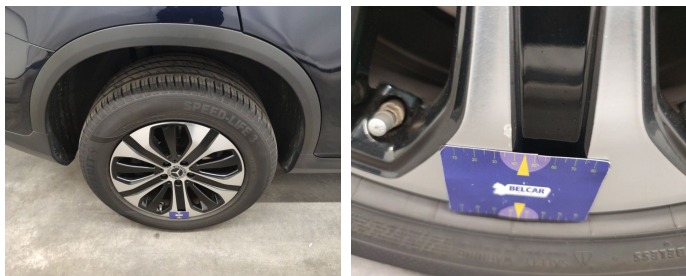
| Damages | Type | Acceptable |
|---|---|---|
| 330 | Wheel Two Tone Rear Right // Repair | Y |

Wheel Two Tone Rear Right // Repair-scratch

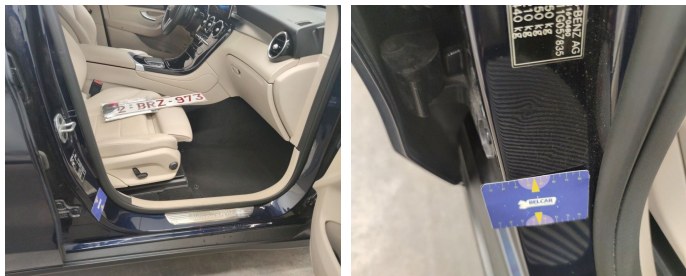
| Damages | Type | Acceptable |
|---|---|---|
| 201 | Rocker Panel Right // Smart Repair Medium | Y |

Rocker Panel Right // Smart Repair Medium-dent

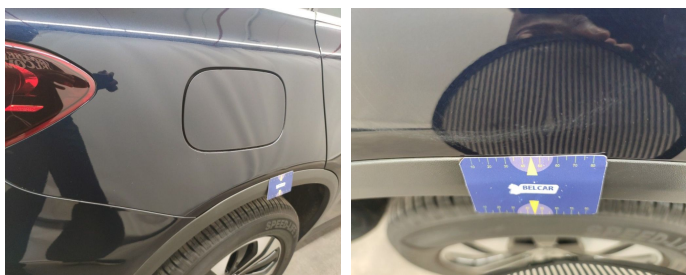
| Damages | Type | Acceptable |
|---|---|---|
| 180 | Wing Rear Right // Smart Repair Small | N |

Wing Rear Right // Smart Repair Small-scratch + dent

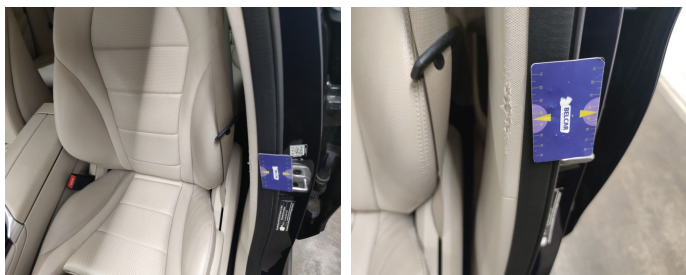
| Damages | Type | Acceptable |
|---|---|---|
| 540 | Interior // Repair 1 | N |

Interior // Repair 1-cracked

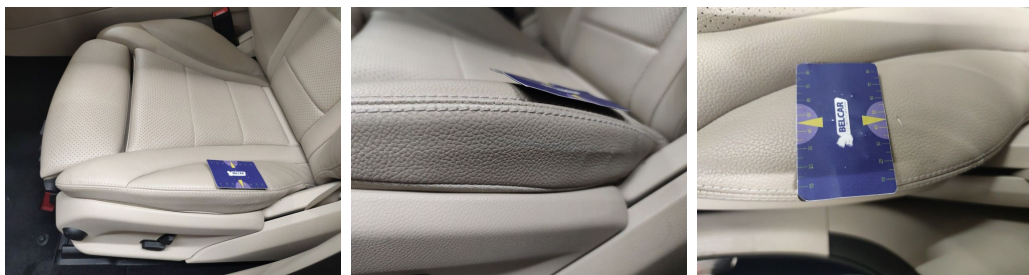
| Damages | Type | Acceptable |
|---|---|---|
| 412 | Seat Front Left / Bottom Coating / Replace | Y |

Seat Front Left / Bottom Coating / Replace-worn
