INSPECTION REPORT

End of contract

| License plate | 1YMX170 |
| Make | Opel Astra ST 1.2 96kW Eleganc |

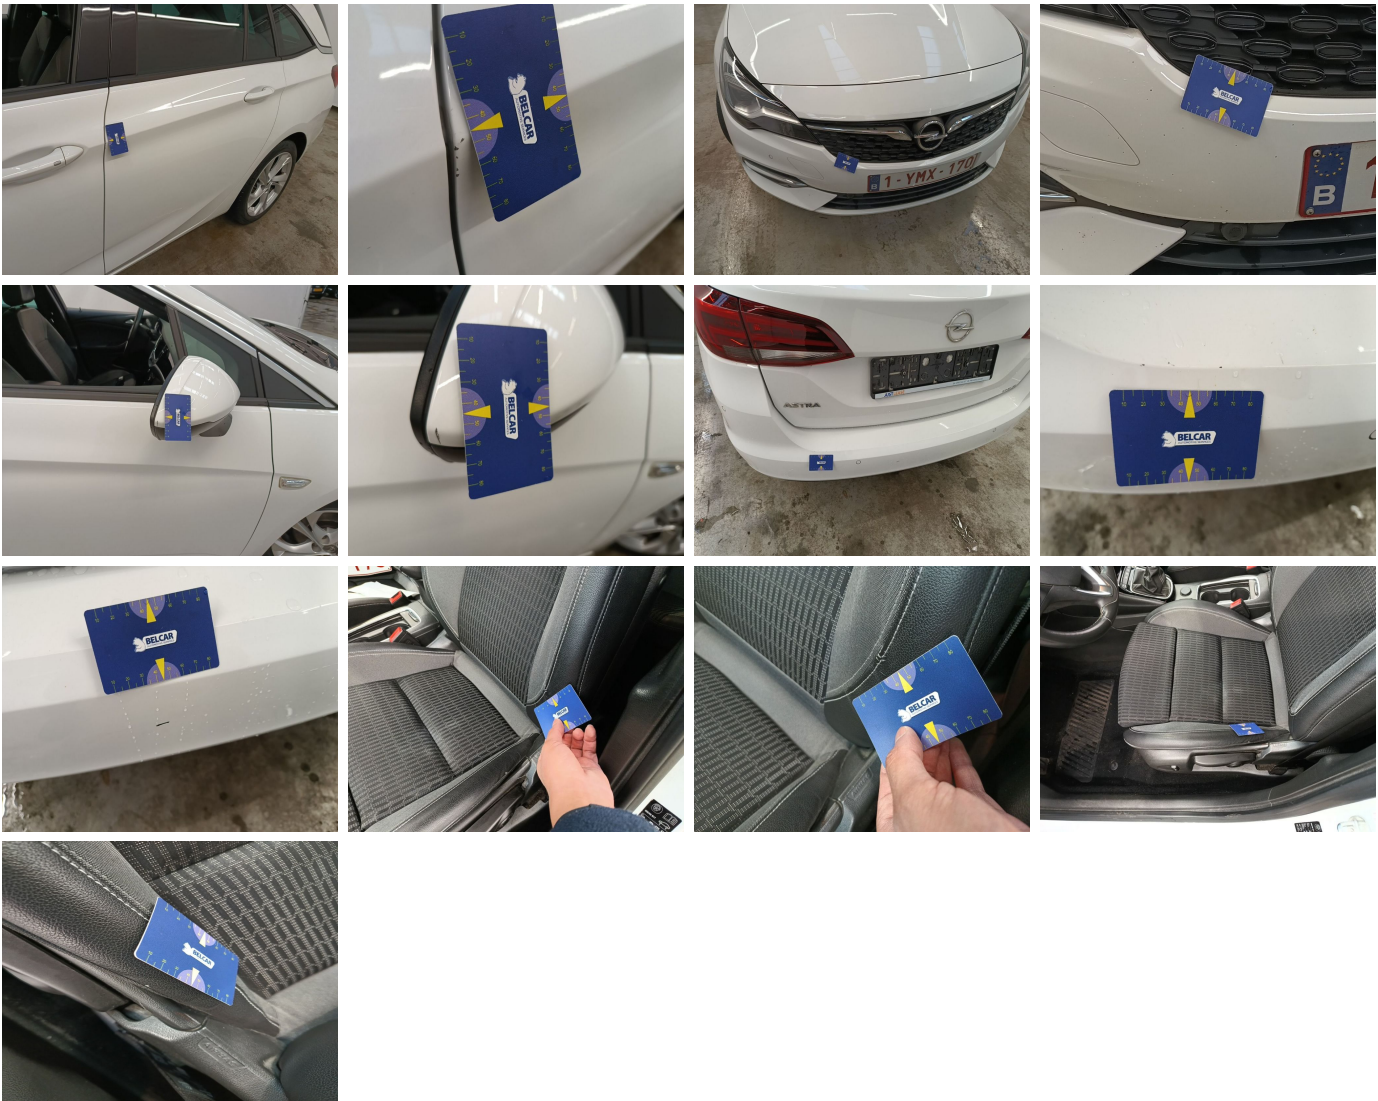
Damage within Renta-norm-scratch

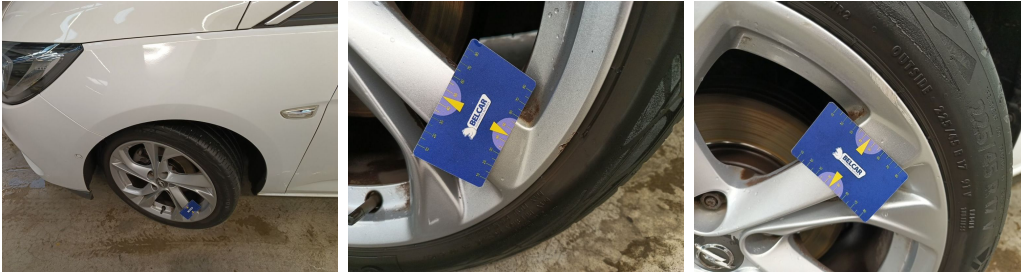
| Damages | Type | Acceptable |
|---|---|---|
| 311 | Wheel Alloy Front Left // Repair | N |

Wheel Alloy Front Left // Repair-scratch

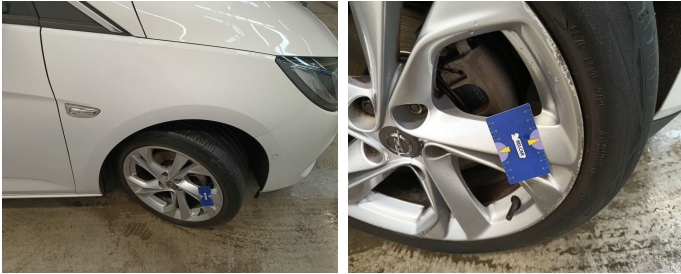
| Damages | Type | Acceptable |
|---|---|---|
| 341 | Wheel Alloy Front Right // Repair | N |

Wheel Alloy Front Right // Repair-scratch

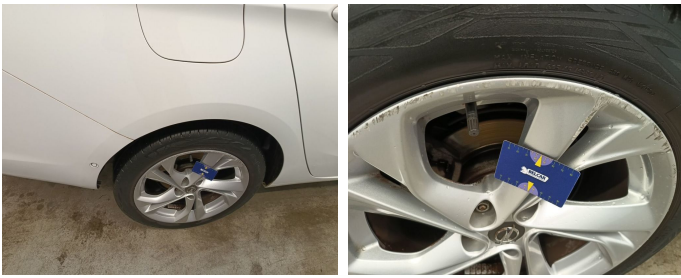
| Damages | Type | Acceptable |
|---|---|---|
| 331 | Wheel Alloy Rear Right // Repair | N |

Wheel Alloy Rear Right // Repair-scratch

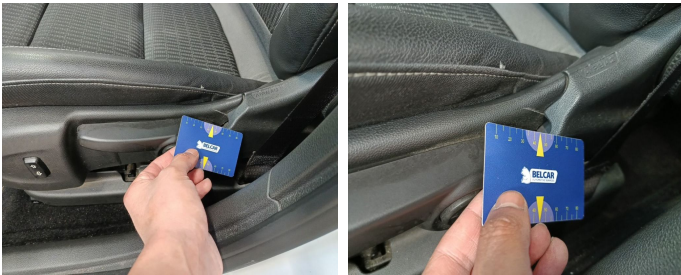
| Damages | Type | Acceptable |
|---|---|---|
| 411 | Seat Front Left // Repair | Y |

Seat Front Left // Repair-scratch

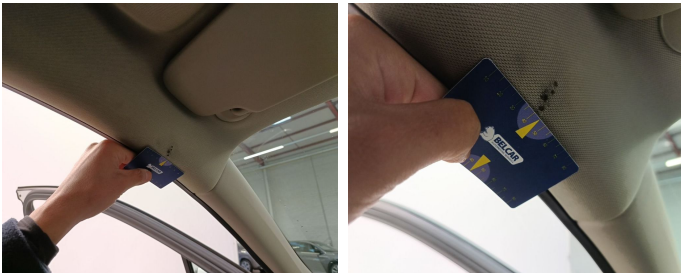
| Damages | Type | Acceptable |
|---|---|---|
| 549 | Interior / Headliner/ Replace | N |

Interior / Headliner/ Replace-Incinerated

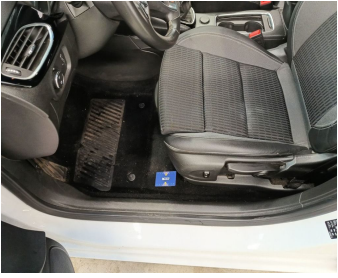
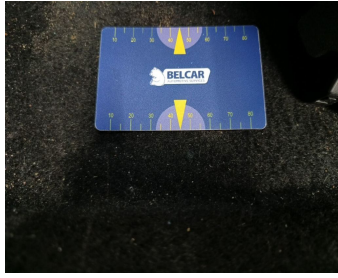
| Damages | Type | Acceptable |
|---|---|---|
| 540 | Interior // Repair 1 | N |

Interior // Repair 1-Incinerated

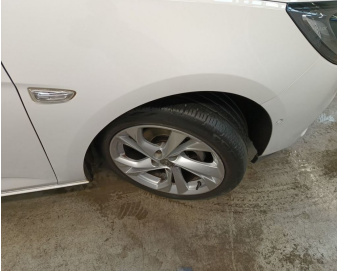
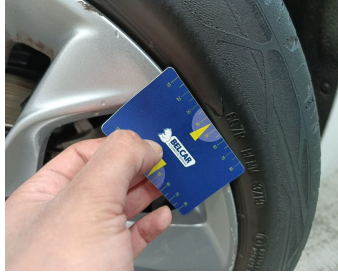
| Damages | Type | Acceptable |
|---|---|---|
| 346 | Tyre Front Right // Replace | N |

Tyre Front Right // Replace-tear
