# INSPECTION REPORT

**End of contract**

| License plate | 2BMM258 |
| Make | Mercedes A 180 d Bus.Sol.Essen |

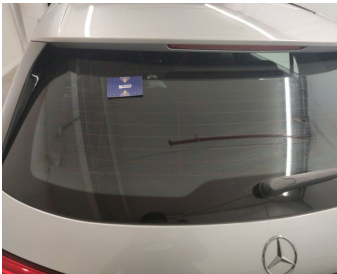
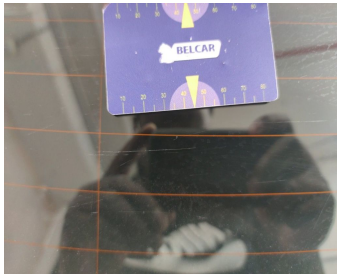
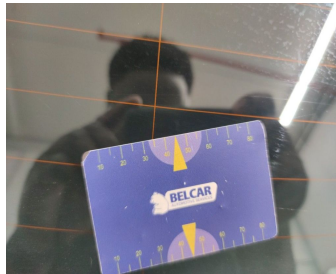
| Damages | Type | Acceptable |
|---|---|---|
| 159 | Rear Bonnet / Rear Window / Replace | Y |

Rear Bonnet / Rear Window / Replace-scratch

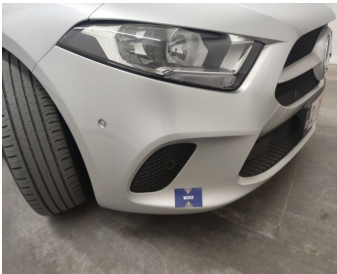
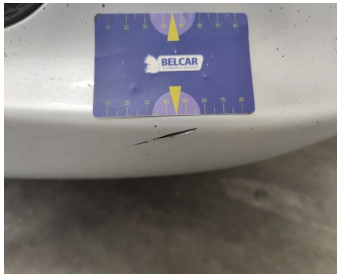
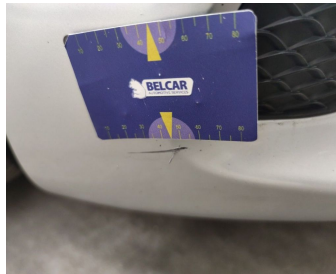
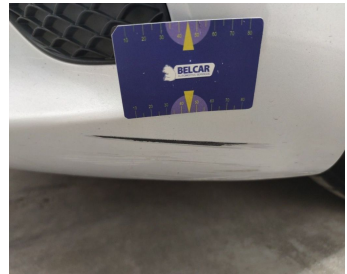
| Damages | Type | Acceptable |
|---|---|---|
| 13 | Bumper Front // Painting | N |

Bumper Front // Painting-scratch

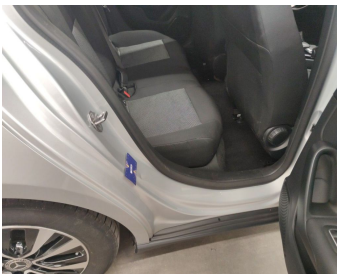
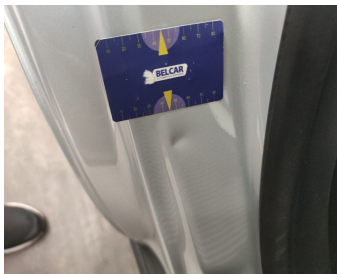
| Damages | Type | Acceptable |
|---|---|---|
| 201 | Rocker Panel Right // Smart Repair Medium | N |

Rocker Panel Right // Smart Repair Medium-dent

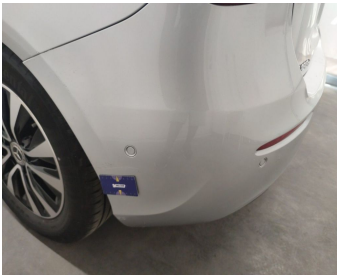
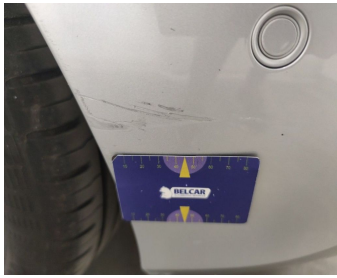
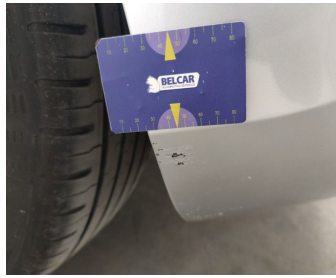
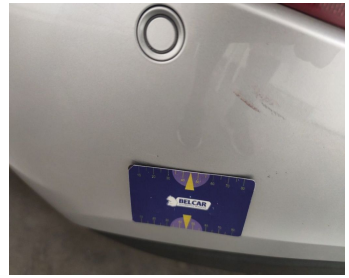
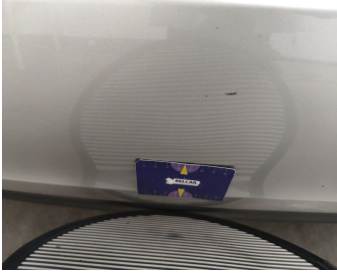
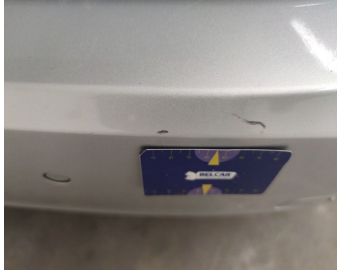
| Damages | Type | Acceptable |
|---|---|---|
| 134 | Bumper Rear // Repair & Painting | N |

Bumper Rear // Repair & Painting-scratch + dent

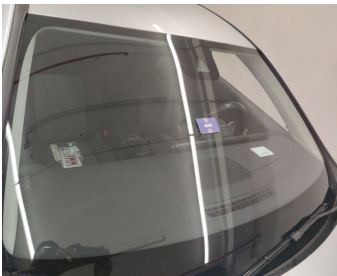
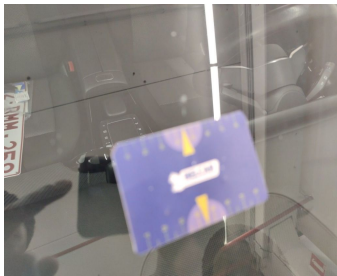
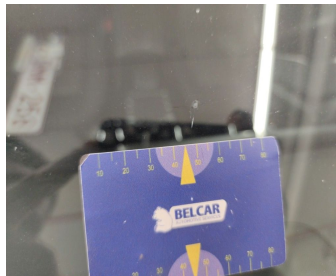
| Damages | Type | Acceptable |
|---|---|---|
| 40 | Windshield // Repair | Y |

Windshield // Repair-cracked

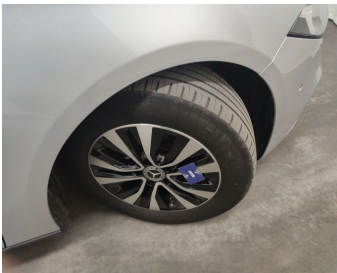
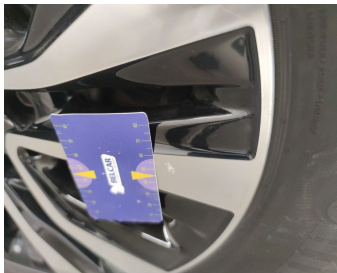
| Damages | Type | Acceptable |
|---|---|---|
| 340 | Wheel Two Tone Front Right // Repair | Y |

Wheel Two Tone Front Right // Repair-Chemical reaction

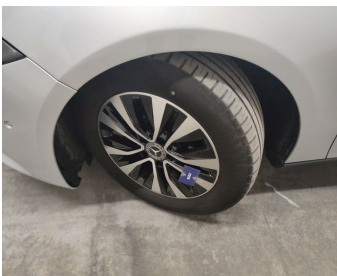
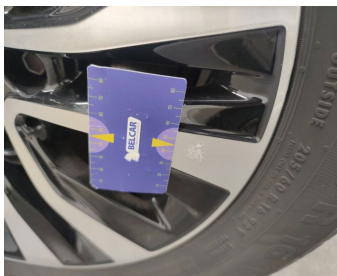
| Damages | Type | Acceptable |
|---|---|---|
| 310 | Wheel Two Tone Front Left // Repair | Y |

Wheel Two Tone Front Left // Repair-Chemical reaction

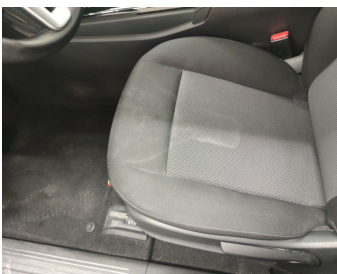
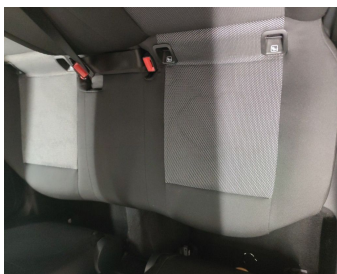
| Damages | Type | Acceptable |
|---|---|---|
| 860 | Interior Cleaning // Small | N |

Interior Cleaning // Small-stain

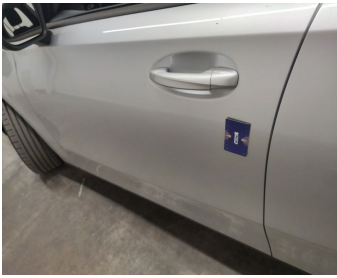
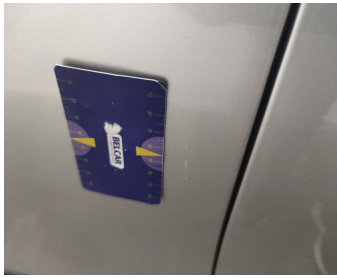
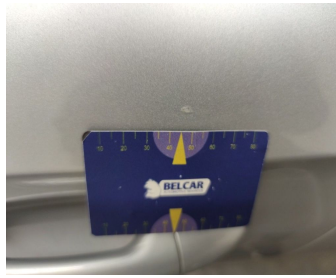
| Damages | Type | Acceptable |
|---|---|---|
| 83 | Door Front Left // Painting | Y |

Door Front Left // Painting-Chipped paint
