INSPECTION REPORT

End of contract

File	312224
License plate	AV4868
Vehicle identification number	W1K1770101N284211
Dossier	2022003002
Make	Mercedes A 180 d 116 Bus.Solut
Mileage	152519
First registration	23/05/2022
client availability date	06/05/2026
inspectionDate	08/05/2026

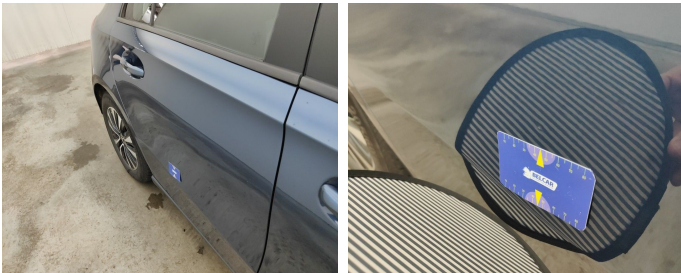
Door Rear Left // Repair & Painting-dent

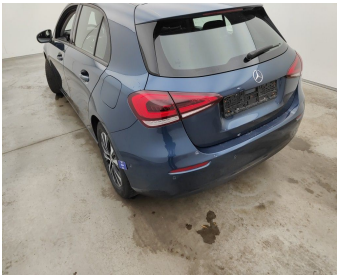
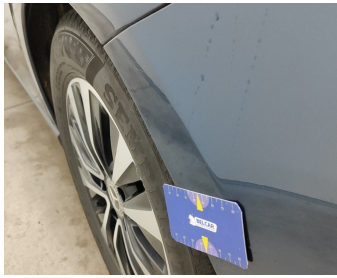
Door Rear Right // Repair & Painting-scratch + dent
