INSPECTION REPORT

End of contract

File	308616
License plate	2AFA901
Vehicle identification number	W1N2539141V290325
Dossier	2020078073
Make	Mercedes GLC 220d
Mileage	207126
First registration	15/03/2021
client availability date	31/03/2026
inspectionDate	10/04/2026

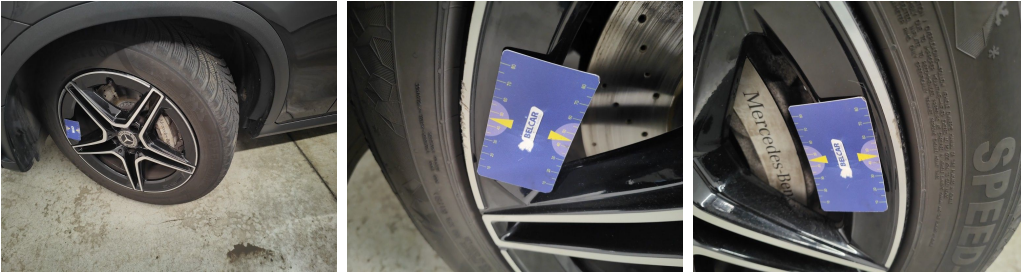
Wheel Two Tone Front Left // Repair-scratch

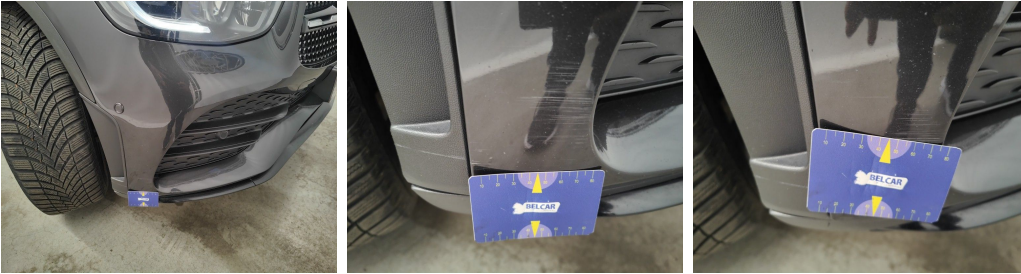
Bumper Front // Polish-scratch

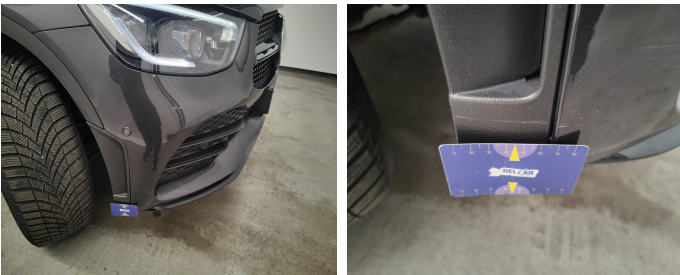
Bumper Front / Trim Right / Replace-scratch

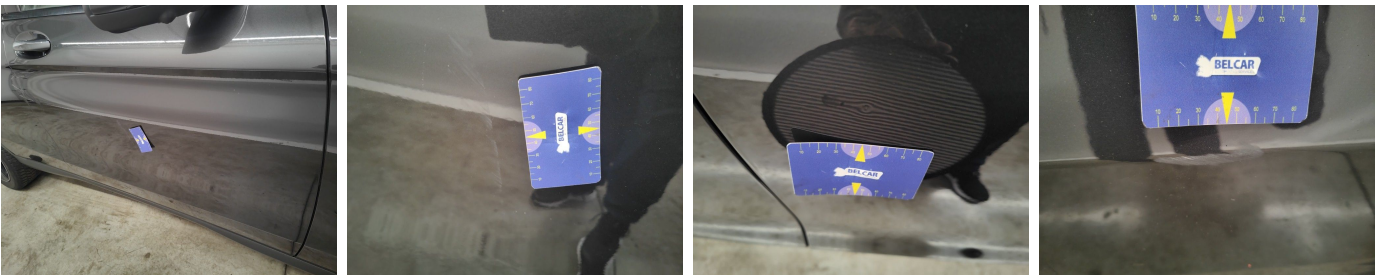
Door Front Right // Polish-scratch

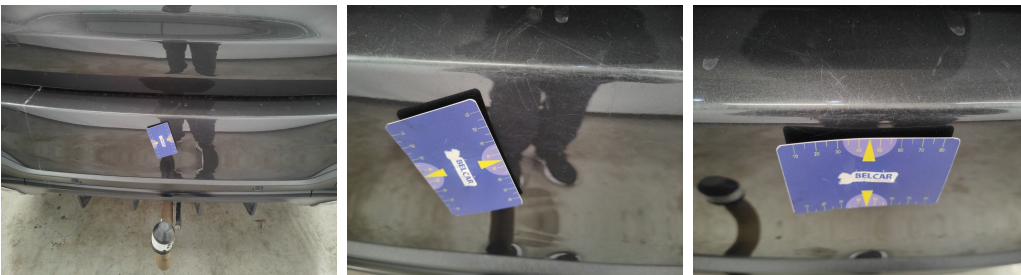
Bumper Rear // Polish-scratch

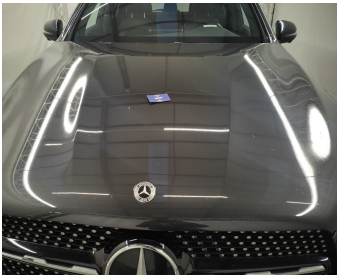
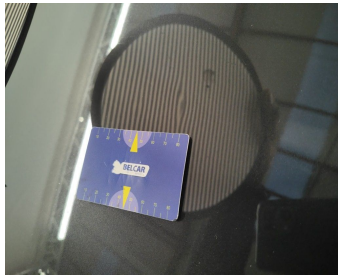
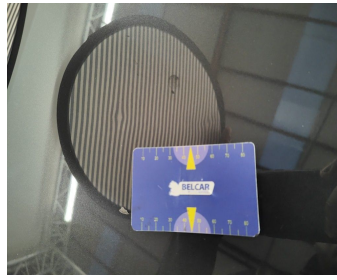
Front Bonnet // Smart Repair Small-dent

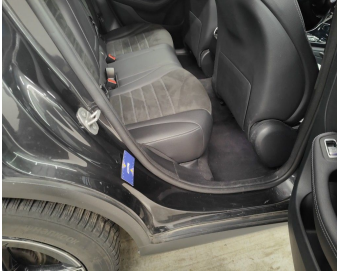
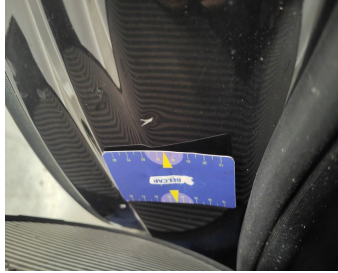
Rocker Panel Right // Smart Repair Medium-scratch + dent

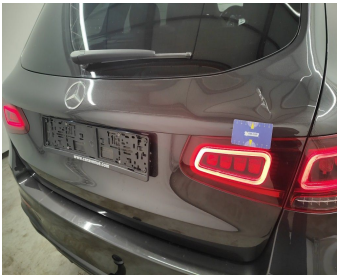
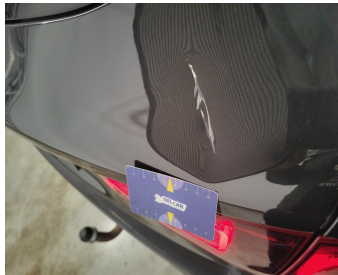
Rear Bonnet // Repair & Painting-scratch + dent
