# INSPECTION REPORT

End of contract

| License plate | QY5134 |
| Make | Mercedes eVito MWB 35kWh 116 L |

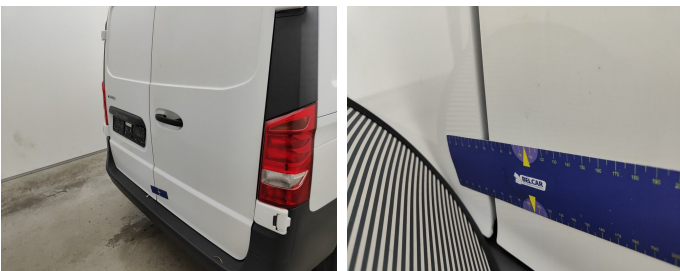
| Damages | Type | Acceptable |
|---|---|---|
| 301 | Rear Loading Door Right // Smart Repair Medium | N |

Rear Loading Door Right // Smart Repair Medium-scratch  
+ dent

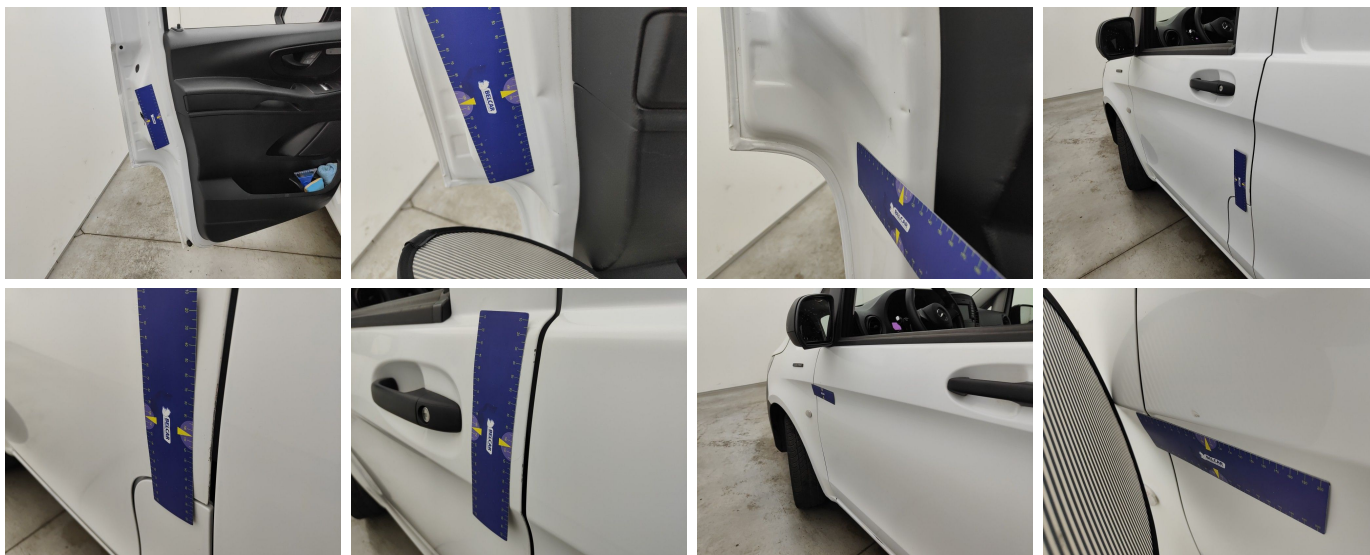
| Damages | Type | Acceptable |
|---|---|---|
| 84 | Door Front Left // Repair & Painting | N |

Door Front Left // Repair & Painting-scratch + dent

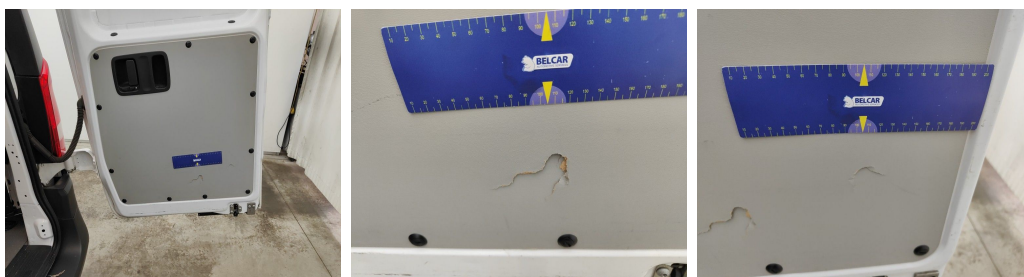
| Damages | Type | Acceptable |
|---|---|---|
| 593 | Trunk Lid Interior Coating / MDF Rear Right / Replace | N |

Trunk Lid Interior Coating / MDF Rear Right / Replace-cracked

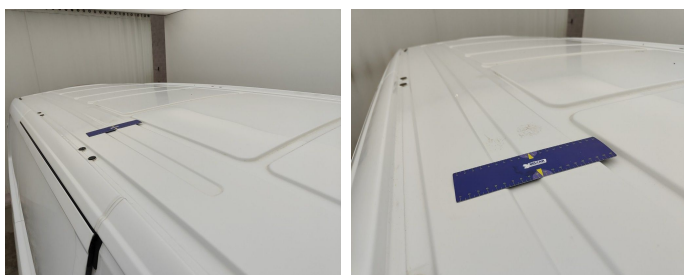
| Damages | Type | Acceptable |
|---|---|---|
| 165 | Roof // Polish | Y |

Roof // Polish-Chemical reaction

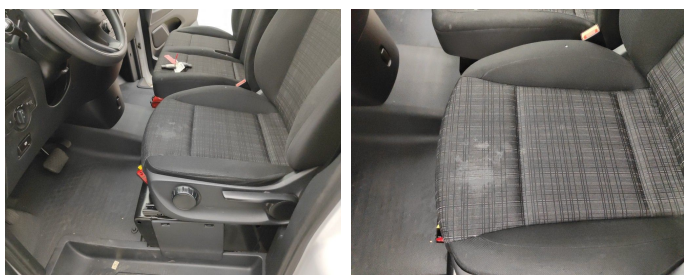
| Damages | Type | Acceptable |
|---|---|---|
| 860 | Interior Cleaning // Small | Y |

Interior Cleaning // Small-stain

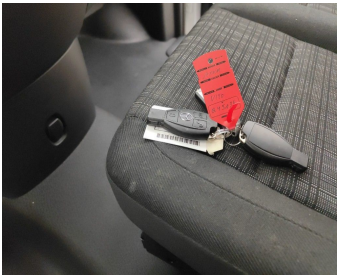
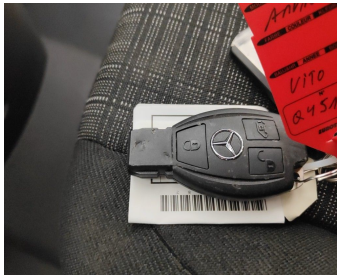
| Damages | Type | Acceptable |
|---|---|---|
| 883 | Key Price Range 2 // | N |

Key Price Range 2 //-worn

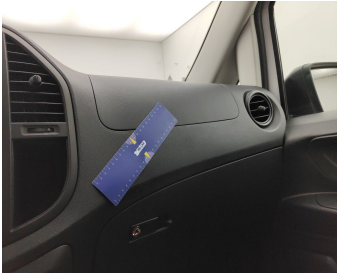
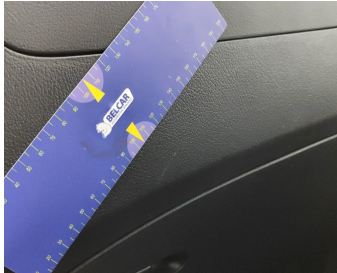
| Damages | Type | Acceptable |
|---|---|---|
| 561 | Dashboard // Repair | Y |

Dashboard // Repair-scratch

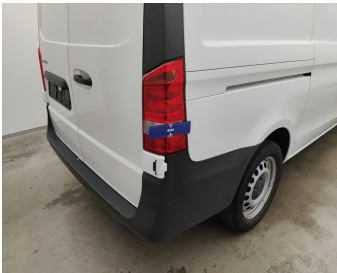
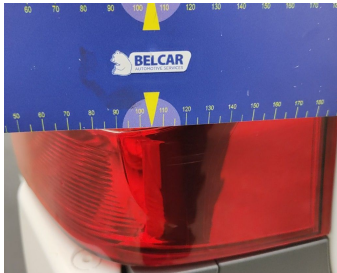
| Damages | Type | Acceptable |
|---|---|---|
| 174 | Light / Rear Right / Replace | Y |

Light / Rear Right / Replace-scratch

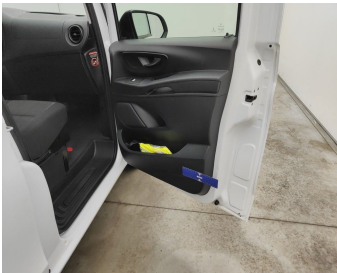
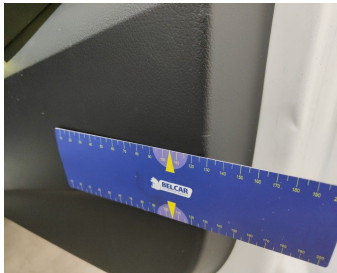
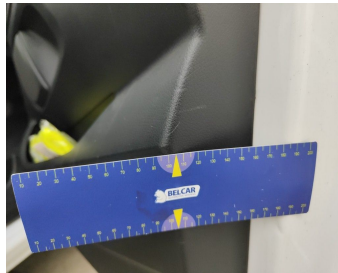
| Damages | Type | Acceptable |
|---|---|---|
| 621 | Front Right Door Interior Coating // Repair | N |

Front Right Door Interior Coating // Repair-scratch

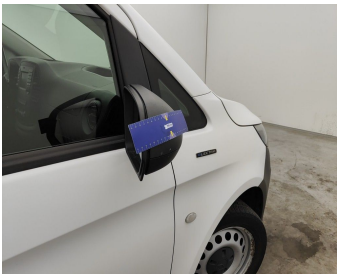
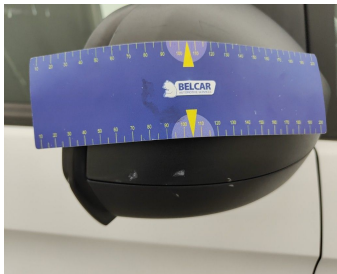
| Damages | Type | Acceptable |
|---|---|---|
| 227 | Side View Mirror Right / Shell / Replace Not Painted | Y |

Side View Mirror Right / Shell / Replace Not Painted-scratch

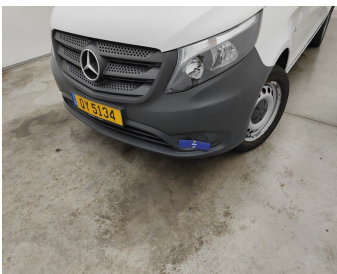
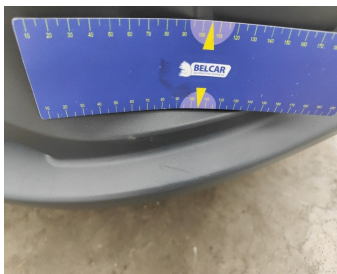
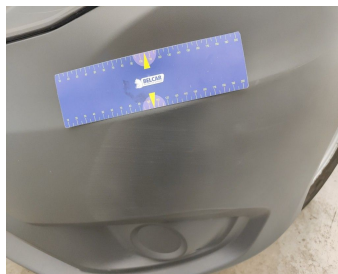
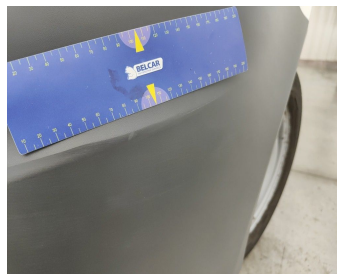
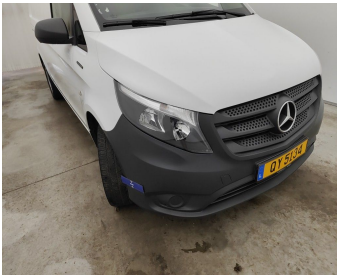
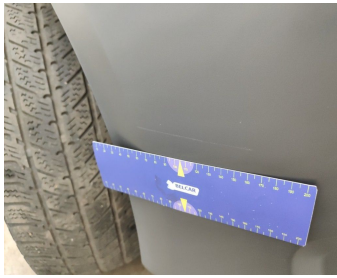
| Damages | Type | Acceptable |
|---|---|---|
| 19 | Bumper Front / Lower Cover Not Painted / Replace | Y |

Bumper Front / Lower Cover Not Painted / Replace-scratch

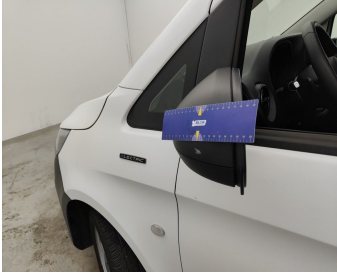
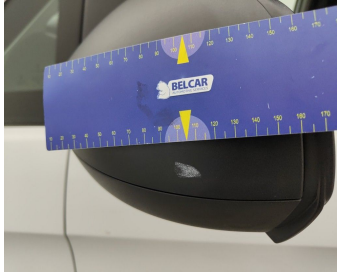
| Damages | Type | Acceptable |
|---|---|---|
| 77 | Side View Mirror Left / Shell / Replace Not Painted | Y |

Side View Mirror Left / Shell / Replace Not Painted-scratch

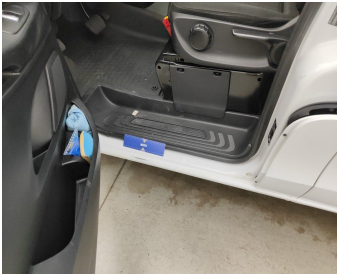
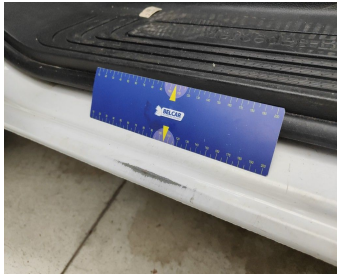
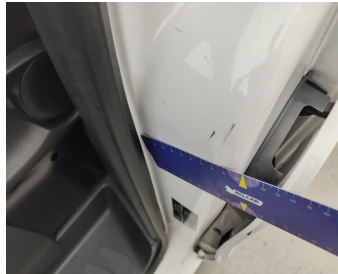
| Damages | Type | Acceptable |
|---|---|---|
| 92 | Rocker Panel Left // Painting | Y |

Rocker Panel Left // Painting-scratch

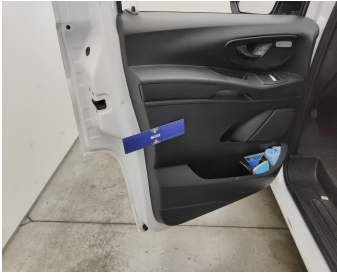
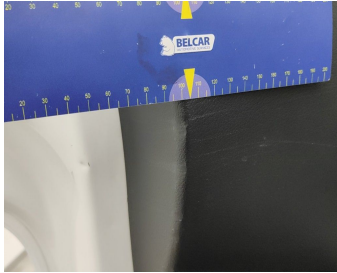
| Damages | Type | Acceptable |
|---|---|---|
| 611 | Front Left Door Interior Coating // Repair | N |

Front Left Door Interior Coating // Repair-scratch

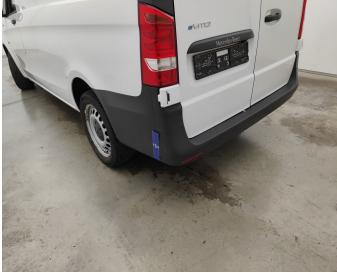
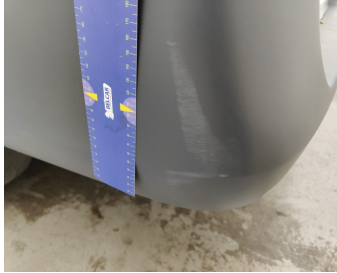
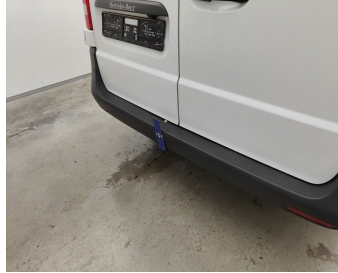
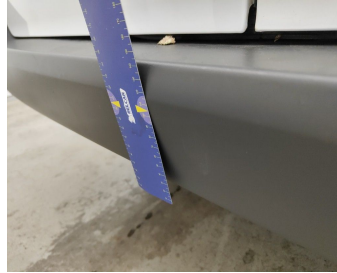
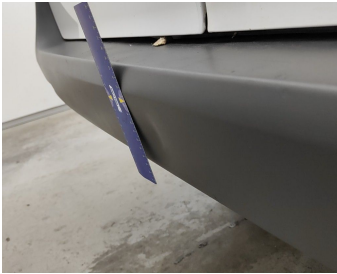
| Damages | Type | Acceptable |
|---|---|---|
| 138 | Bumper Rear / Lower Cover Not Painted / Replace | Y |

Bumper Rear / Lower Cover Not Painted / Replace-dent

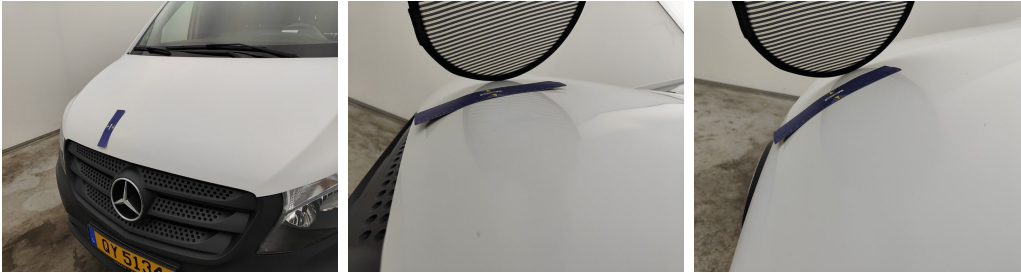
| Damages | Type | Acceptable |
|---|---|---|
| 31 | Front Bonnet // Smart Repair Small | N |

Front Bonnet // Smart Repair Small-dent

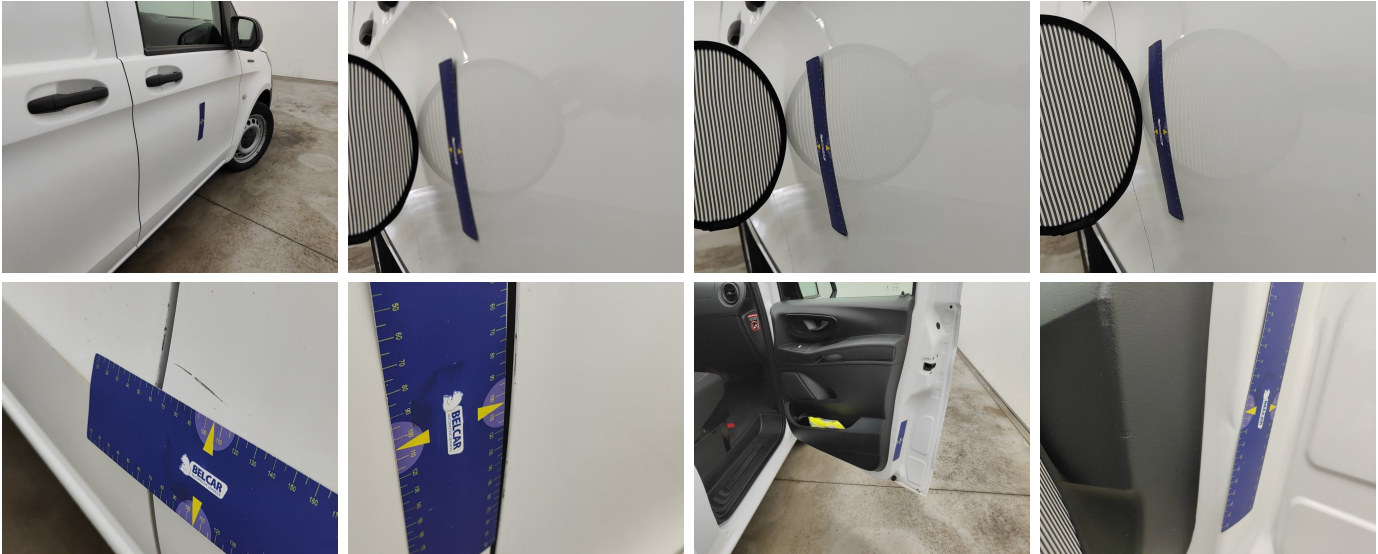
| Damages | Type | Acceptable |
|---|---|---|
| 210 | Door Front Right // Smart Repair Small | Y |

Door Front Right // Smart Repair Small-dent

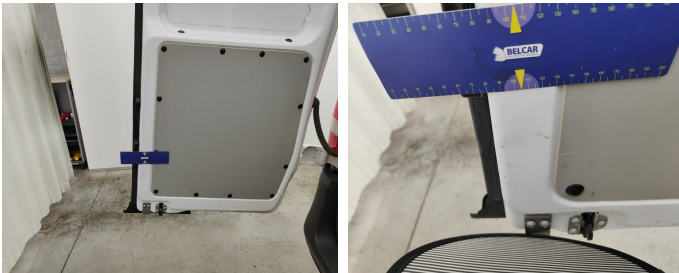
| Damages | Type | Acceptable |
|---|---|---|
| 291 | Rear Loading Door Left // Smart Repair Medium | Y |

Rear Loading Door Left // Smart Repair Medium-dent

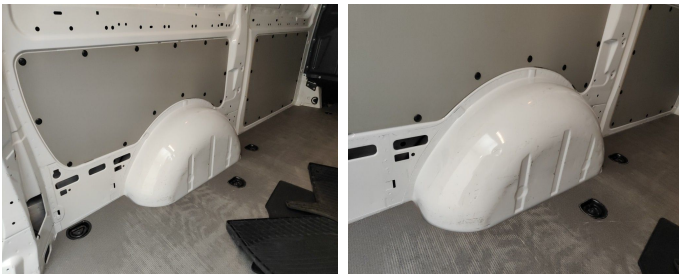
| Damages | Type | Acceptable |
|---|---|---|
| 532 | Trunk Compartment / Side Cover Left / Replace | Y |

Trunk Compartment / Side Cover Left / Replace-scratch + dent

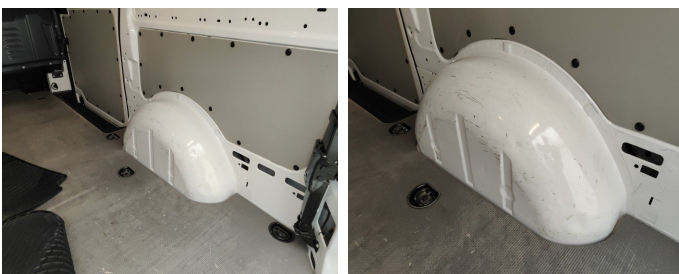
| Damages | Type | Acceptable |
|---|---|---|
| 533 | Trunk Compartment / Side Cover Right / Replace | Y |

Trunk Compartment / Side Cover Right / Replace-scratch  
+ dent

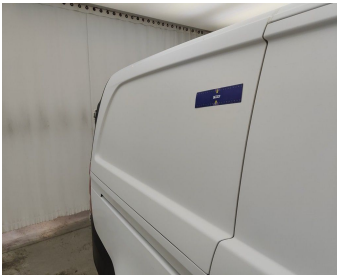
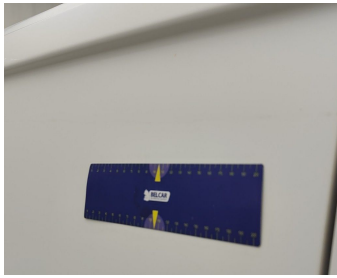
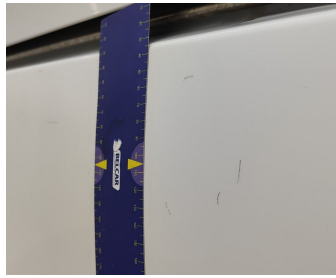
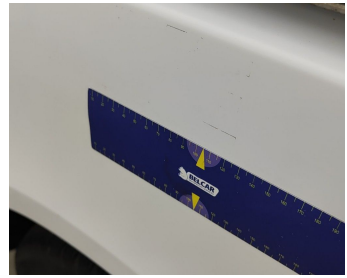
| Damages | Type | Acceptable |
|---|---|---|
| 186 | Wing Rear Right // Polish | N |

Wing Rear Right // Polish-scratch

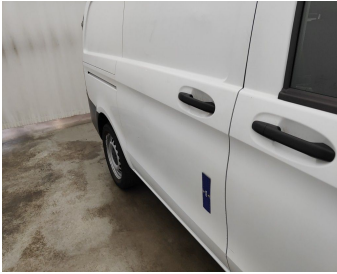
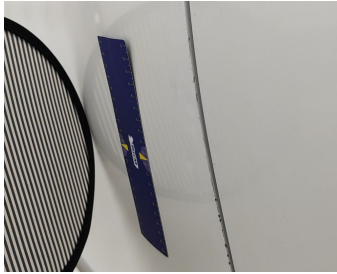
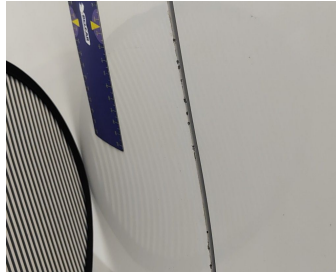
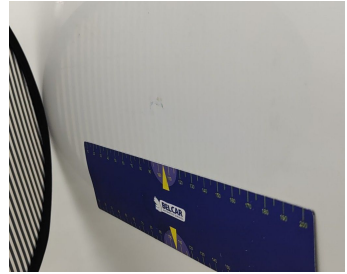
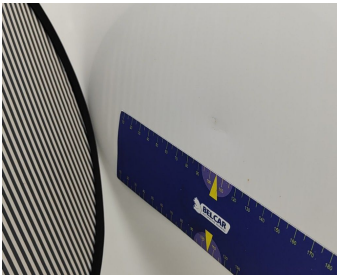
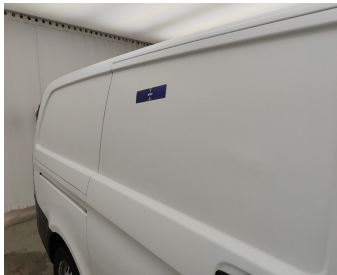
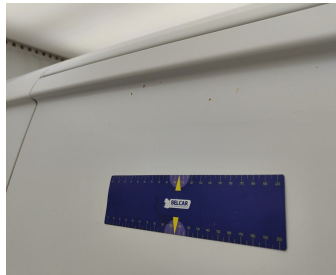
| Damages | Type | Acceptable |
|---|---|---|
| 194 | Door Rear Right // Repair & Painting | N |

Door Rear Right // Repair & Painting-scratch + dent
