INSPECTION REPORT

End of contract

File	306819
License plate	1XHY386
Vehicle identification number	W1V4156031U280410
Dossier	2019331170
Make	Mercedes Citan 109CDI L2 Perf.
Mileage	100182
First registration	10/01/2020
client availability date	27/02/2026
inspectionDate	09/03/2026

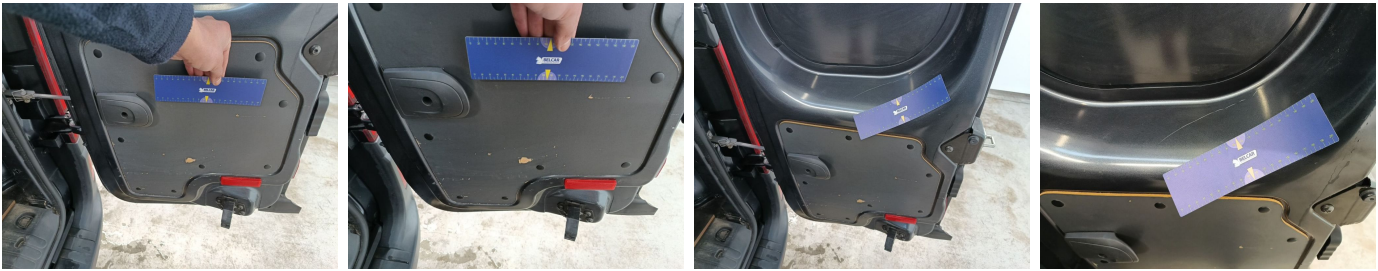
Damage within Renta-norm-scratch

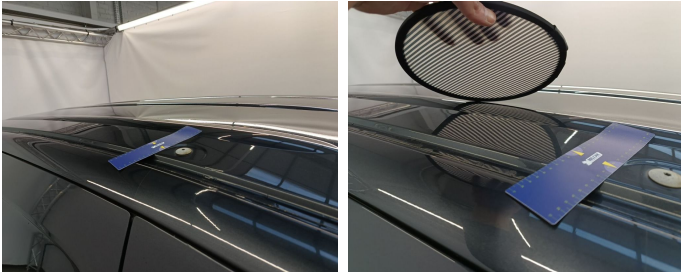
Roof // Repair & Painting-dent

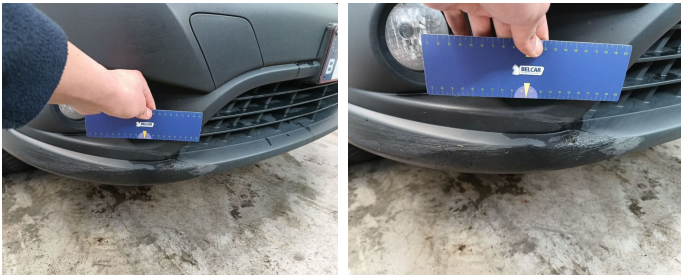
Bumper Front // Replace without painting-scratch + dent

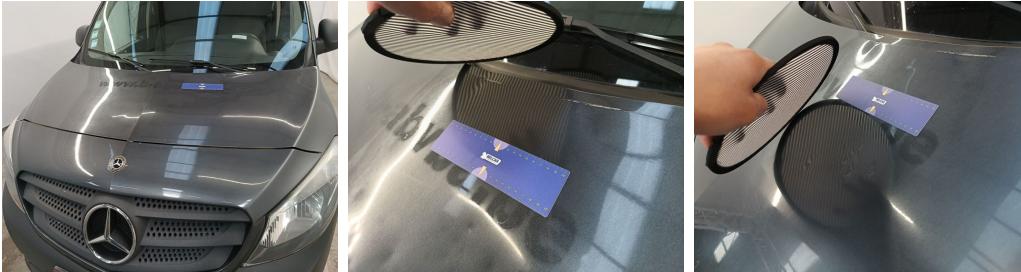
Front Bonnet // Repair & Painting-scratch + dent

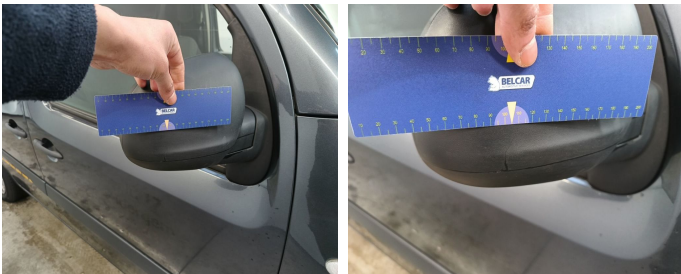
Side View Mirror Right / Shell / Replace Not Painted-cracked

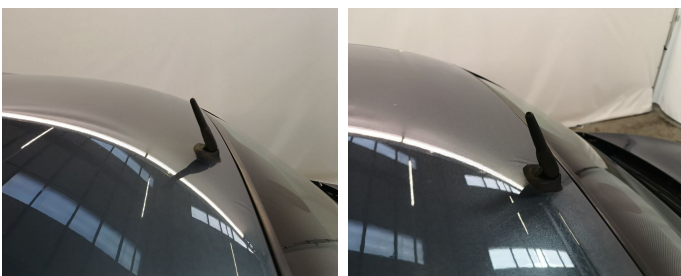
Roof / Antenna / Replace-cracked

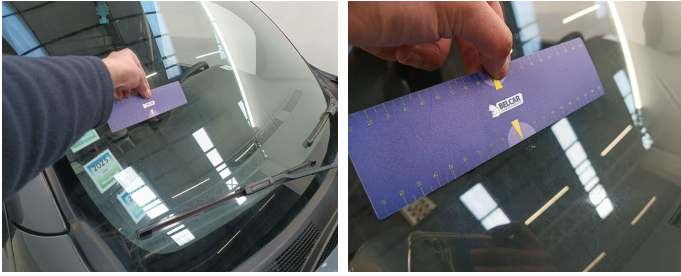
Windshield // Repair-glass damage

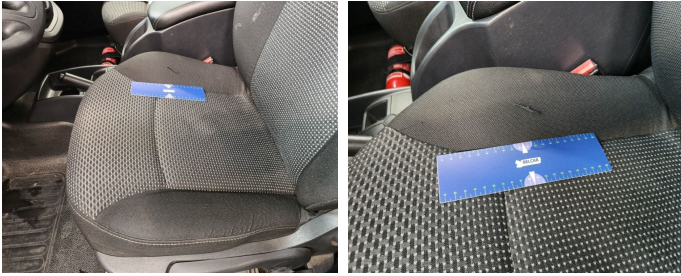
Seat Front Left / Bottom Coating / Replace-tear

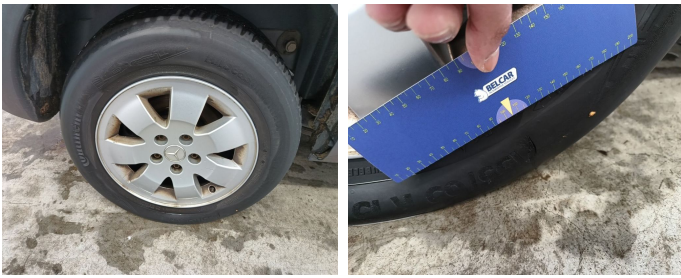
Tyre Rear Right // Replace-tear

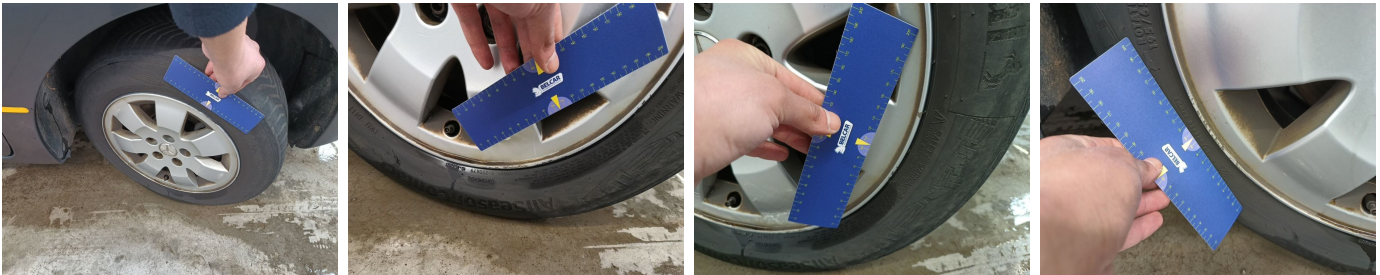
Wheel Alloy Front Right // Repair-scratch

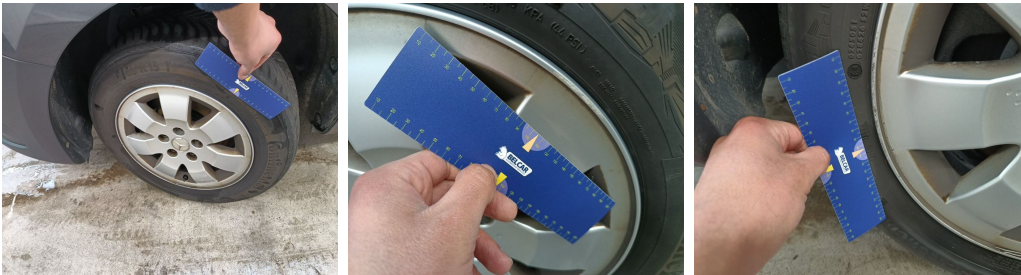
Wheel Alloy Front Left // Repair-scratch

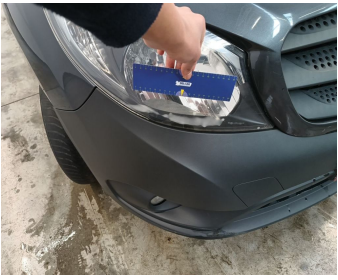
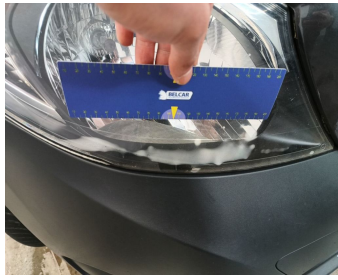
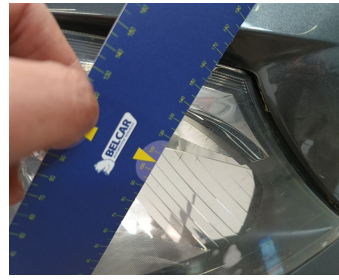
Light / Front Right / Replace-scratch
