INSPECTION REPORT

End of contract

| License plate | 1XME338 |
| Make | Opel Viv.TD 90kW 31 L3H1 Edit. |

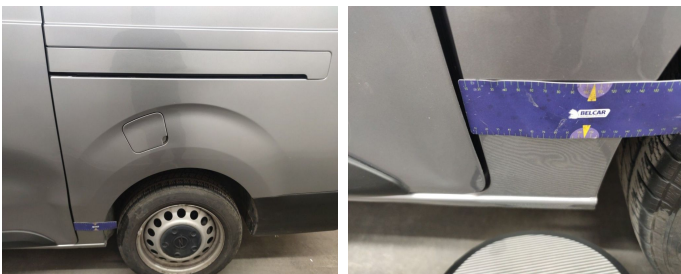
| Damages | Type | Acceptable |
|---|--|---|
| 114 | Wing Rear Left // Repair & Painting | N |

Wing Rear Left // Repair & Painting-dent

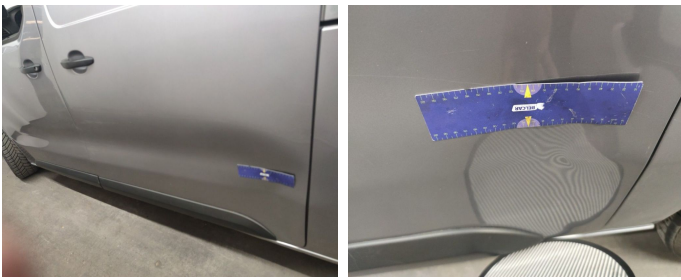
| Damages | Type | Acceptable |
|---|--|---|
| 104 | Door Rear Left // Repair & Painting | N |

Door Rear Left // Repair & Painting-dent

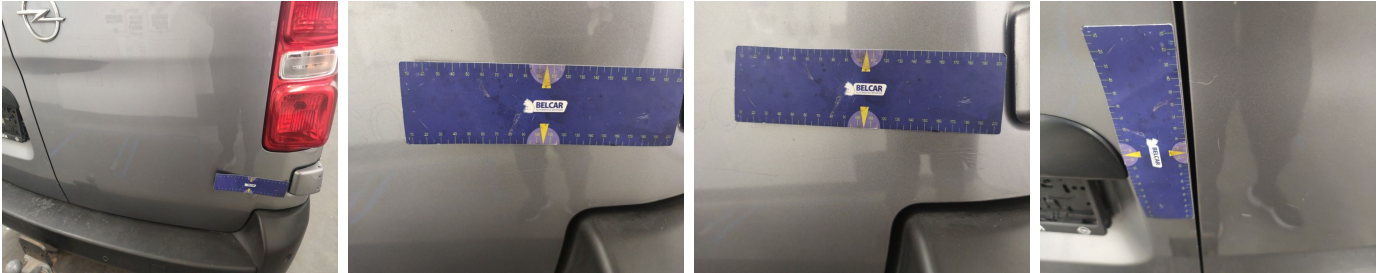
| Damages | Type | Acceptable |
|---|--|---|
| 306 | Rear Loading Door Right / Polish | Y |

Rear Loading Door Right / Polish-scratch

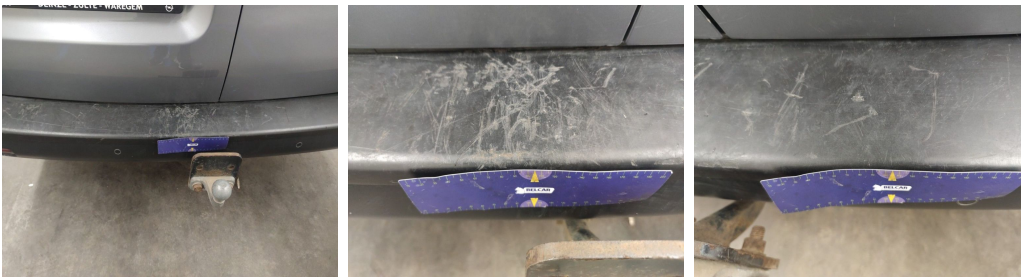
| Damages | Type | Acceptable |
|---|--|---|
| 137 | Bumper Rear // Replace without painting | N |

Bumper Rear // Replace without painting-scratch

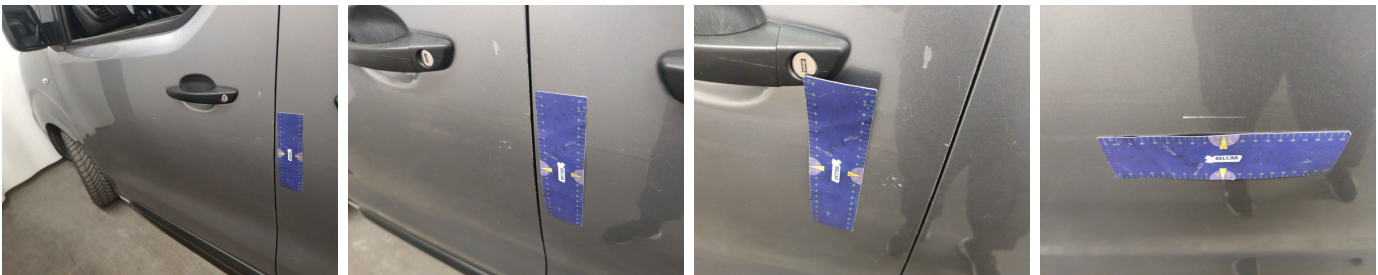
| Damages | Type | Acceptable |
|---|--|---|
| 81 | Door Front Left // Smart Repair Medium | N |

Door Front Left // Smart Repair Medium-scratch

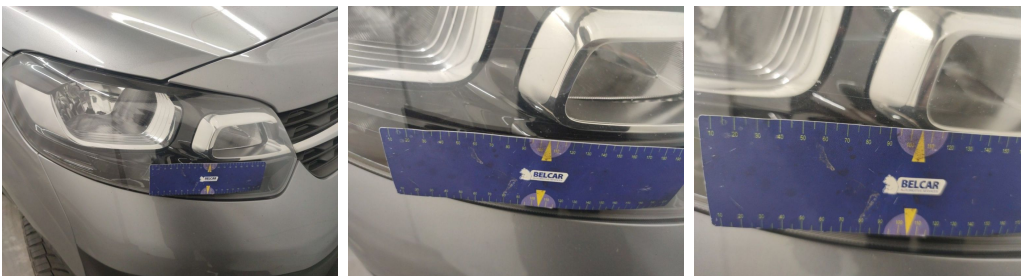
| Damages | Type | Acceptable |
|---|--|---|
| 244 | Light / Front Right / Replace | Y |

Light / Front Right / Replace-scratch

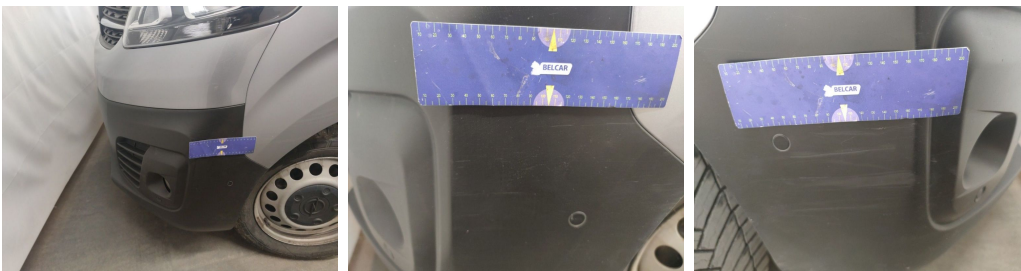
| Damages | Type | Acceptable |
|---|--|---|
| 12 | Bumper Front // Smart Repair Large | N |

Bumper Front // Smart Repair Large-scratch

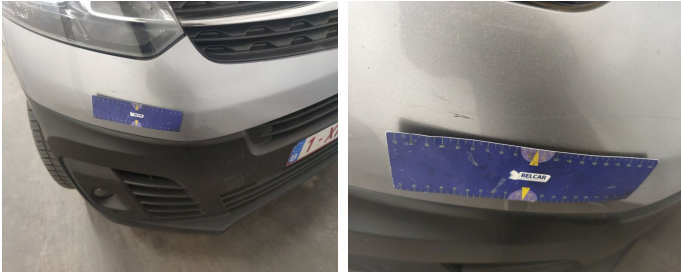
| Damages | Type | Acceptable |
|---|--|---|
| 13 | Bumper Front // Painting | Y |

Bumper Front // Painting-scratch

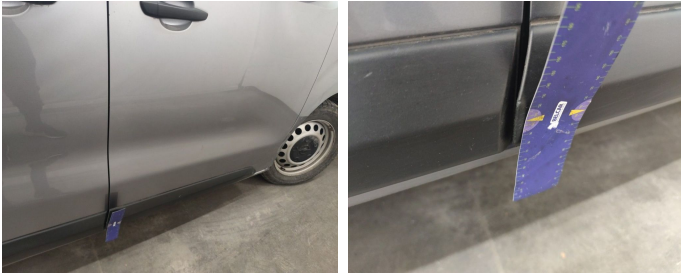
| Damages | Type | Acceptable |
|---|--|---|
| 217 | Door Front Right / Trim / Replace | Y |

Door Front Right / Trim / Replace-scratch

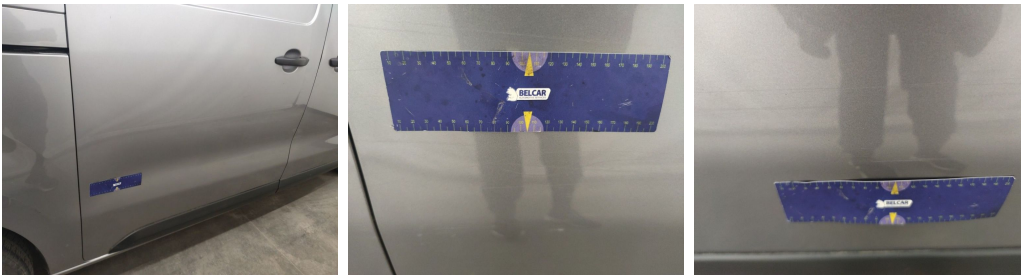
| Damages | Type | Acceptable |
|---|--|---|
| 196 | Door Rear Right // Polish | Y |

Door Rear Right // Polish-scratch

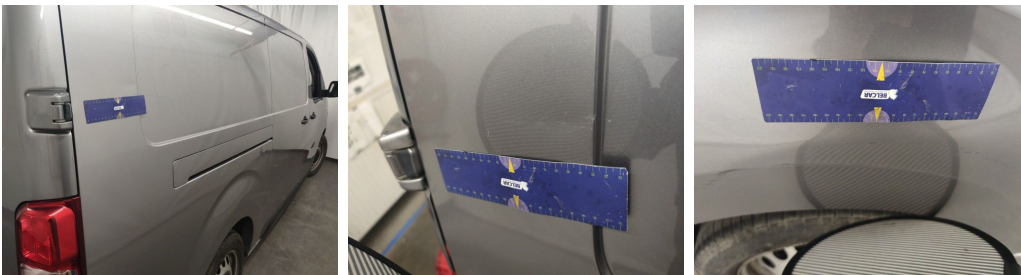
| Damages | Type | Acceptable |
|---|--|---|
| 184 | Wing Rear Right // Repair & Painting | N |

Wing Rear Right // Repair & Painting-scratch + dent

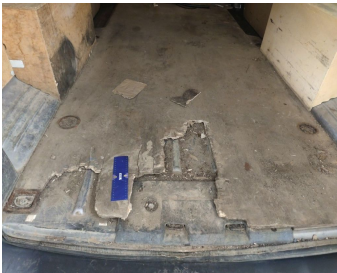
| Damages | Type | Acceptable |
|---|--|---|
| 534 | Trunk Compartment / Carpet / Replace | Y |

Trunk Compartment / Carpet / Replace-cracked

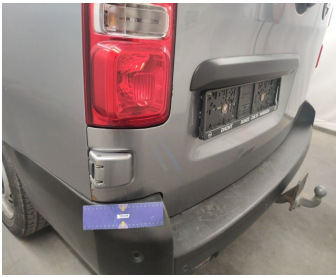
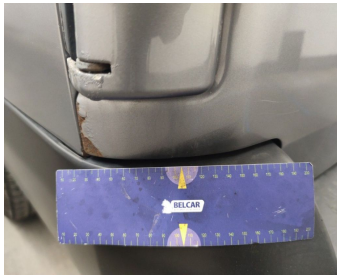
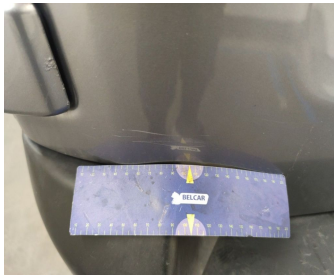
| Damages | Type | Acceptable |
|---|--|---|
| 293 | Rear Loading Door Left // Painting | N |

Rear Loading Door Left // Painting-rust

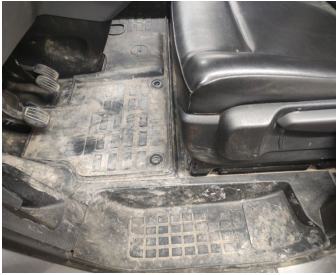
| Damages | Type | Acceptable |
|---|--|---|
| 860 | Interior Cleaning // Small | Y |

Interior Cleaning // Small-stain

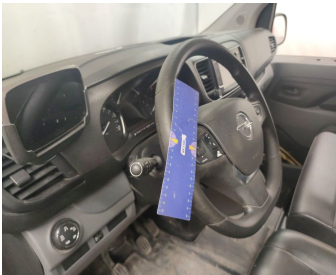
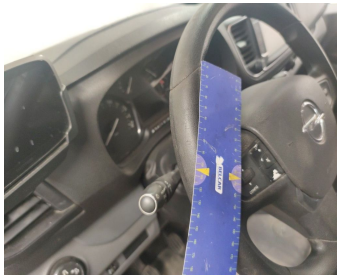
| Damages | Type | Acceptable |
|---|--|---|
| 569 | Dashboard / Steering Wheel / Replace | Y |

Dashboard / Steering Wheel / Replace-worn

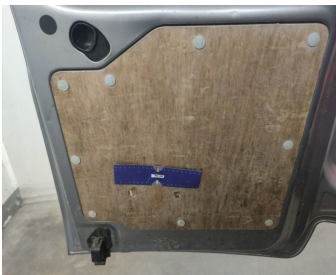
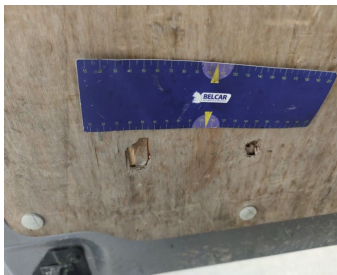
| Damages | Type | Acceptable |
|---|--|---|
| 592 | Trunk Lid Interior Coating / MDF Rear Left / Replace | Y |

Trunk Lid Interior Coating / MDF Rear Left / Replace-hole

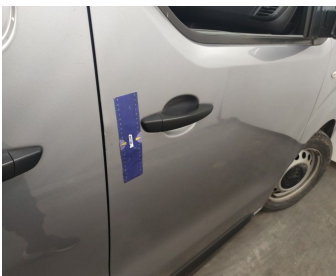
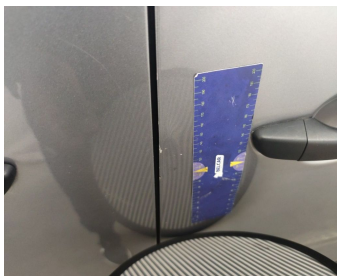
| Damages | Type | Acceptable |
|---|--|---|
| 214 | Door Front Right // Repair & Painting | N |

Door Front Right // Repair & Painting-scratch + dent

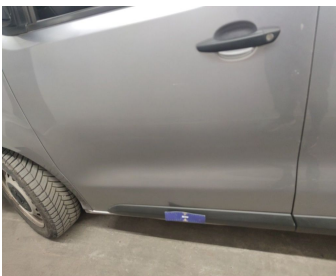
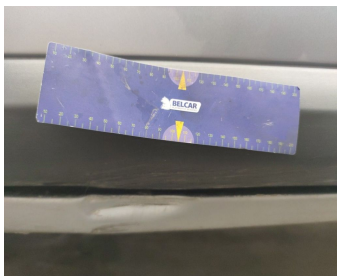
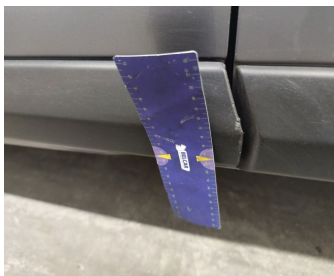
| Damages | Type | Acceptable |
|---|--|---|
| 87 | Door Front Left / Trim / Replace | N |

Door Front Left / Trim / Replace-scratch

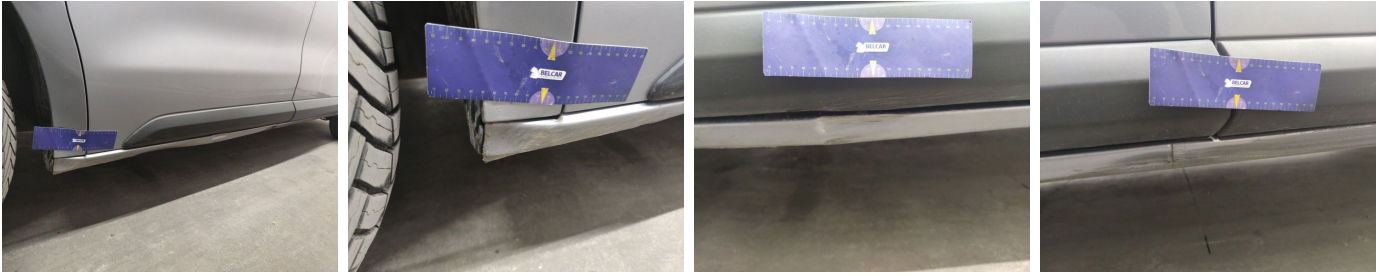
| Damages | Type | Acceptable |
|---|--|---|
| 93 | Rocker Panel Left // Repair & Painting | N |

Rocker Panel Left // Repair & Painting-scratch + dent

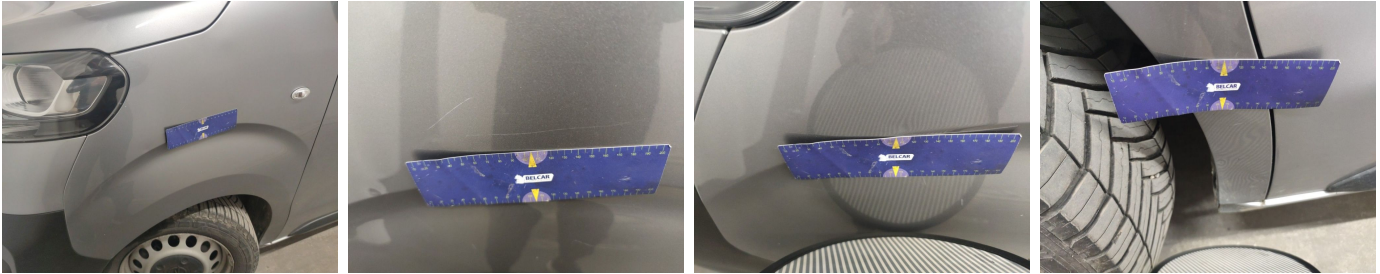
| Damages | Type | Acceptable |
|---|--|---|
| 64 | Wing Front Left // Repair & Painting | N |

Wing Front Left // Repair & Painting-scratch + dent

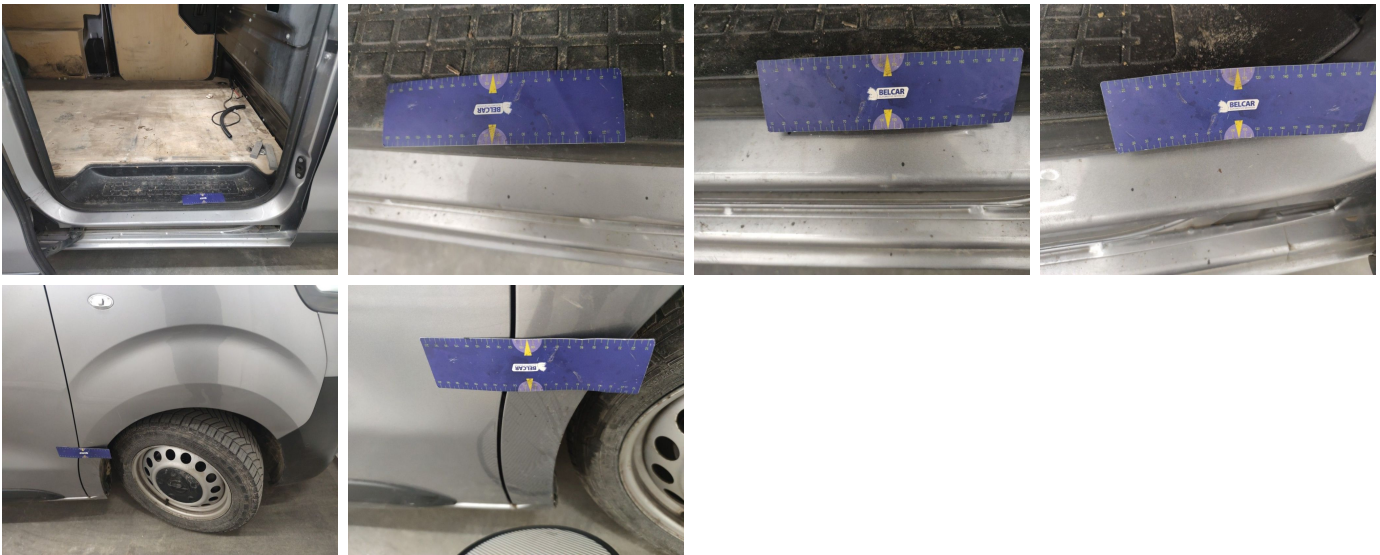
| Damages | Type | Acceptable |
|---|--|---|
| 203 | Rocker Panel Right // Repair & Painting | N |

Rocker Panel Right // Repair & Painting-scratch + dent

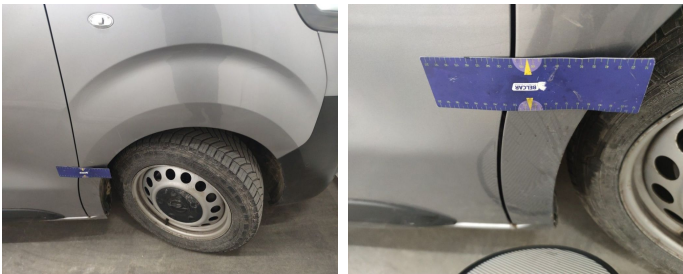
| Damages | Type | Acceptable |
|---|--|---|
| 234 | Wing Front right // Repair & Painting | N |

Wing Front right // Repair & Painting-dent
