INSPECTION REPORT

End of contract

File	308747
License plate	1YNA550
Vehicle identification number	VR3UDYHZRLJ867226
Dossier	2020030036
Make	Peugeot 2008 1.5BlueHDi 96kW G
Mileage	134310
First registration	23/10/2020
client availability date	03/04/2026
inspectionDate	10/04/2026

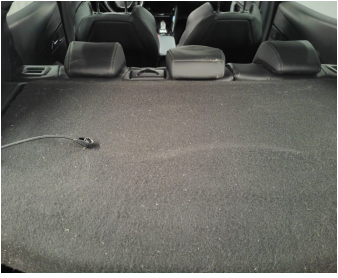
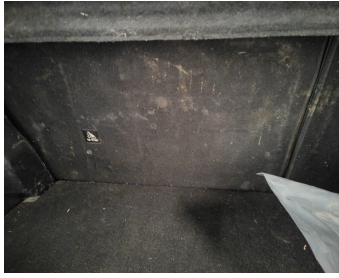
Interior Cleaning // Large-stain
