# INSPECTION REPORT

**End of contract**

| License plate | 2CEH869 |
| Make | Mercedes GLC 300de 4M Bus.Sol. |

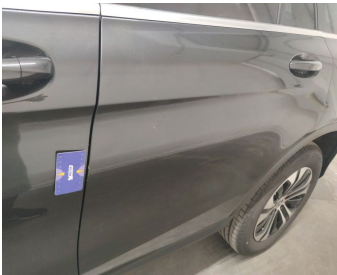
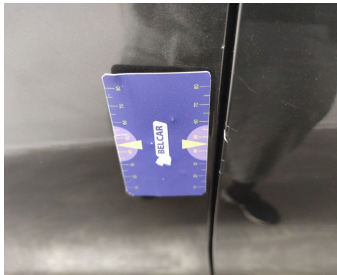
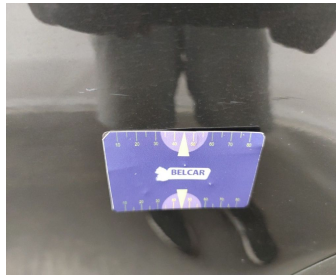
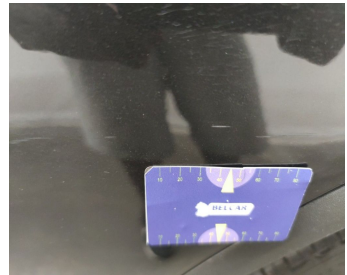
| Damages | Type | Acceptable |
|---|---|---|
| 103 | Door Rear Left // Painting | Y |

Door Rear Left // Painting-scratch

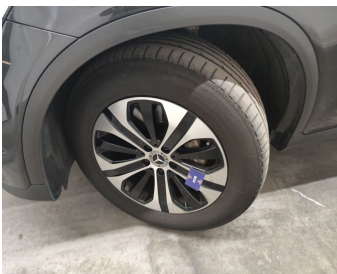
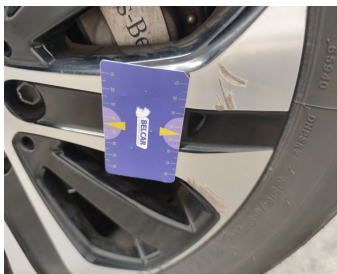
| Damages | Type | Acceptable |
|---|---|---|
| 310 | Wheel Two Tone Front Left // Repair | N |

Wheel Two Tone Front Left // Repair-scratch

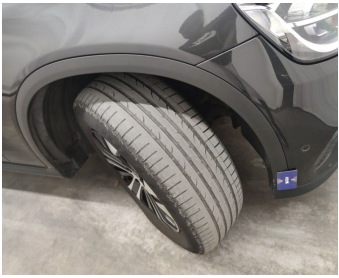
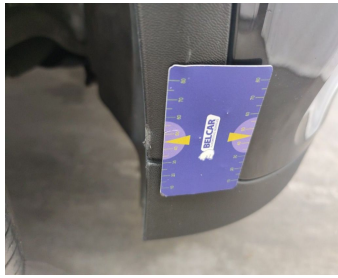
| Damages | Type | Acceptable |
|---|---|---|
| 237 | Wing Front right / Trim / Replace | Y |

Wing Front right / Trim / Replace-scratch

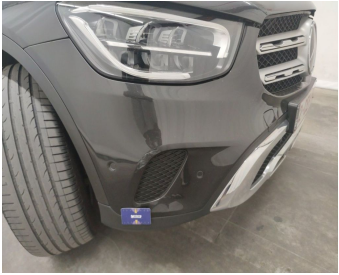
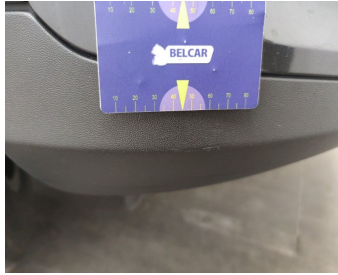
| Damages | Type | Acceptable |
|---|---|---|
| 19 | Bumper Front / Lower Cover Not Painted / Replace | Y |

Bumper Front / Lower Cover Not Painted / Replace-scratch

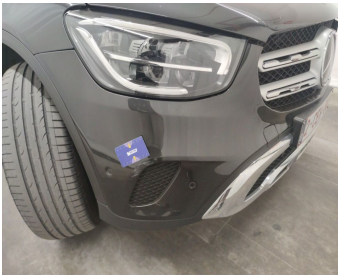
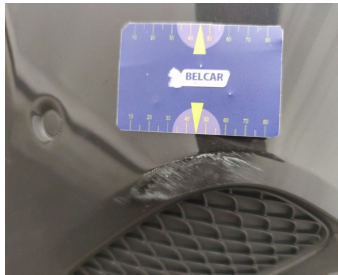
| Damages | Type | Acceptable |
|---|---|---|
| 11 | Bumper Front // Smart Repair Medium | N |

Bumper Front // Smart Repair Medium-scratch

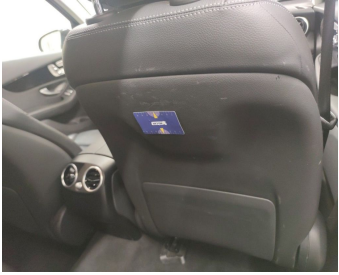
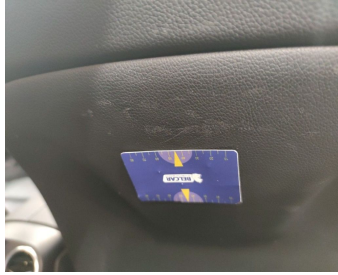
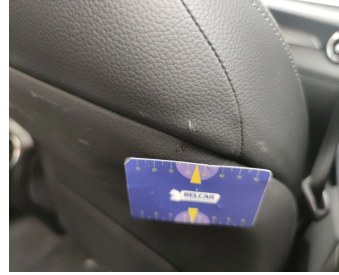
| Damages | Type | Acceptable |
|---|---|---|
| 421 | Seat Front Right // Repair | N |

Seat Front Right // Repair-scratch

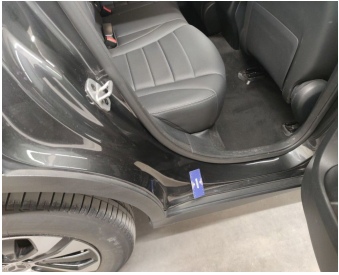
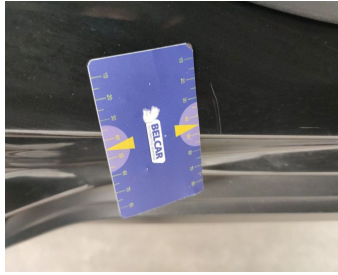
| Damages | Type | Acceptable |
|---|---|---|
| 201 | Rocker Panel Right // Smart Repair Medium | Y |

Rocker Panel Right // Smart Repair Medium-scratch

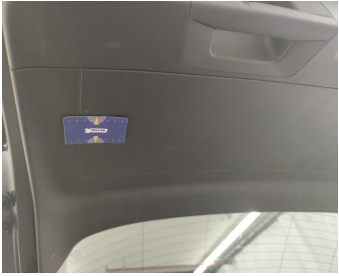
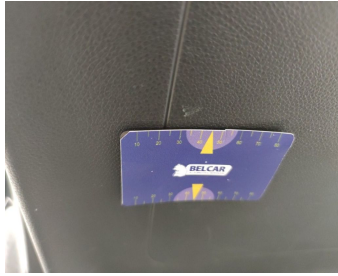
| Damages | Type | Acceptable |
|---|---|---|
| 594 | Trunk Lid Interior Coating / Complete Panel / Replace | Y |

Trunk Lid Interior Coating / Complete Panel / Replace-scratch

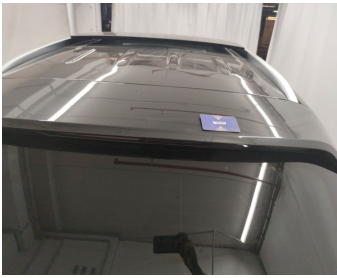
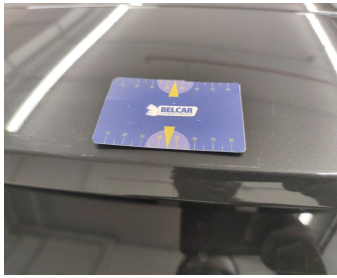
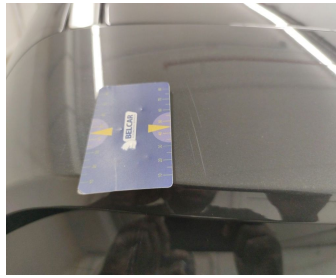
| Damages | Type | Acceptable |
|---|---|---|
| 151 | Rear Bonnet // Smart Repair Medium | Y |

Rear Bonnet // Smart Repair Medium-scratch

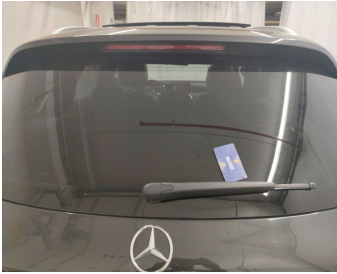
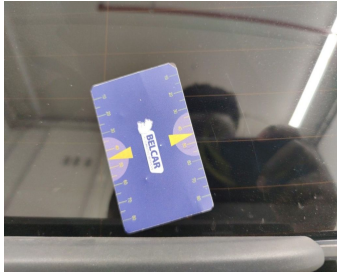
| Damages | Type | Acceptable |
|---|---|---|
| 159 | Rear Bonnet / Rear Window / Replace | Y |

Rear Bonnet / Rear Window / Replace-scratch

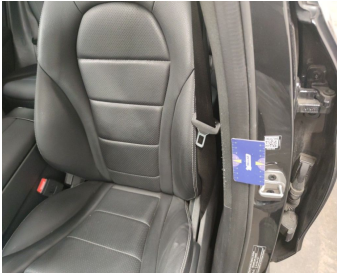
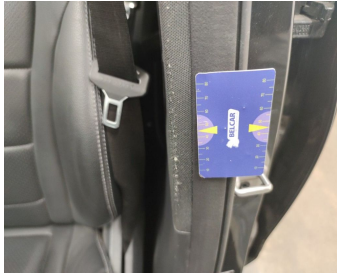
| Damages | Type | Acceptable |
|---|---|---|
| 540 | Interior // Repair 1 | Y |

Interior // Repair 1-scratch

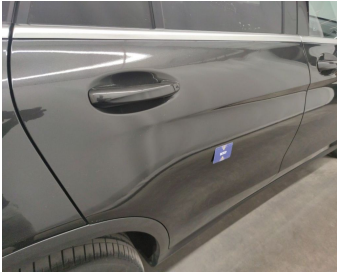
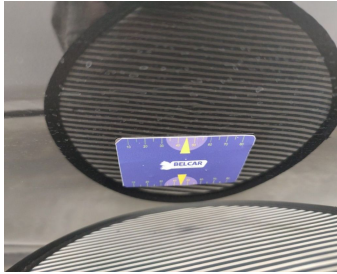
| Damages | Type | Acceptable |
|---|---|---|
| 190 | Door Rear Right // Smart Repair Small | Y |

Door Rear Right // Smart Repair Small-dent

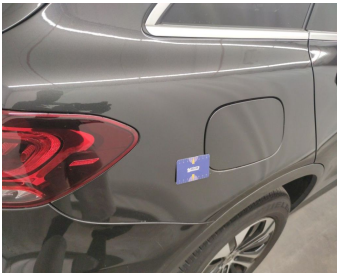
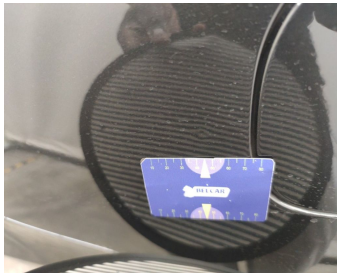
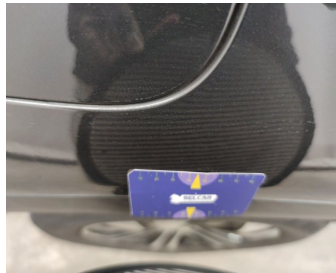
| Damages | Type | Acceptable |
|---|---|---|
| 180 | Wing Rear Right // Smart Repair Small | Y |

Wing Rear Right // Smart Repair Small-dent

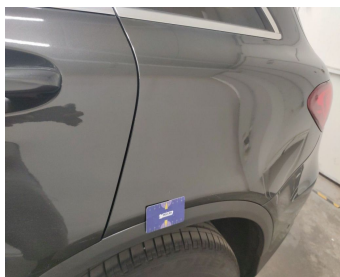
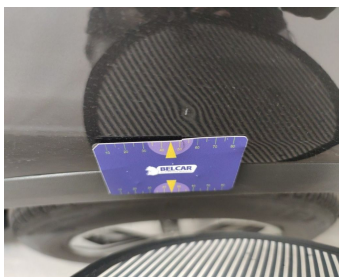
| Damages | Type | Acceptable |
|---|---|---|
| 114 | Wing Rear Left // Repair & Painting | Y |

Wing Rear Left // Repair & Painting-scratch + dent
