INSPECTION REPORT

End of contract

| License plate | 2BMM287 |
| Make | Hyundai Ioniq 1.6GDi Hybride F |

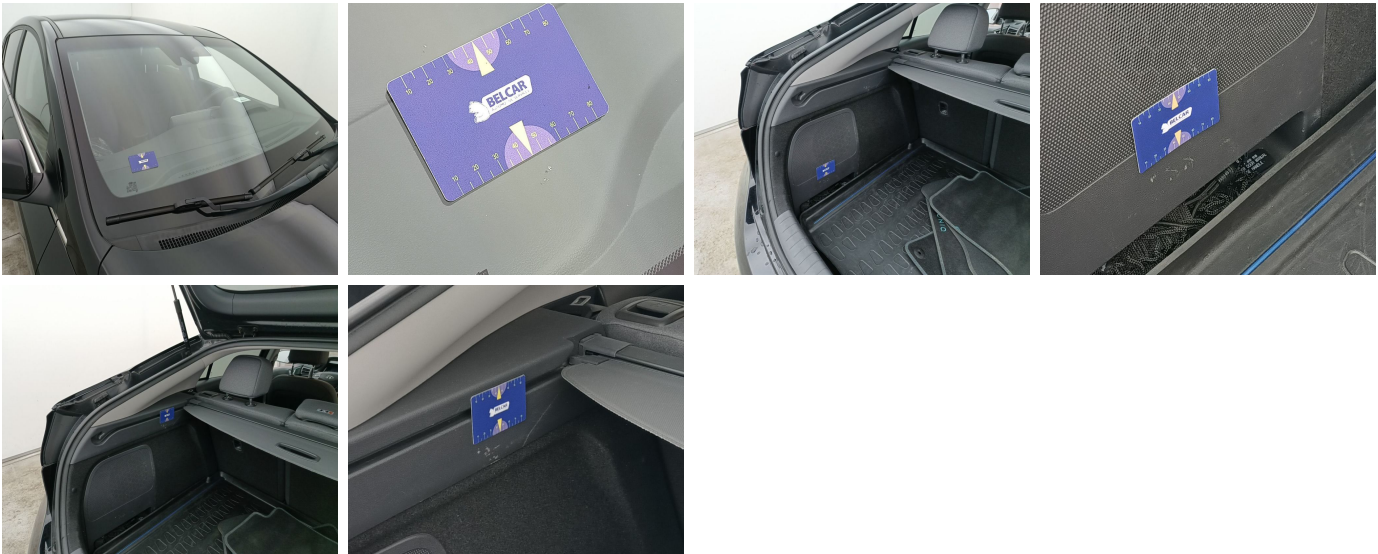
Damage within Renta-norm-stone chipping

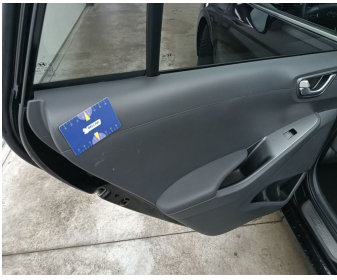
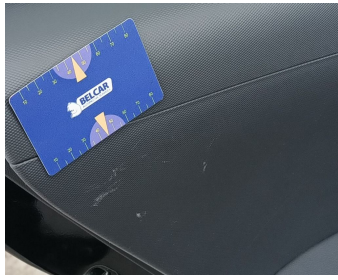
| Damages | Type | Acceptable |
|---|---|---|
| 634 | Rear Left Door Interior Coating // Replace Completely | Y |

Rear Left Door Interior Coating // Replace Completely-scratch

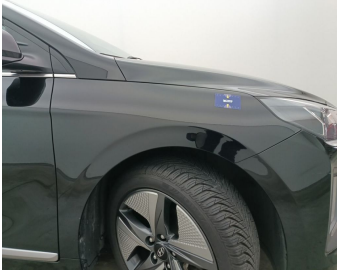
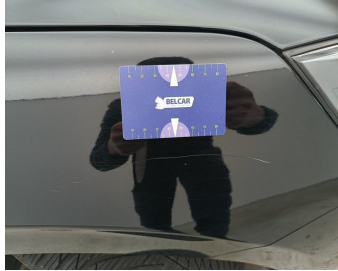
| Damages | Type | Acceptable |
|---|---|---|
| 233 | Wing Front right // Painting | N |

Wing Front right // Painting-scratch

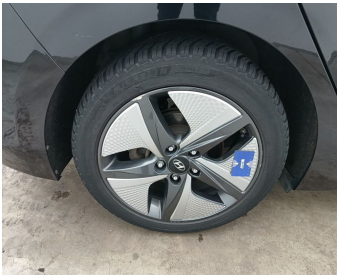
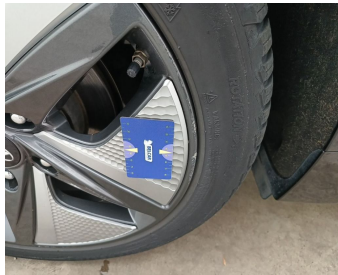
| Damages | Type | Acceptable |
|---|---|---|
| 331 | Wheel Alloy Rear Right // Repair | N |

Wheel Alloy Rear Right // Repair-scratch

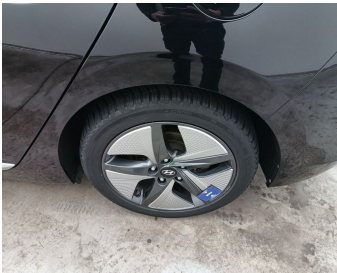
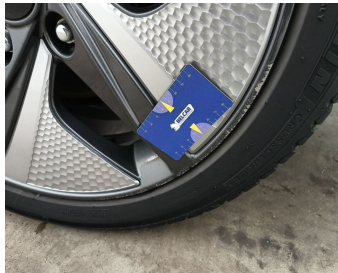
| Damages | Type | Acceptable |
|---|---|---|
| 321 | Wheel Alloy Rear Left // Repair | N |

Wheel Alloy Rear Left // Repair-scratch

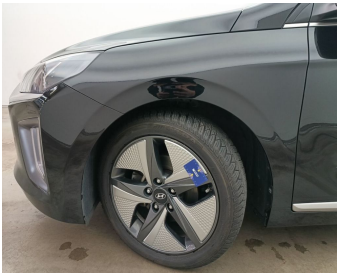
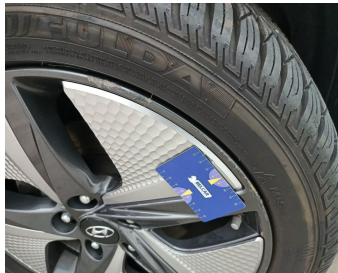
| Damages | Type | Acceptable |
|---|---|---|
| 311 | Wheel Alloy Front Left // Repair | N |

Wheel Alloy Front Left // Repair-scratch

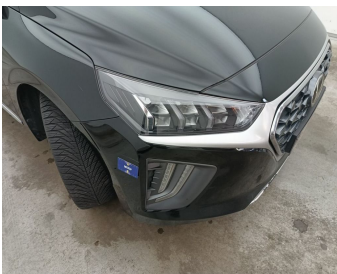
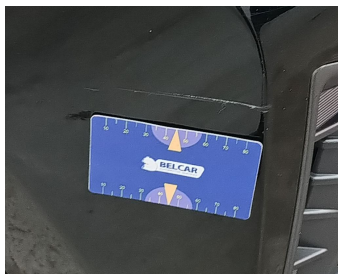
| Damages | Type | Acceptable |
|---|---|---|
| 11 | Bumper Front // Smart Repair Medium | N |

Bumper Front // Smart Repair Medium-scratch

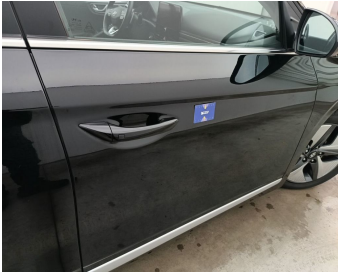
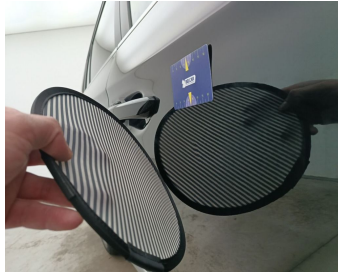
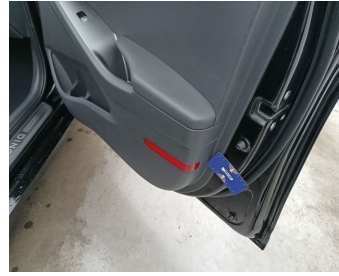
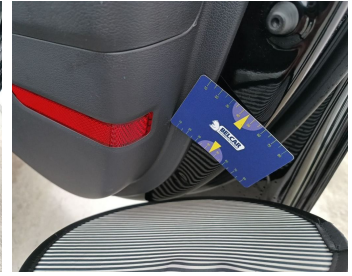
| Damages | Type | Acceptable |
|---|---|---|
| 214 | Door Front Right // Repair & Painting | Y |

Door Front Right // Repair & Painting-dent

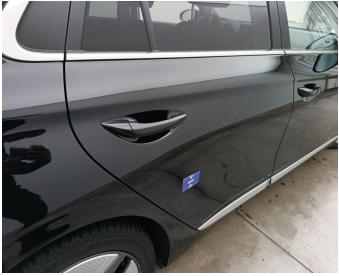
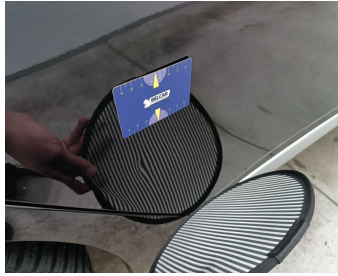
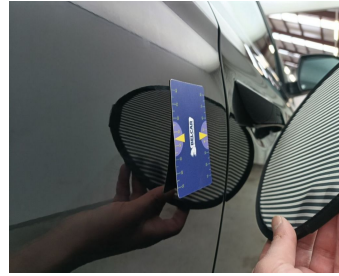
| Damages | Type | Acceptable |
|---|---|---|
| 190 | Door Rear Right // Smart Repair Small | N |

Door Rear Right // Smart Repair Small-dent

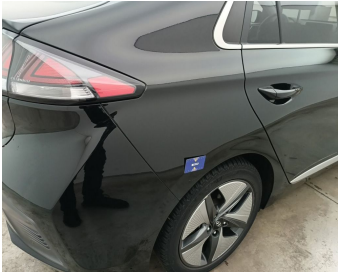
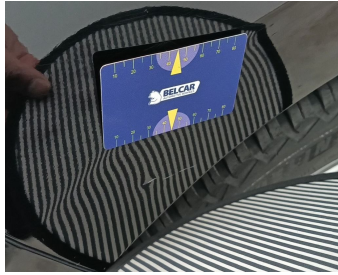
| Damages | Type | Acceptable |
|---|---|---|
| 184 | Wing Rear Right // Repair & Painting | N |

Wing Rear Right // Repair & Painting-scratch + dent

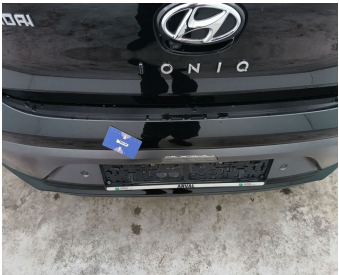
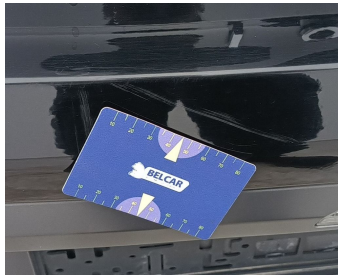
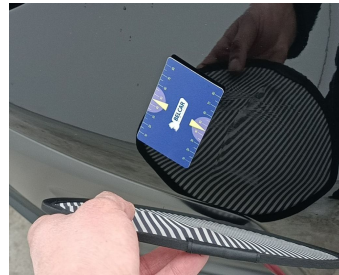
| Damages | Type | Acceptable |
|---|---|---|
| 134 | Bumper Rear // Repair & Painting | N |

Bumper Rear // Repair & Painting-scratch + dent

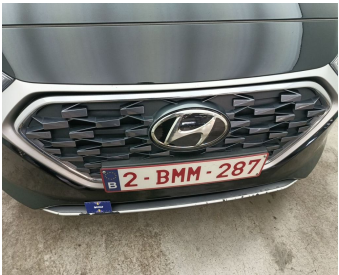
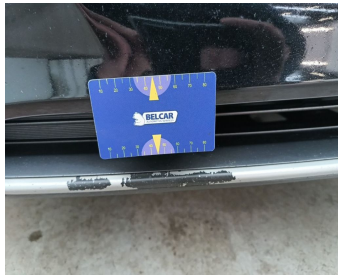
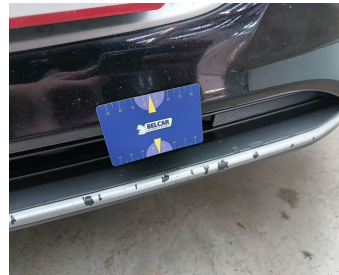
| Damages | Type | Acceptable |
|---|---|---|
| 18 | Bumper Front / Spoiler / Replace | Y |

Bumper Front / Spoiler / Replace-bad repair

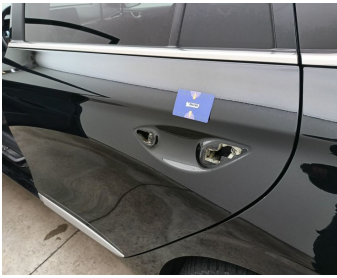
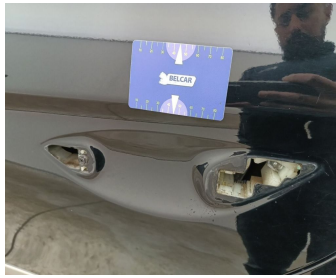
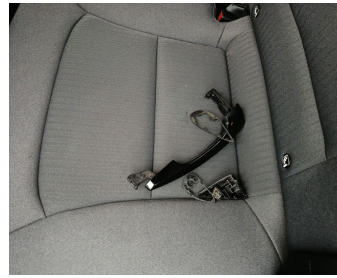
| Damages | Type | Acceptable |
|---|---|---|
| 108 | Door Rear Left / Door Handle / Replace | N |

Door Rear Left / Door Handle / Replace-cracked

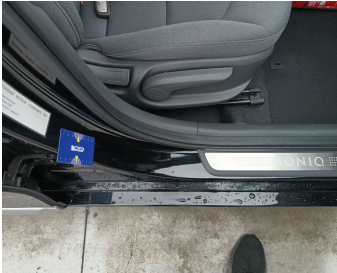
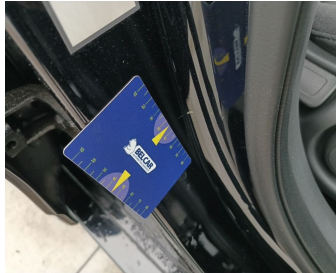
| Damages | Type | Acceptable |
|---|---|---|
| 202 | Rocker Panel Right // Painting | Y |

Rocker Panel Right // Painting-rust

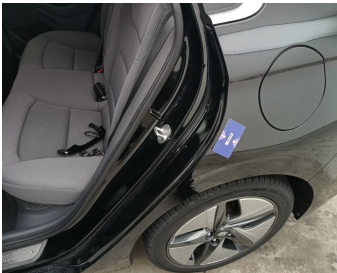
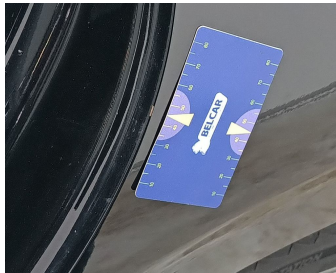
| Damages | Type | Acceptable |
|---|---|---|
| 92 | Rocker Panel Left // Painting | Y |

Rocker Panel Left // Painting-rust
