# INSPECTION REPORT

**End of contract**

| License plate | 2CEW232 |
| Make | Skoda Kamiq 1.0TGI 66kW Monte |

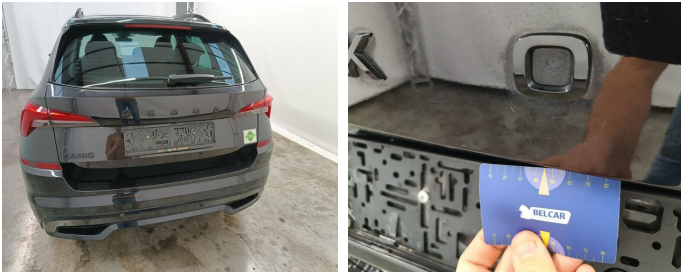
| Damages | Type | Acceptable |
|---|---|---|
| 153 | Rear Bonnet // Painting | Y |

Rear Bonnet // Painting-scratch

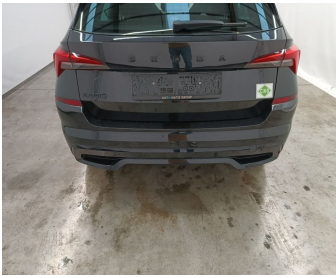
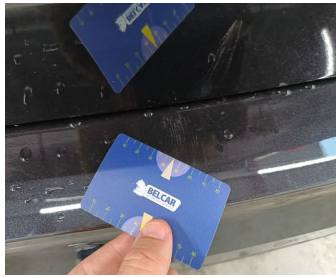
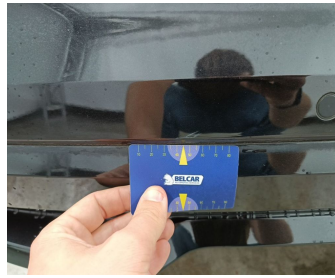
| Damages | Type | Acceptable |
|---|---|---|
| 133 | Bumper Rear // Painting | Y |

Bumper Rear // Painting-scratch

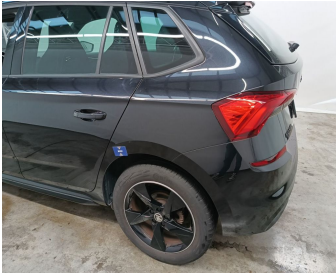
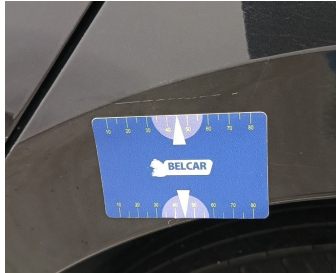
| Damages | Type | Acceptable |
|---|---|---|
| 113 | Wing Rear Left // Painting | Y |

Wing Rear Left // Painting-scratch

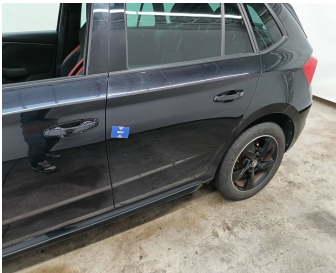
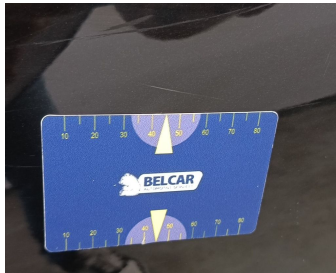
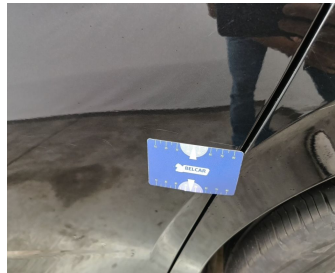
| Damages | Type | Acceptable |
|---|---|---|
| 106 | Door Rear Left // Polish | Y |

Door Rear Left // Polish-scratch

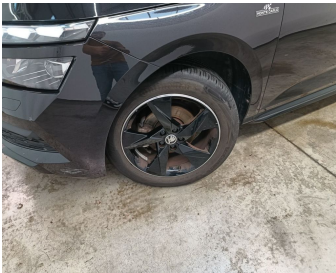
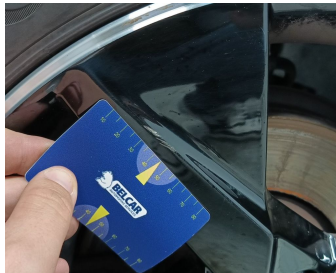
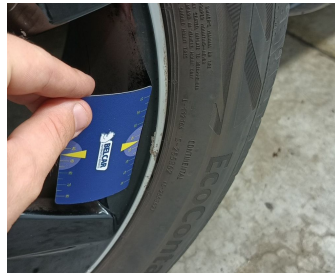
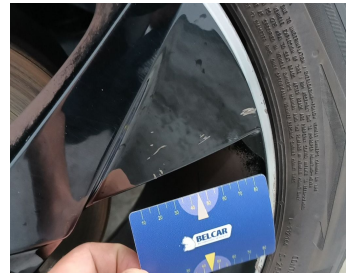
| Damages | Type | Acceptable |
|---|---|---|
| 311 | Wheel Alloy Front Left // Repair | N |

Wheel Alloy Front Left // Repair-scratch

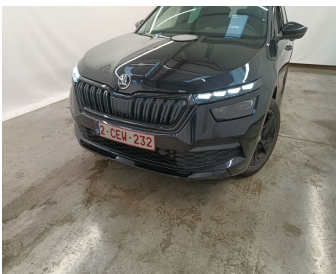
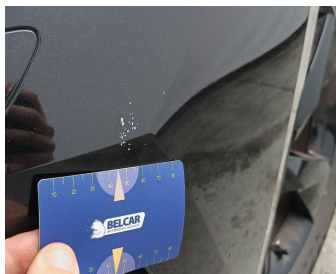
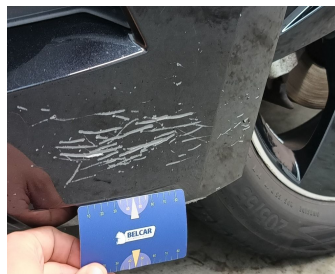
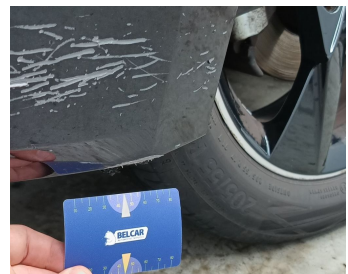
| Damages | Type | Acceptable |
|---|---|---|
| 13 | Bumper Front // Painting | N |

Bumper Front // Painting-scratch

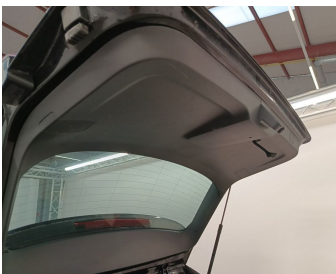
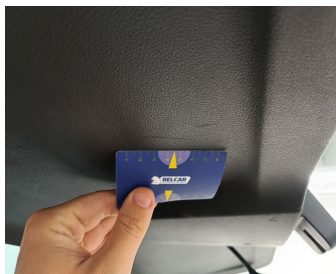
| Damages | Type | Acceptable |
|---|---|---|
| 594 | Trunk Lid Interior Coating / Complete Panel / Replace | Y |

Trunk Lid Interior Coating / Complete Panel / Replace-scratch

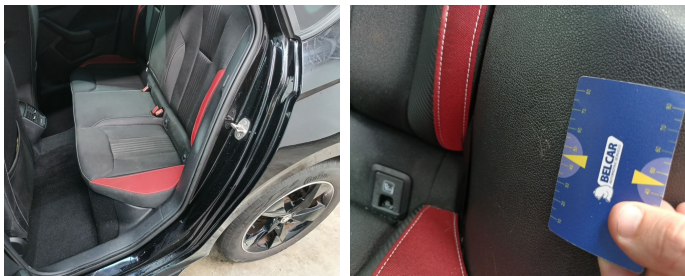
| Damages | Type | Acceptable |
|---|---|---|
| 431 | Seat Rear Left // Repair | Y |

Seat Rear Left // Repair-scratch

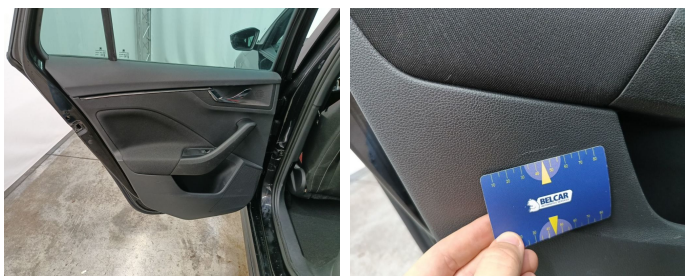
| Damages | Type | Acceptable |
|---|---|---|
| 634 | Rear Left Door Interior Coating // Replace Completely | Y |

Rear Left Door Interior Coating // Replace Completely-scratch

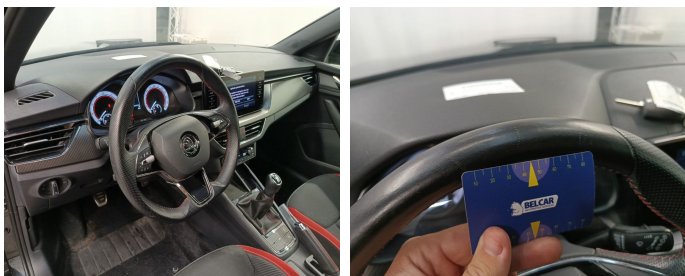
| Damages | Type | Acceptable |
|---|---|---|
| 569 | Dashboard / Steering Wheel / Replace | Y |

Dashboard / Steering Wheel / Replace-scratch

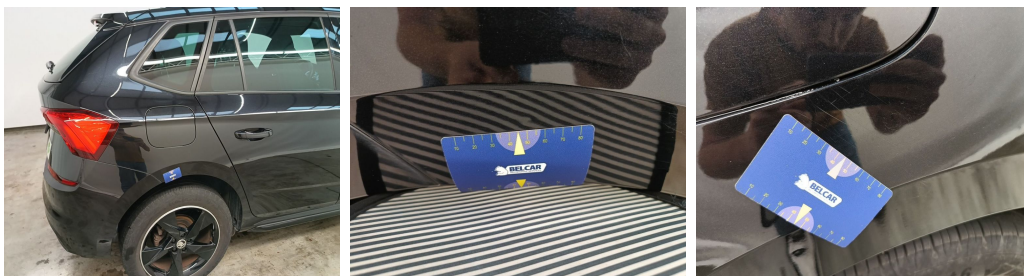
| Damages | Type | Acceptable |
|---|---|---|
| 184 | Wing Rear Right // Repair & Painting | Y |

Wing Rear Right // Repair & Painting-dent

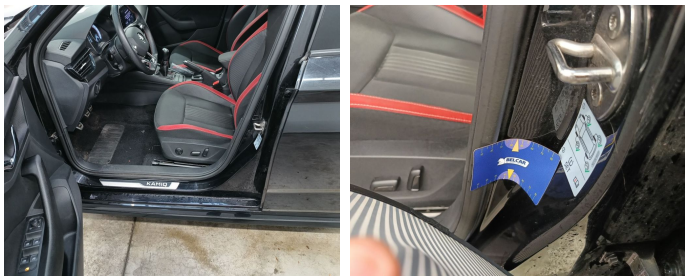
| Damages | Type | Acceptable |
|---|---|---|
| 91 | Rocker Panel Left // Smart Repair Medium | Y |

Rocker Panel Left // Smart Repair Medium-dent

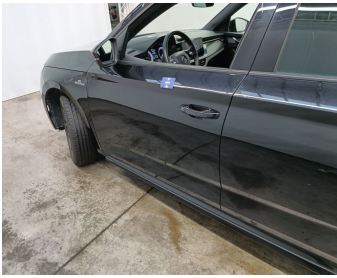
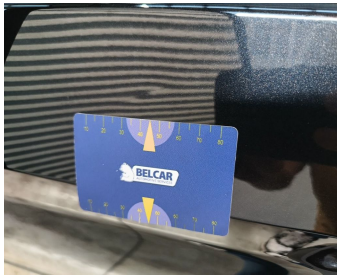
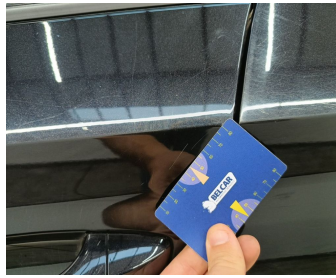
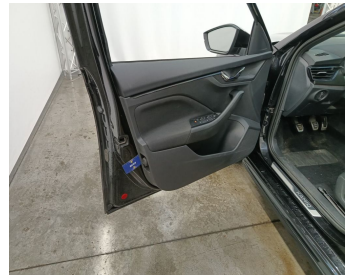
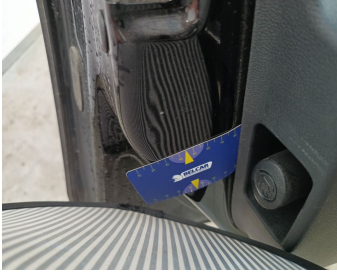
| Damages | Type | Acceptable |
|---|---|---|
| 84 | Door Front Left // Repair & Painting | Y |

Door Front Left // Repair & Painting-dent

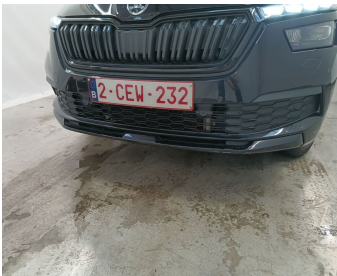
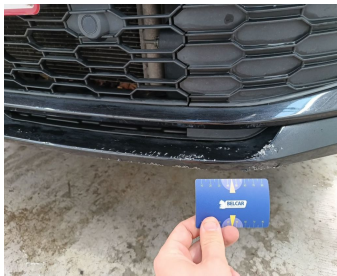
| Damages | Type | Acceptable |
|---|---|---|
| 18 | Bumper Front / Spoiler / Replace | N |

Bumper Front / Spoiler / Replace-scratch + dent

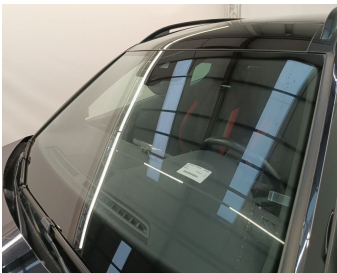
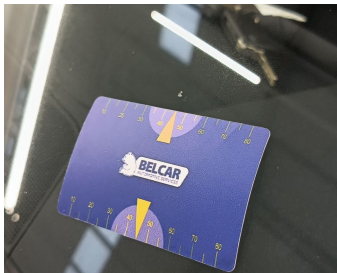
| Damages | Type | Acceptable |
|---|---|---|
| 40 | Windshield // Repair | Y |

Windshield // Repair-cracked

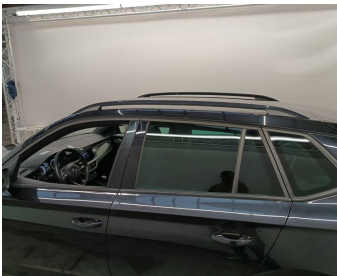
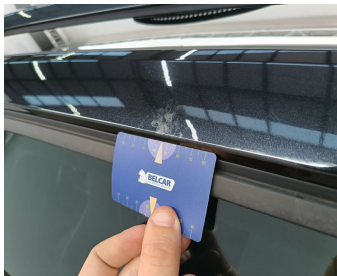
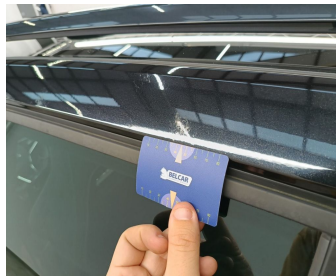
| Damages | Type | Acceptable |
|---|---|---|
| 165 | Roof // Polish | Y |

Roof // Polish-Chemical reaction

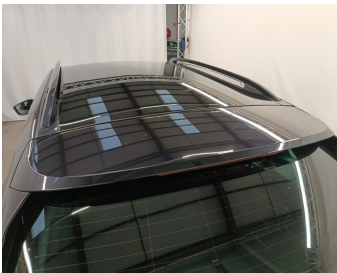
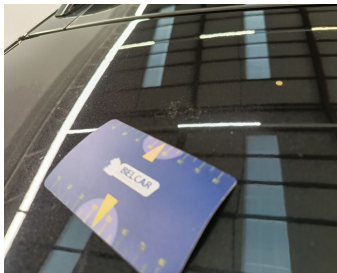
| Damages | Type | Acceptable |
|---|---|---|
| 156 | Rear Bonnet // Polish | Y |

Rear Bonnet // Polish-Chemical reaction

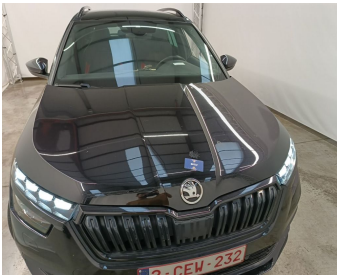
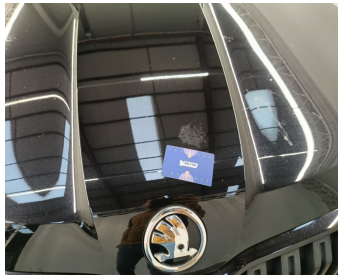
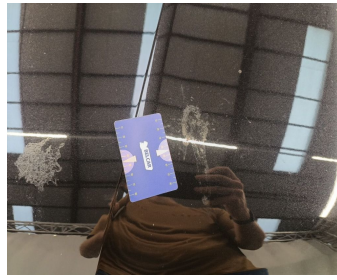
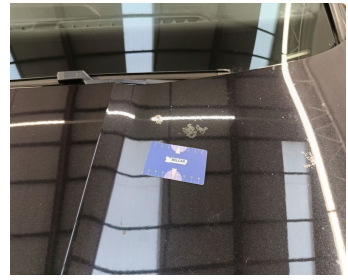
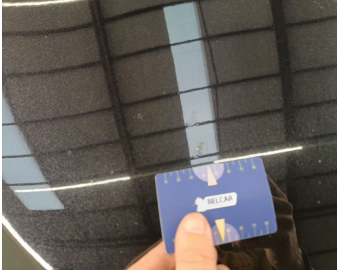
| Damages | Type | Acceptable |
|---|---|---|
| 32 | Front Bonnet // Painting | N |

Front Bonnet // Painting-Chemical reaction

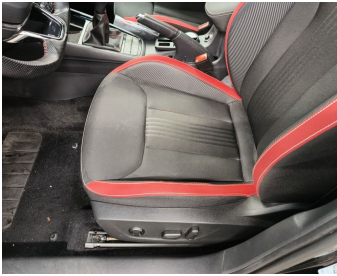
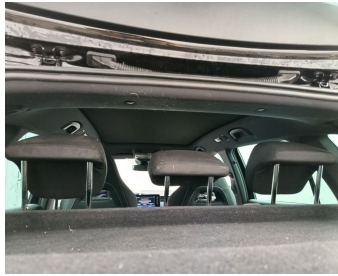
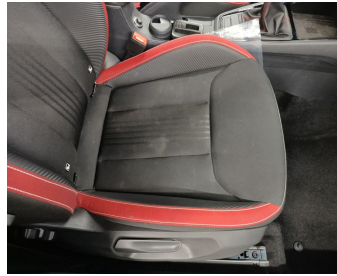
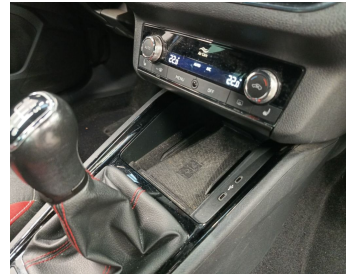
| Damages | Type | Acceptable |
|---|---|---|
| 860 | Interior Cleaning // Small | N |

Interior Cleaning // Small-dirty
