# INSPECTION REPORT

**End of contract**

| License plate | 1XNS467 |
| Make | Mercedes A Berline 180 d Bus.S |

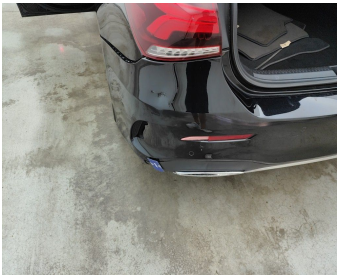
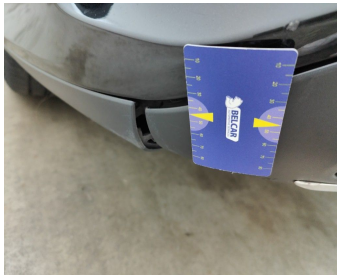
| Damages | Type | Acceptable |
|---|---|---|
| 138 | Bumper Rear / Lower Cover Not Painted / Replace | Y |

Bumper Rear / Lower Cover Not Painted / Replace-bad position

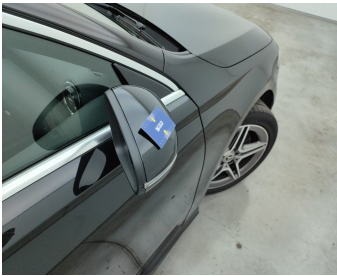
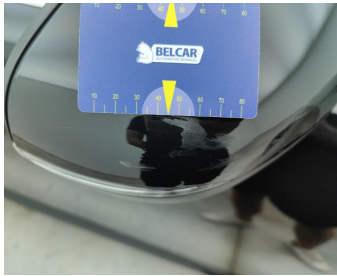
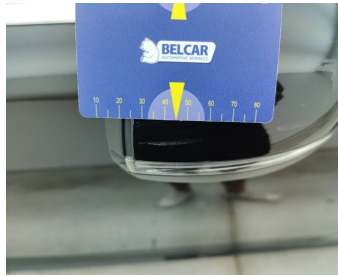
| Damages | Type | Acceptable |
|---|---|---|
| 225 | Side View Mirror Right // Polish | Y |

Side View Mirror Right // Polish-scratch

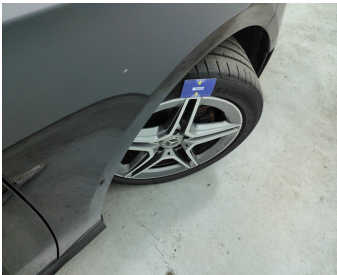
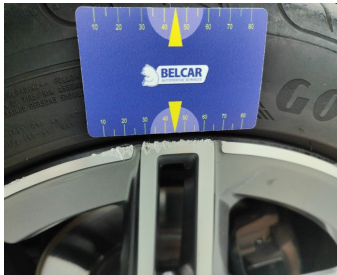
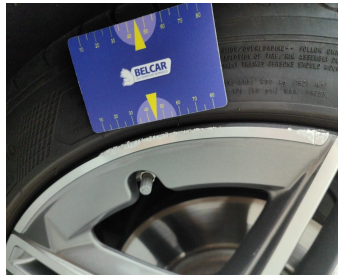
| Damages | Type | Acceptable |
|---|---|---|
| 340 | Wheel Two Tone Front Right // Repair | N |

Wheel Two Tone Front Right // Repair-scratch

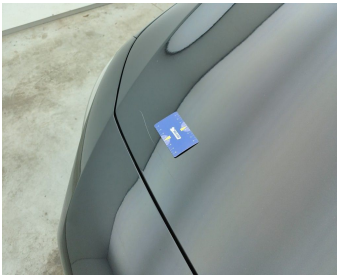
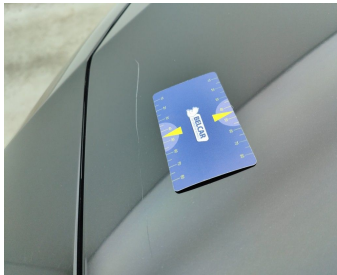
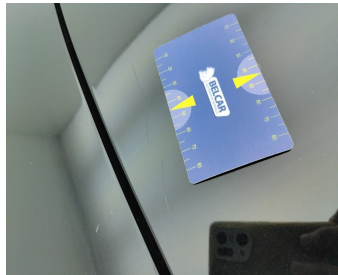
| Damages | Type | Acceptable |
|---|---|---|
| 32 | Front Bonnet // Painting | N |

Front Bonnet // Painting-scratch

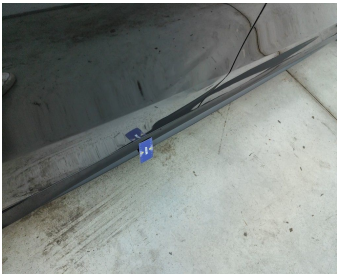
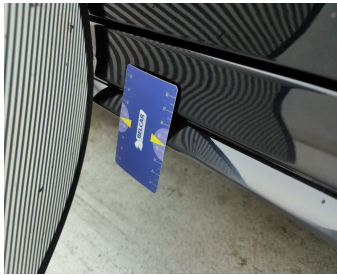
| Damages | Type | Acceptable |
|---|---|---|
| 208 | Rocker Panel Right / Cover Not Painted / Replace | Y |

Rocker Panel Right / Cover Not Painted / Replace-dent

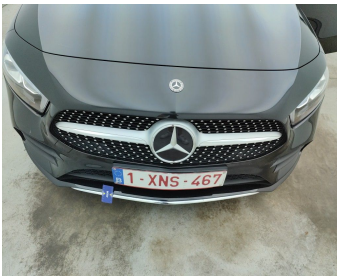
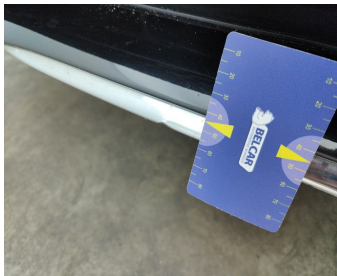
| Damages | Type | Acceptable |
|---|---|---|
| 18 | Bumper Front / Spoiler / Replace | Y |

Bumper Front / Spoiler / Replace-dent

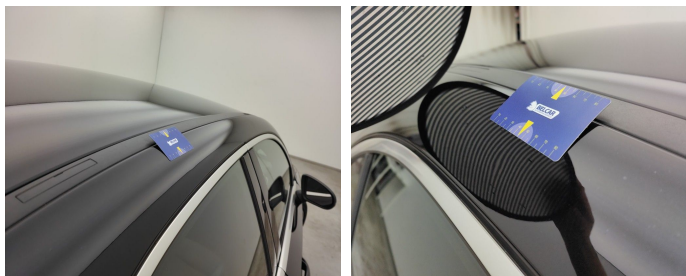
| Damages | Type | Acceptable |
|---|---|---|
| 161 | Roof // Smart Repair Medium | Y |

Roof // Smart Repair Medium-dent

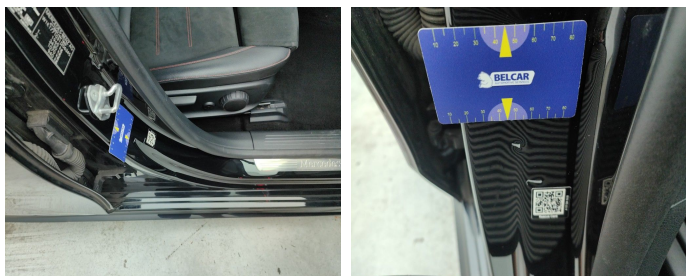
| Damages | Type | Acceptable |
|---|---|---|
| 201 | Rocker Panel Right // Smart Repair Medium | N |

Rocker Panel Right // Smart Repair Medium-scratch + dent

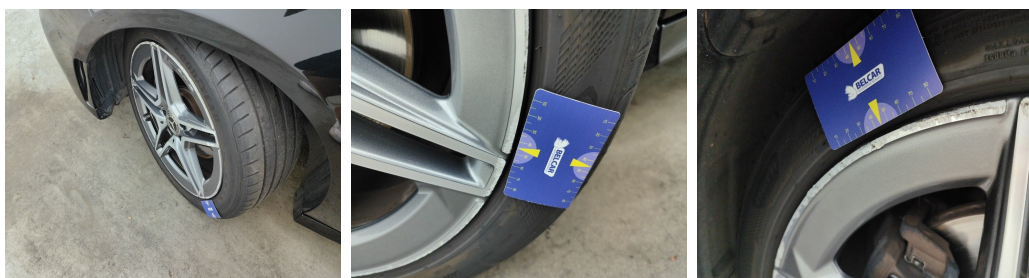
| Damages | Type | Acceptable |
|---|---|---|
| 310 | Wheel Two Tone Front Left // Repair | N |

Wheel Two Tone Front Left // Repair-scratch

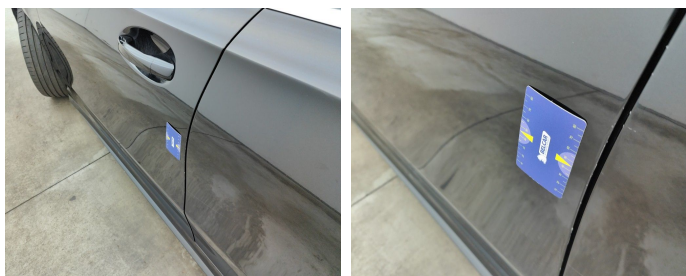
| Damages | Type | Acceptable |
|---|---|---|
| 80 | Door Front Left // Smart Repair Small | Y |

Door Front Left // Smart Repair Small-scratch

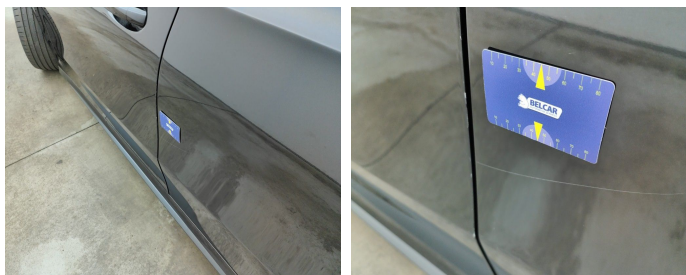
| Damages | Type | Acceptable |
|---|---|---|
| 103 | Door Rear Left // Painting | N |

Door Rear Left // Painting-scratch

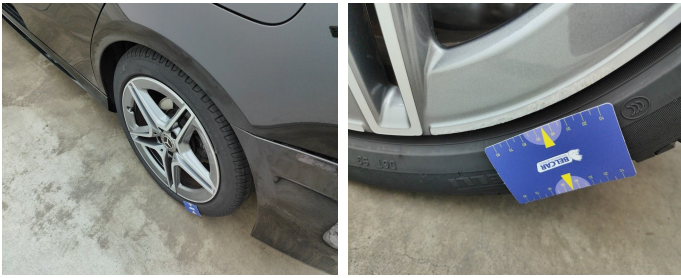
| Damages | Type | Acceptable |
|---|---|---|
| 320 | Wheel Two Tone Rear Left // Repair | N |

Wheel Two Tone Rear Left // Repair-scratch

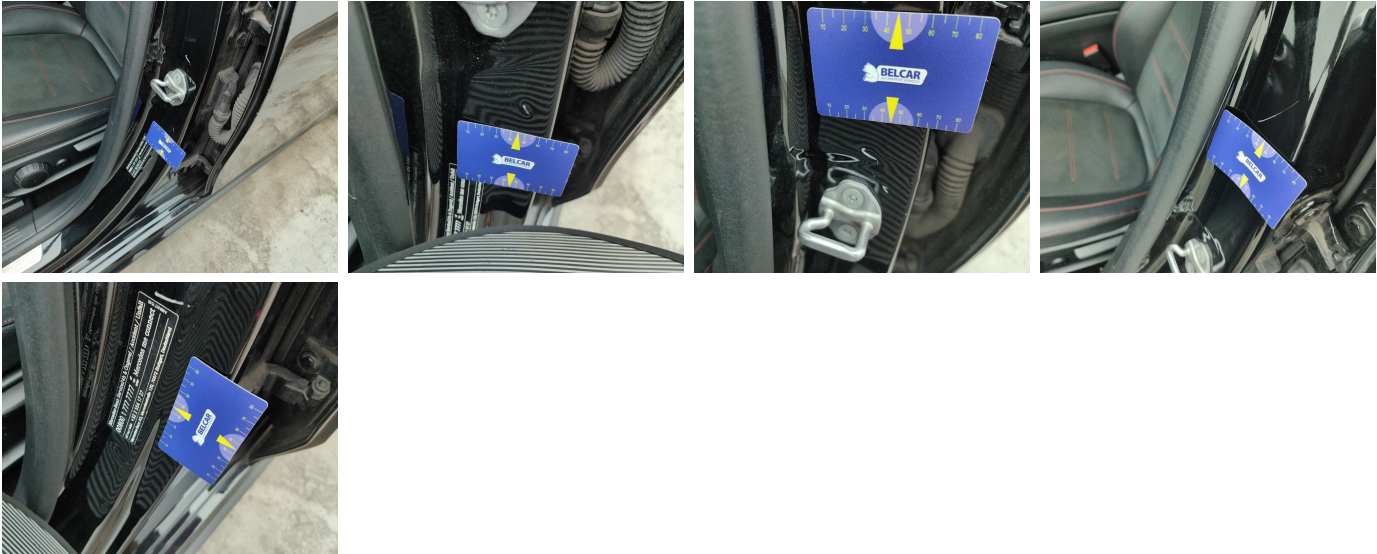
| Damages | Type | Acceptable |
|---|---|---|
| 91 | Rocker Panel Left // Smart Repair Medium | N |

Rocker Panel Left // Smart Repair Medium-scratch + dent

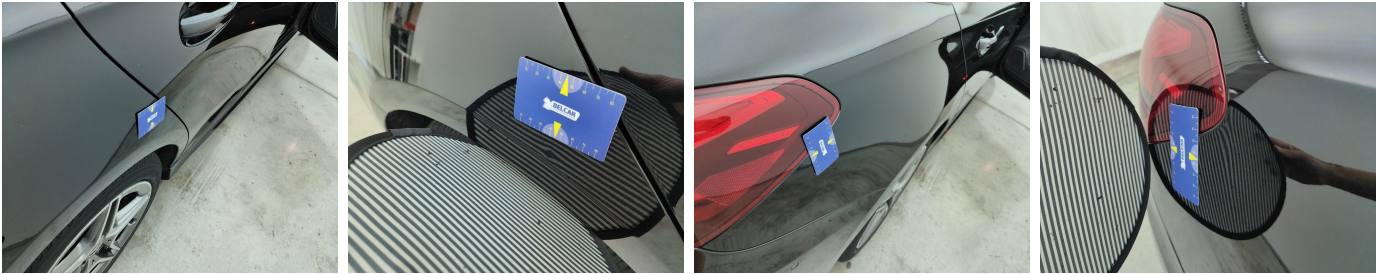
| Damages | Type | Acceptable |
|---|---|---|
| 184 | Wing Rear Right // Repair & Painting | Y |

Wing Rear Right // Repair & Painting-scratch + dent

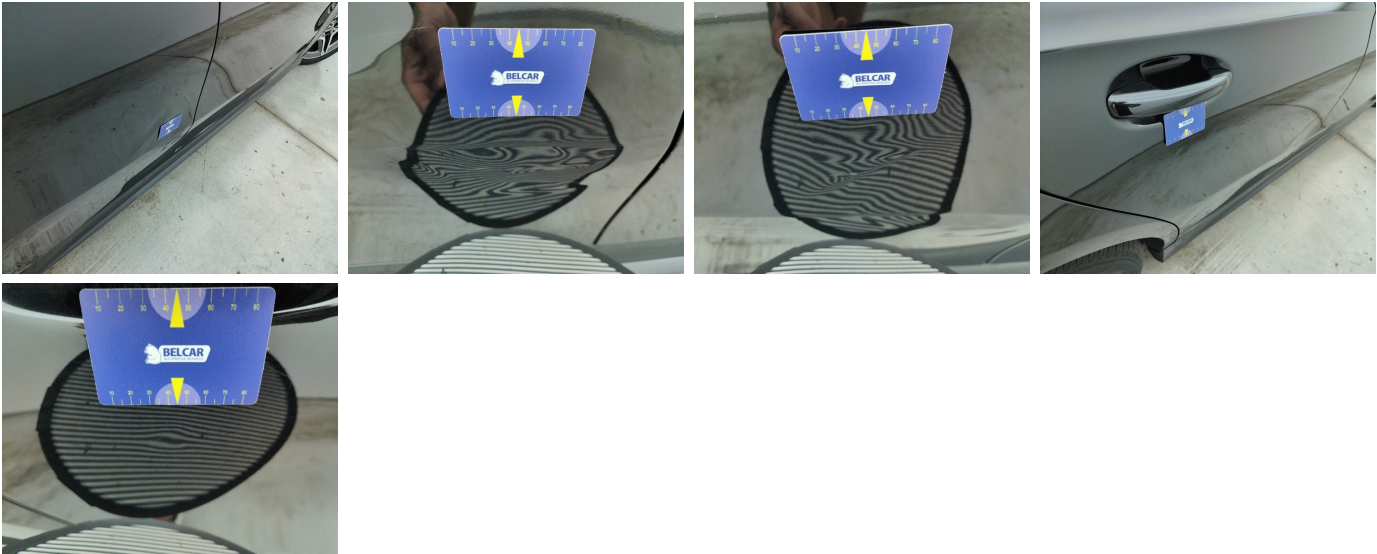
| Damages | Type | Acceptable |
|---|---|---|
| 194 | Door Rear Right // Repair & Painting | N |

Door Rear Right // Repair & Painting-scratch + dent

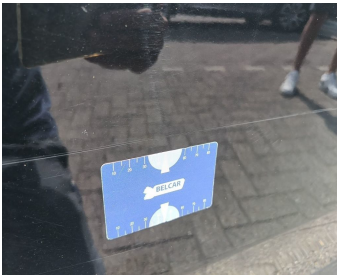
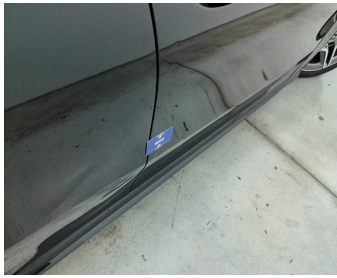
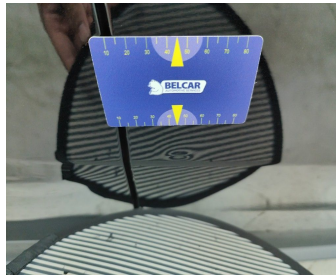
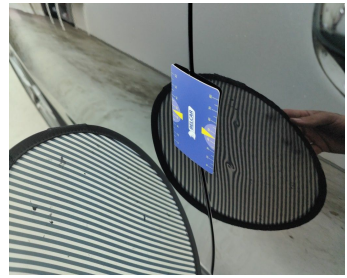
| Damages | Type | Acceptable |
|---|---|---|
| 214 | Door Front Right // Repair & Painting | N |

Door Front Right // Repair & Painting-scratch + dent

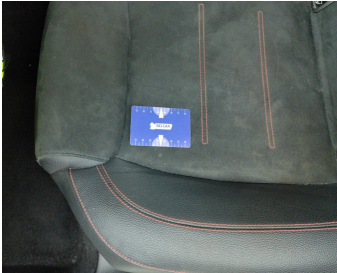
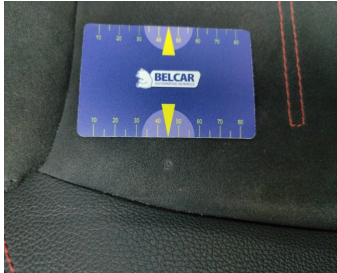
| Damages | Type | Acceptable |
|---|---|---|
| 432 | Seat Rear Left / Bottom Coating / Replace | N |

Seat Rear Left / Bottom Coating / Replace-Incinerated

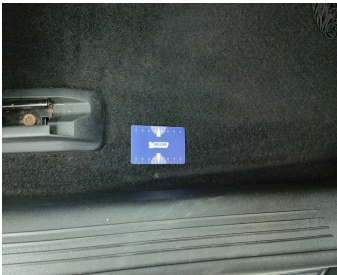
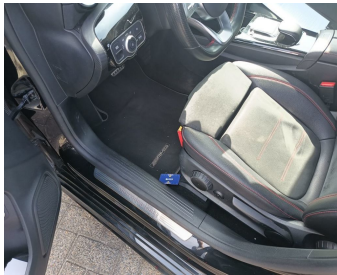
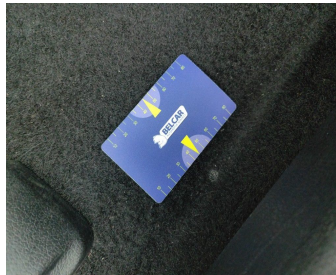
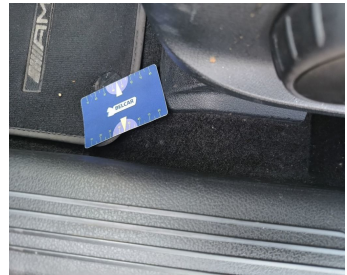
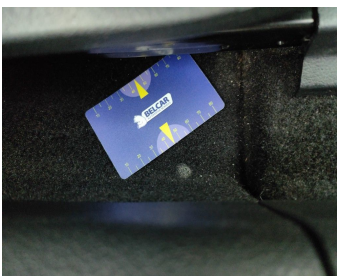
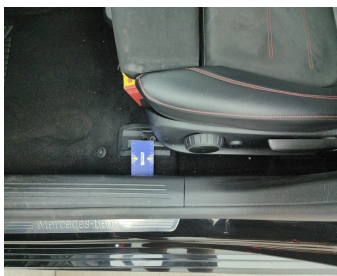
| Damages | Type | Acceptable |
|---|---|---|
| 544 | Interior / Floor Covering / Replace | N |

Interior / Floor Covering / Replace-Incinerated

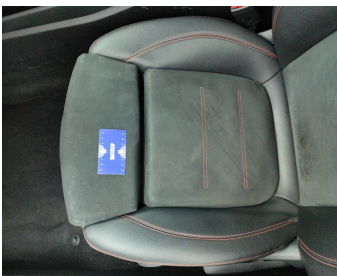
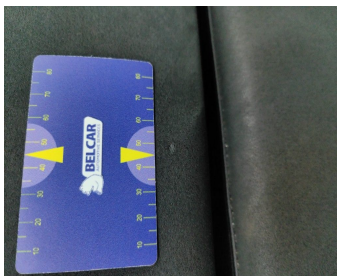
| Damages | Type | Acceptable |
|---|---|---|
| 412 | Seat Front Left / Bottom Coating / Replace | N |

Seat Front Left / Bottom Coating / Replace-Incinerated

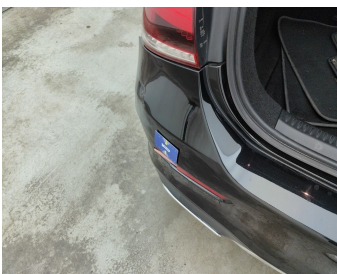
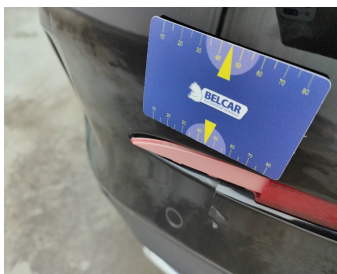
| Damages | Type | Acceptable |
|---|---|---|
| 146 | Back Side / Reflector L / Replace | N |

Back Side / Reflector L / Replace-cracked

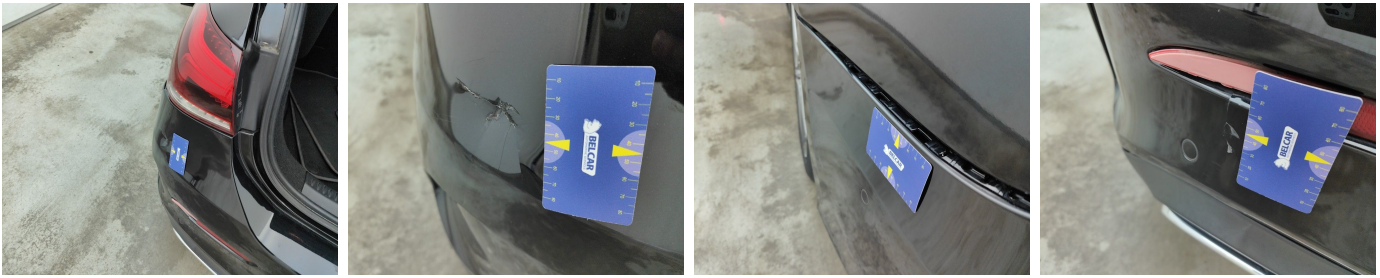
| Damages | Type | Acceptable |
|---|---|---|
| 135 | Bumper Rear // Replace & Painting | N |

Bumper Rear // Replace & Painting-cracked

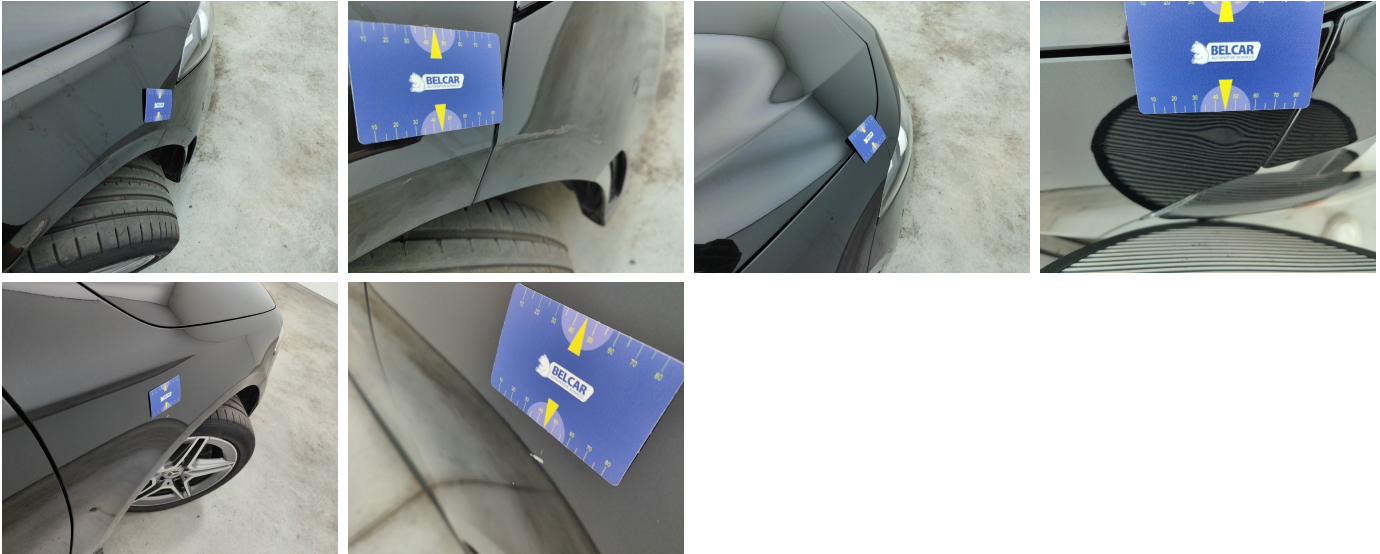
| Damages | Type | Acceptable |
|---|---|---|
| 234 | Wing Front right // Repair & Painting | N |

Wing Front right // Repair & Painting-scratch + dent

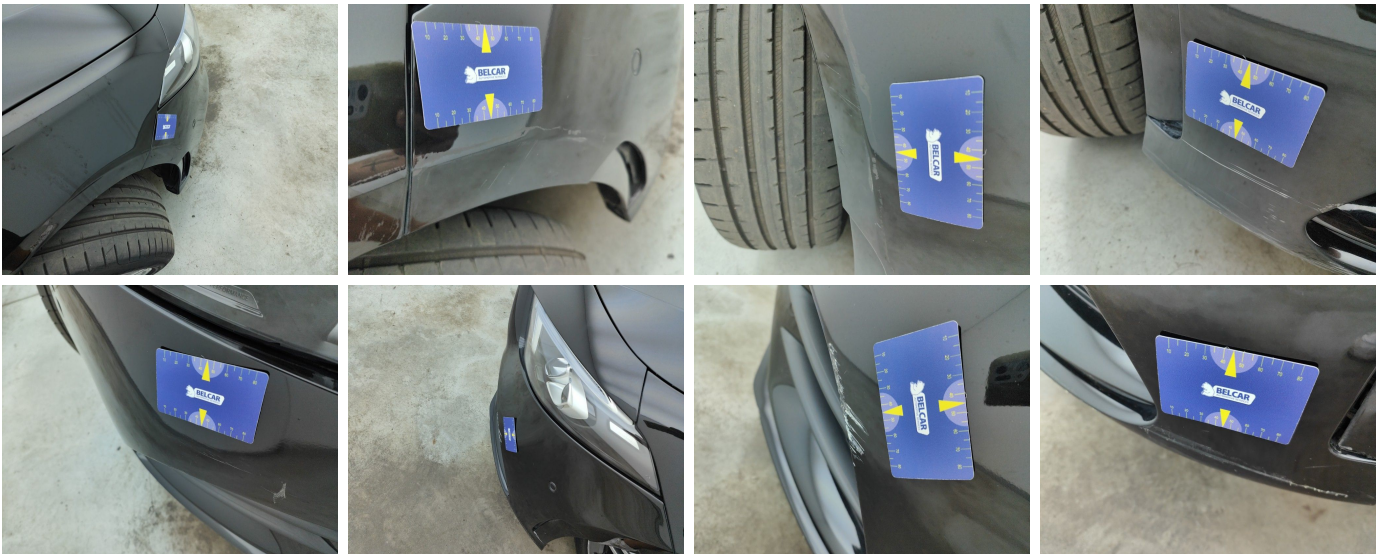
| Damages | Type | Acceptable |
|---|---|---|
| 13 | Bumper Front // Painting | N |

Bumper Front // Painting-scratch

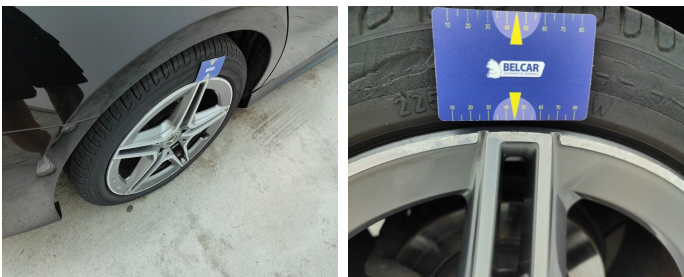
| Damages | Type | Acceptable |
|---|---|---|
| 330 | Wheel Two Tone Rear Right // Repair | N |

Wheel Two Tone Rear Right // Repair-scratch

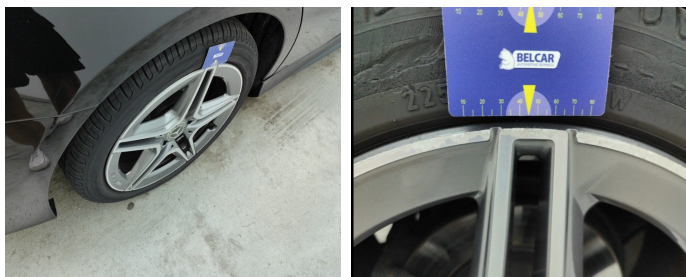
| Damages | Type | Acceptable |
|---|---|---|
| 336 | Tyre Rear Right // Replace | N |

Tyre Rear Right // Replace-tear
