# INSPECTION REPORT

End of contract

File	309215
License plate	2ABA953
Vehicle identification number	TMBJJ7NX3MY109706
Dossier	2020 328 081
Make	Skoda Oct.Com.2.0TDI 110kW Sty
Mileage	176502
First registration	04/02/2021
client availability date	30/03/2026
inspectionDate	02/04/2026

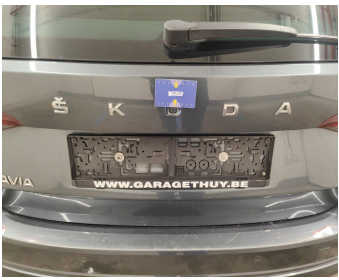
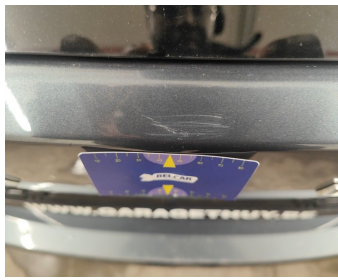
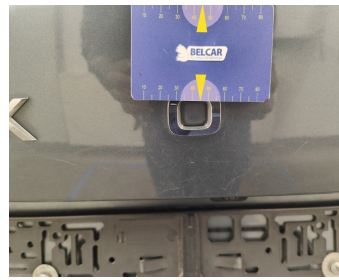
Trunk Lid Interior Coating / Complete Panel / Replace-scratch

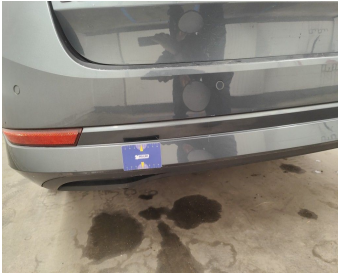
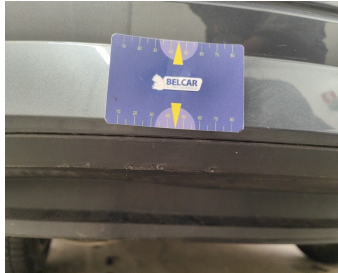
Rear Bonnet // Polish-scratch

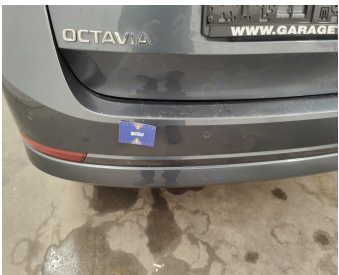
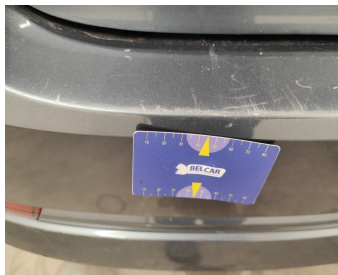
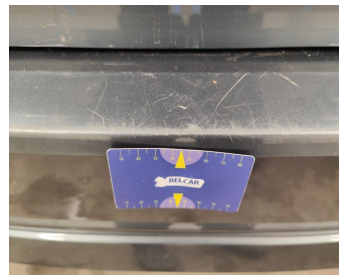
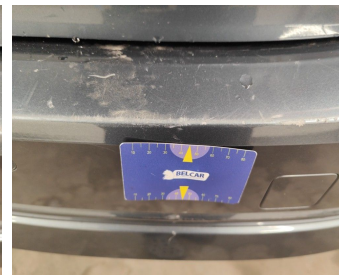
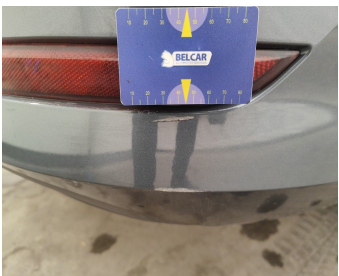
Bumper Rear / Lower Cover Not Painted / Replace-scratch
