# INSPECTION REPORT

End of contract

File	311333
License plate	2BGE044
Vehicle identification number	VF3MCYHZMMS221916
Dossier	2021085009
Make	Peugeot 3008 1.5BHDi 96kW Allu
Mileage	146136
First registration	12/11/2021
client availability date	28/04/2026
inspectionDate	06/05/2026

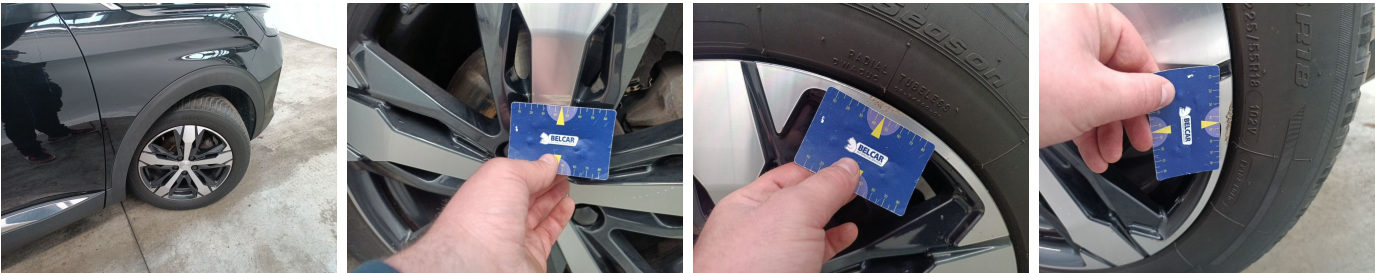
Wheel Two Tone Front Right // Repair-scratch

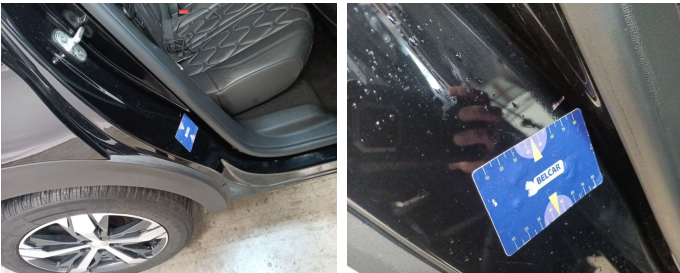
Rocker Panel Right // Painting-scratch

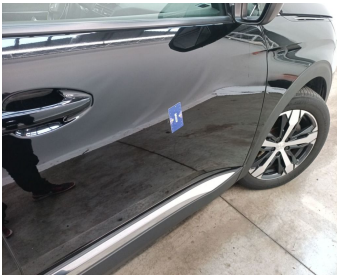
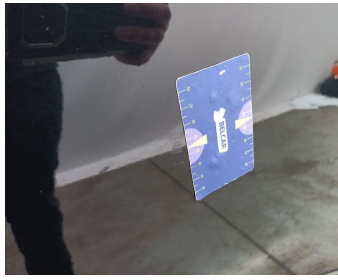
Door Front Right // Painting-scratch

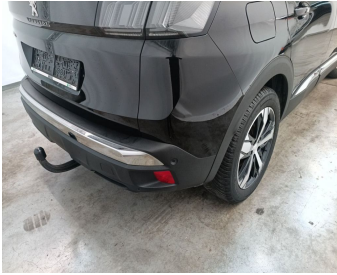
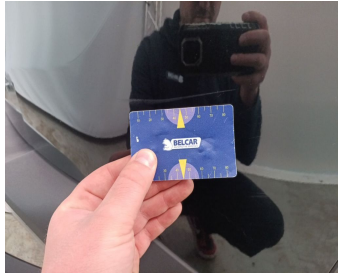
Bumper Rear // Polish-scratch

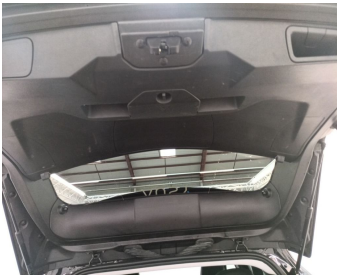
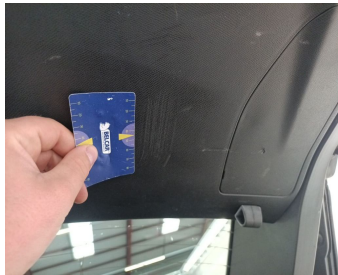
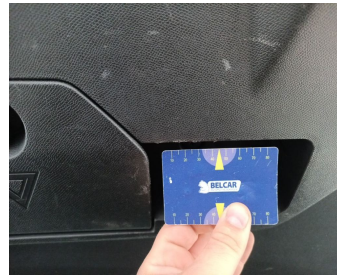
Trunk Lid Interior Coating / Complete Panel / Replace-scratch

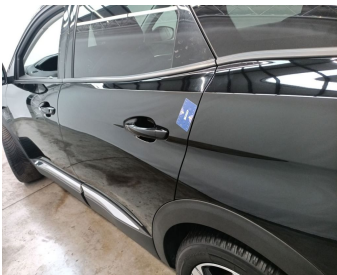
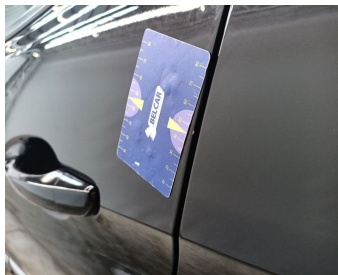
Door Rear Left // Painting-scratch

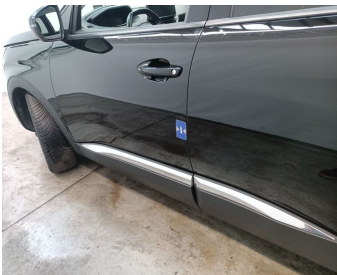
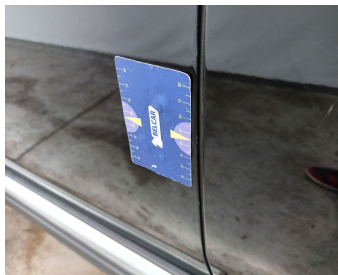
Door Front Left // Smart Repair Small-scratch

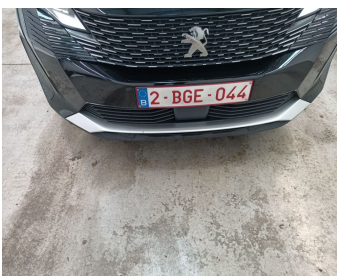
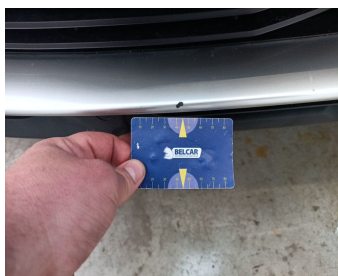
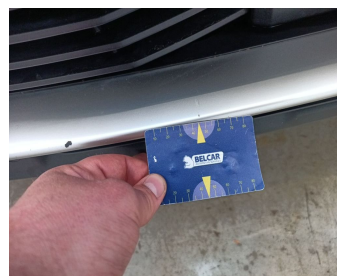
Bumper Front // Smart Repair Medium-scratch

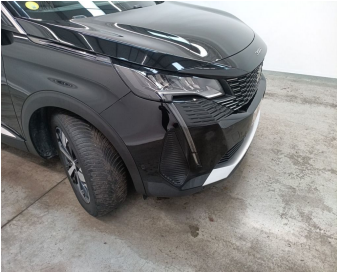
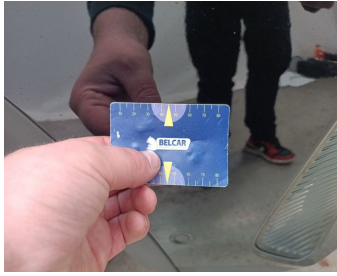
Bumper Front // Painting-scratch

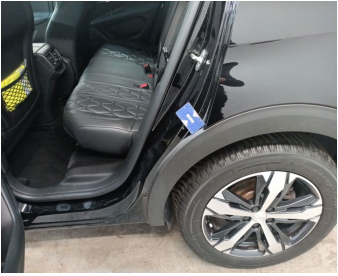
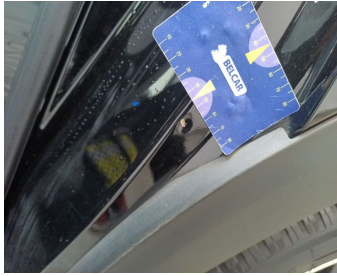
Rocker Panel Left // Smart Repair Medium-scratch + dent

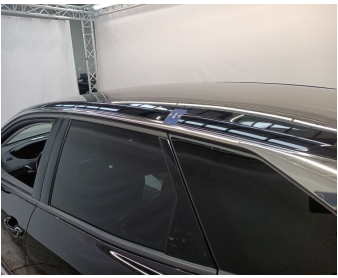
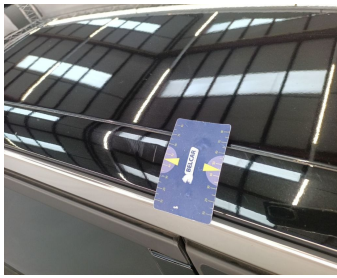
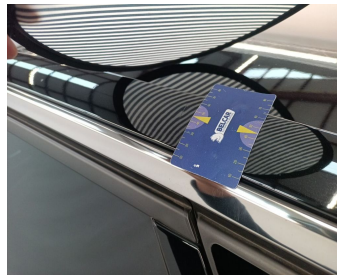
Roof // Smart Repair Medium-scratch + dent

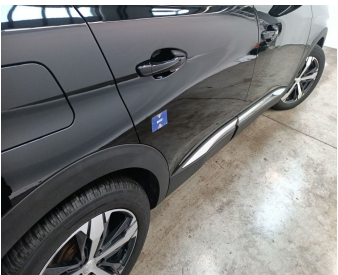
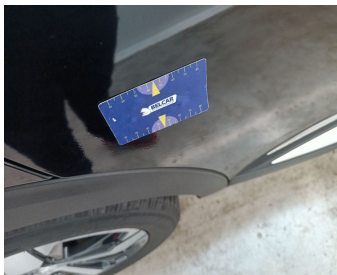
Door Rear Right // Repair & Painting-bad repair
