INSPECTION REPORT

End of contract

File	306687
License plate	1YVR863
Vehicle identification number	W1N2533111F908768
Dossier	2020 274 027
Make	Mercedes GLC Coupé 300de 4M
Mileage	92404
First registration	05/01/2021
client availability date	04/03/2026
inspectionDate	09/03/2026

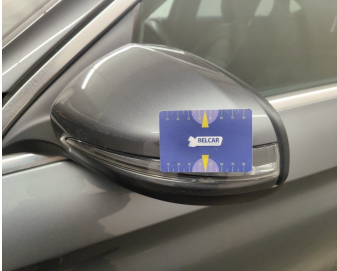
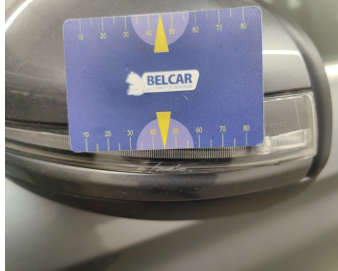
Side View Mirror Left / Direction Indicator / Replace-scratch

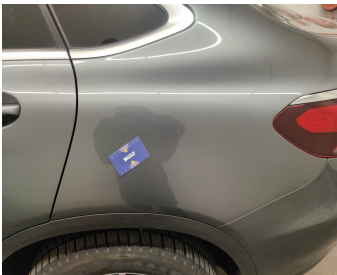
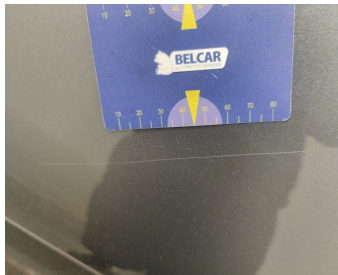
Wing Rear Left // Polish-scratch

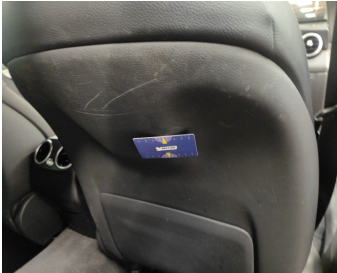
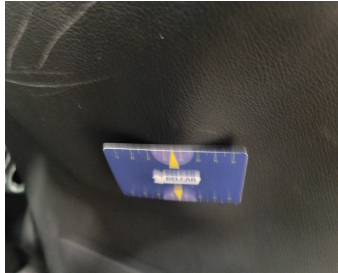
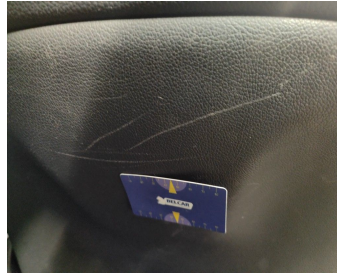
Seat Front Right // Repair-scratch

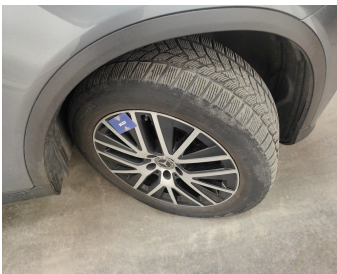
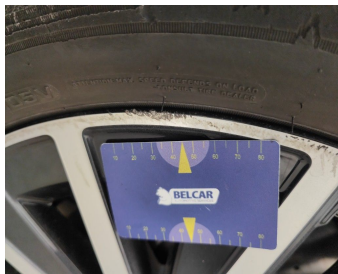
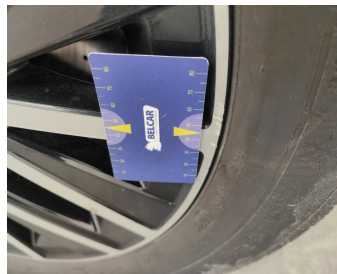
Wheel Two Tone Front Right // Repair-scratch

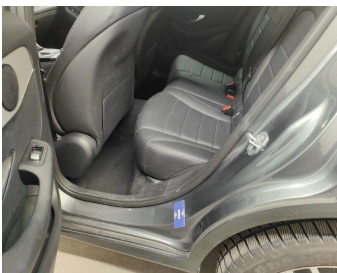
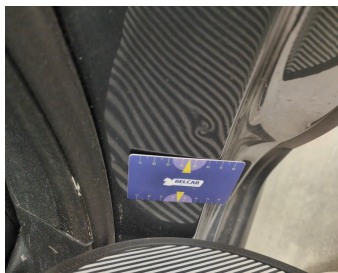
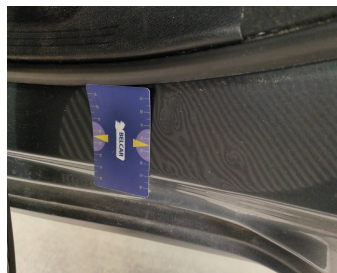
Rocker Panel Left // Smart Repair Medium-dent

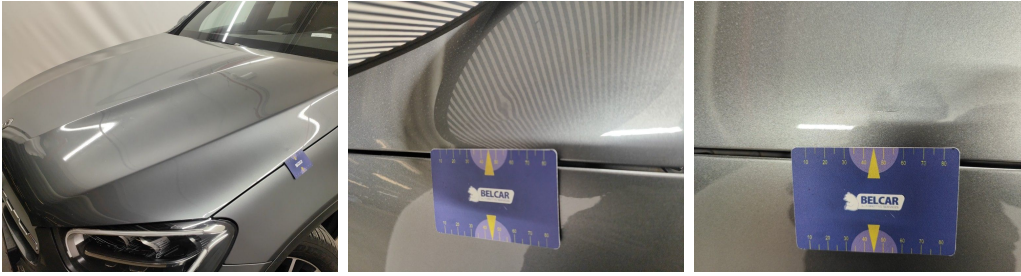
Front Bonnet // Painting-scratch + dent

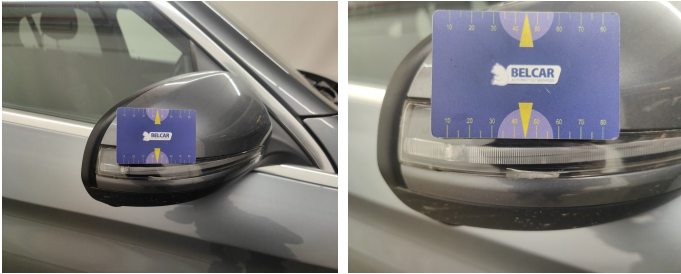
Side View Mirror Right / Direction Indicator / Replace-cracked
