# INSPECTION REPORT

End of contract

File	306856
License plate	1XQM882
Vehicle identification number	W1V4156031U281136
Dossier	2019331183
Make	Mercedes Citan 109CDI L2 Perf.
Mileage	95266
First registration	09/03/2020
client availability date	27/02/2026
inspectionDate	09/03/2026

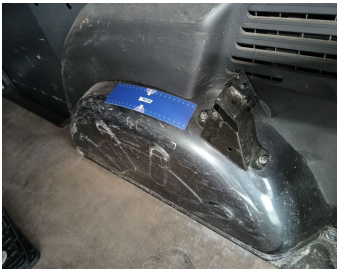
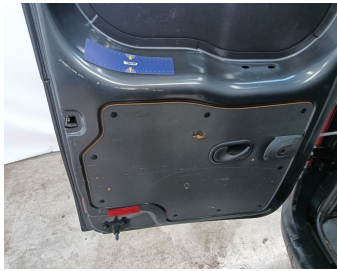
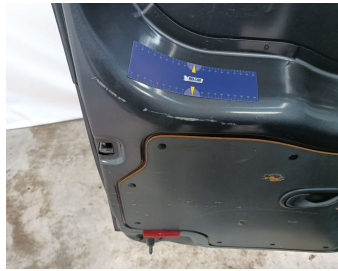
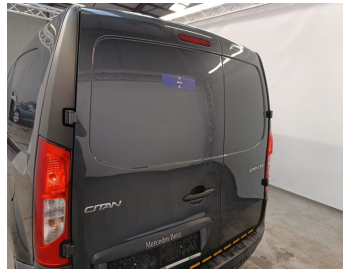
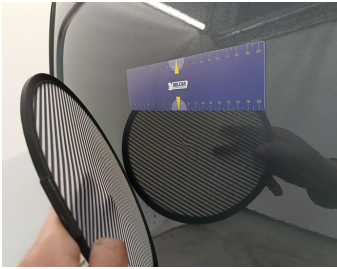
Damage within Renta-norm-scratch

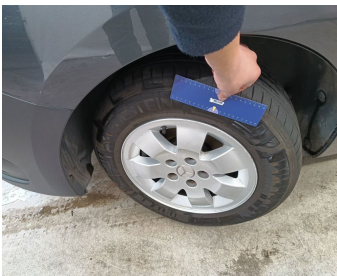
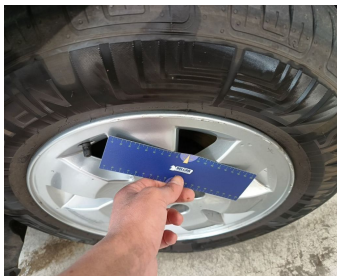
Wheel Alloy Front Left // Repair-scratch

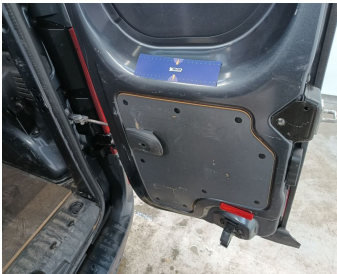
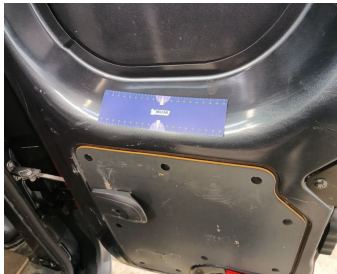
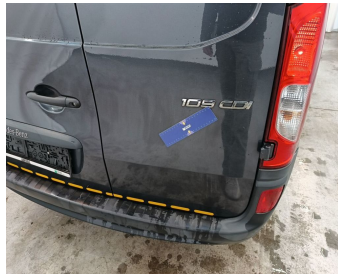
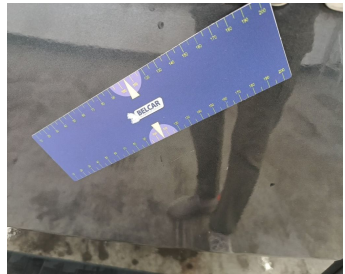
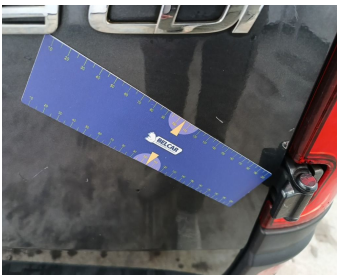
Rear Loading Door Right // Painting-scratch

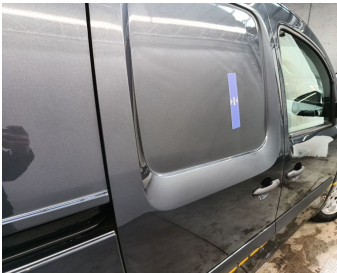
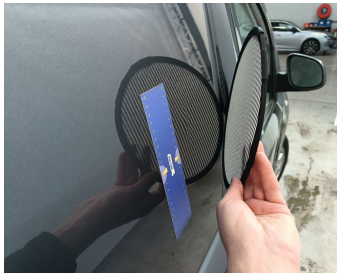
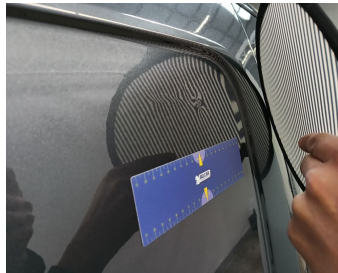
Door Rear Right // Repair & Painting-dent

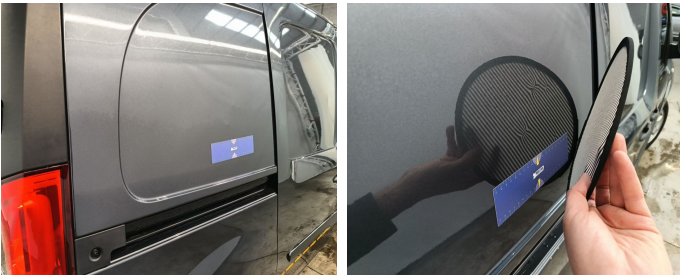
Door Rear Right // Smart Repair Medium-dent

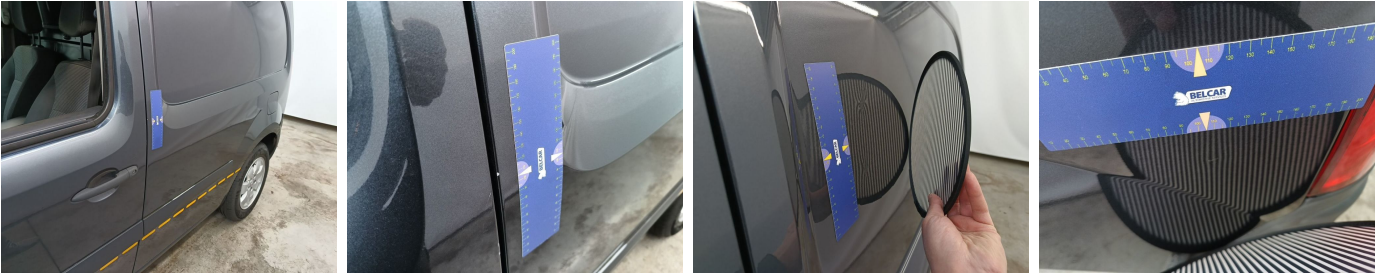
Wing Rear Left // Smart Repair Large-scratch + dent

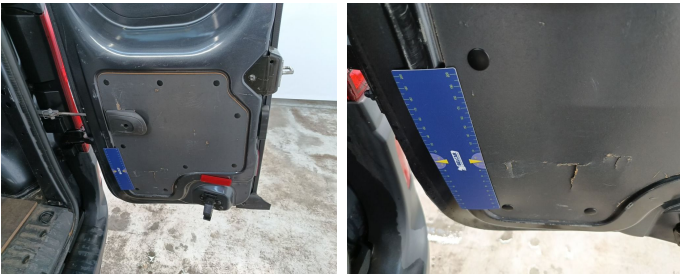
Trunk Lid Interior Coating / MDF Rear Right / Replace-cracked

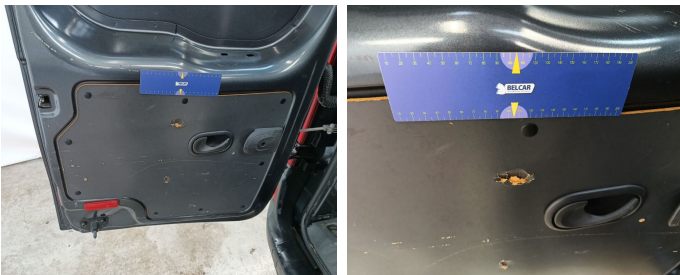
Trunk Lid Interior Coating / MDF Rear Left / Replace-cracked

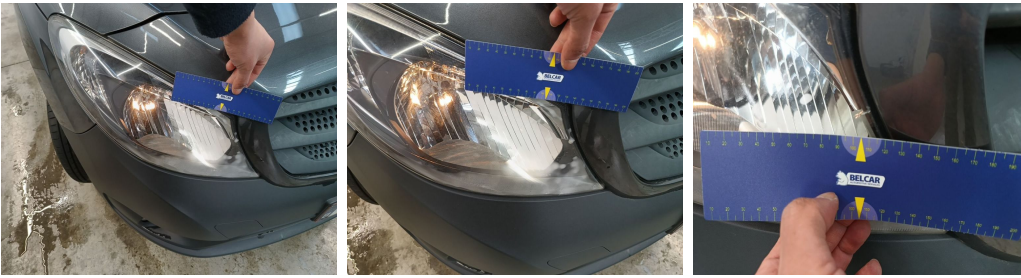
Light / Front Right / Replace-cracked

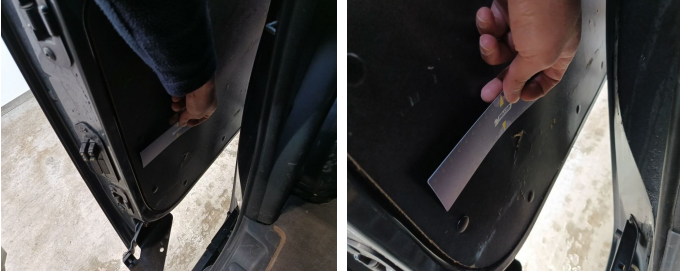
Trunk Lid Interior Coating / MDF Side Door Right / Replace-cracked

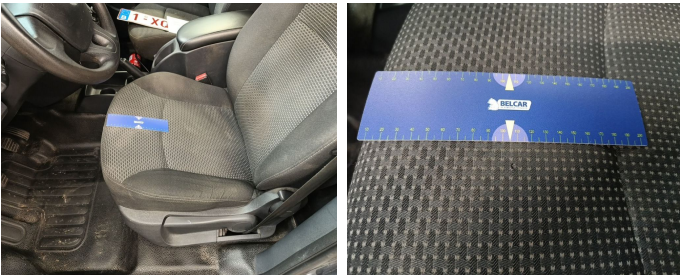
Seat Front Left / Bottom Coating / Replace-Incinerated

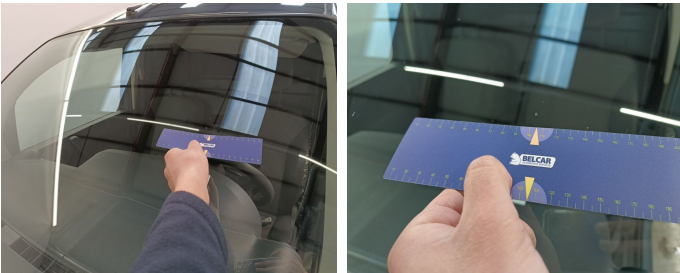
Windshield // Replace-glass damage

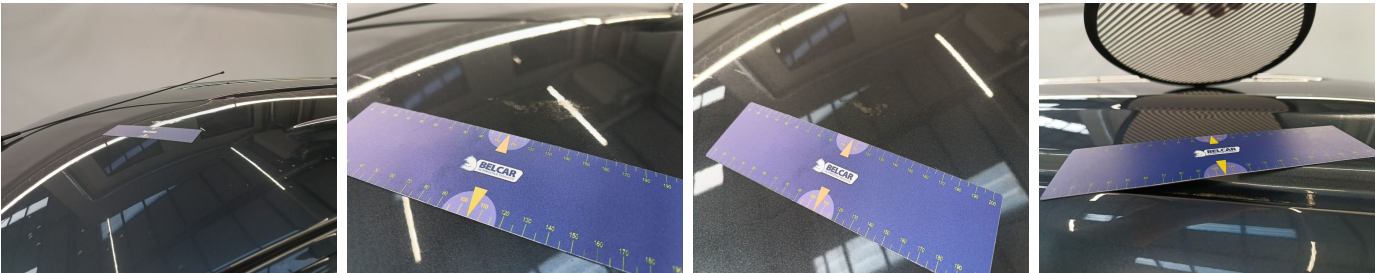
Roof // Painting-Chemical reaction

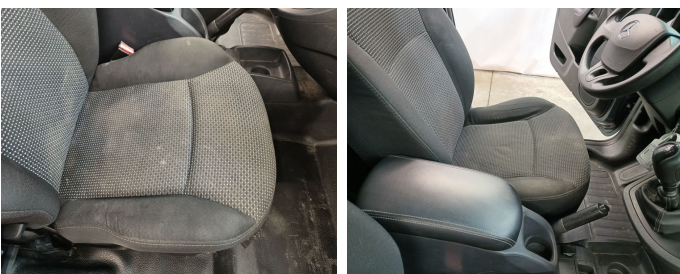
Interior Cleaning // Small-stain

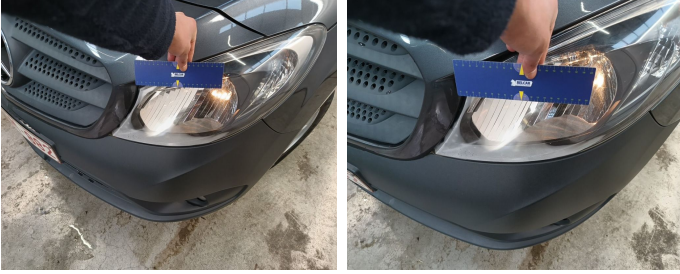
Headlight / Front left / Replace-N comf / out of order

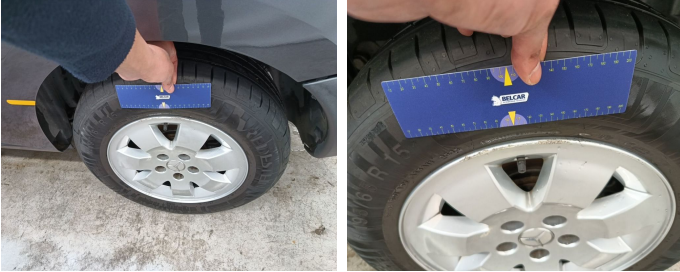
Wheel Alloy Rear Left // Repair-scratch

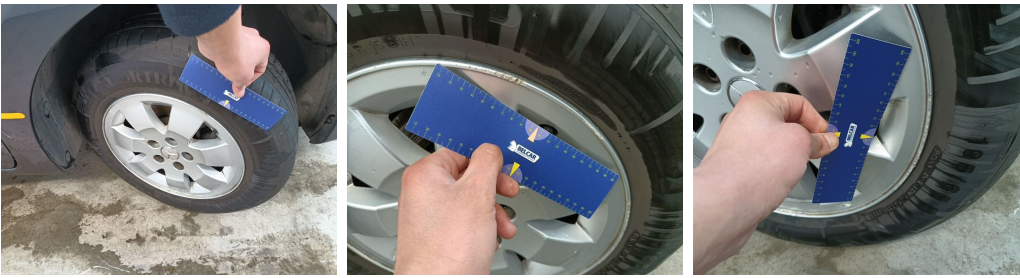
Wheel Alloy Front Right // Repair-scratch
