# INSPECTION REPORT

**End of contract**

| License plate | 2BRT164 |
| Make | Peugeot Exp.Lo.2.0BHDi 145 L3 |

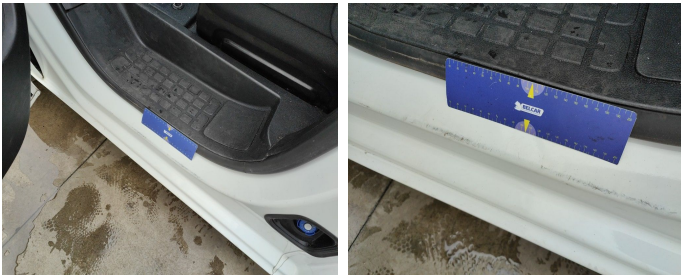
| Damages | Type | Acceptable |
|---|---|---|
| 91 | Rocker Panel Left // Smart Repair Medium | Y |

Rocker Panel Left // Smart Repair Medium-scratch

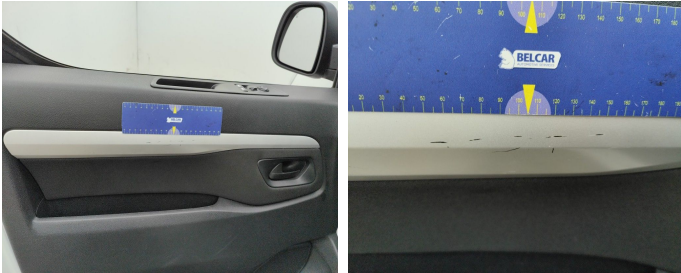
| Damages | Type | Acceptable |
|---|---|---|
| 618 | Front Left Door Interior Coating / Door Handle / Replace | Y |

Front Left Door Interior Coating / Door Handle / Replace-scratch

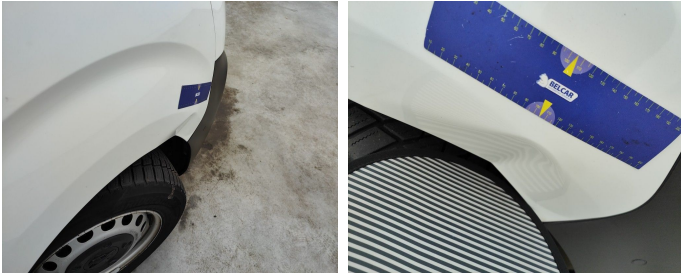
| Damages | Type | Acceptable |
|---|---|---|
| 234 | Wing Front right // Repair & Painting | N |

Wing Front right // Repair & Painting-dent

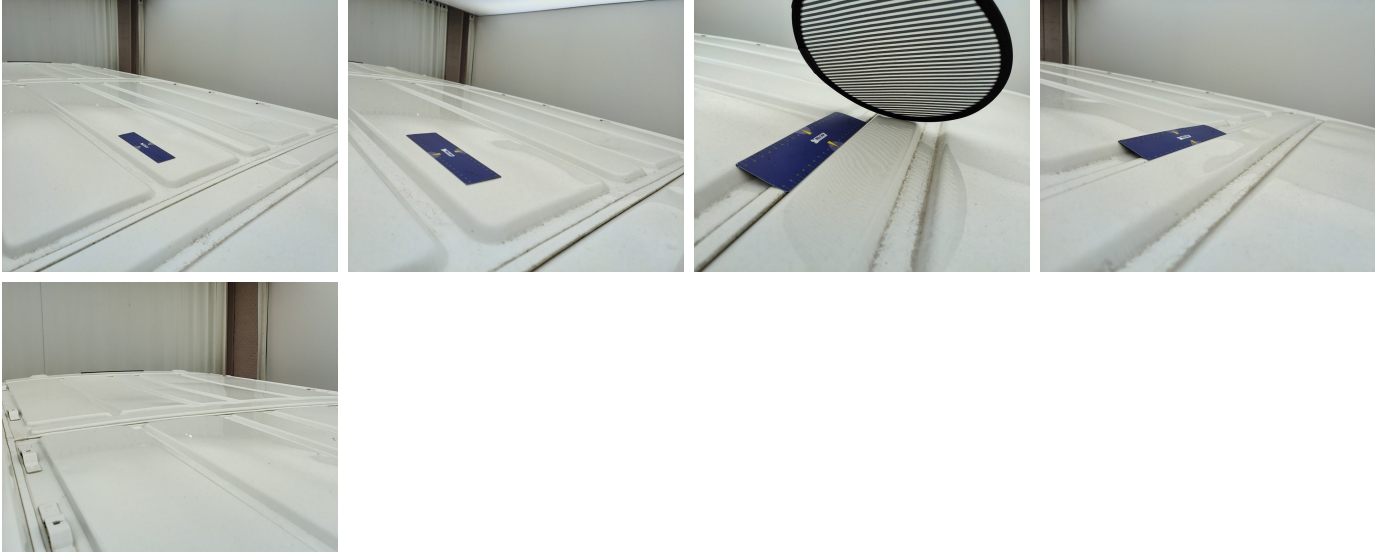
| Damages | Type | Acceptable |
|---|---|---|
| 163 | Roof // Repair & Painting | N |

Roof // Repair & Painting-dent

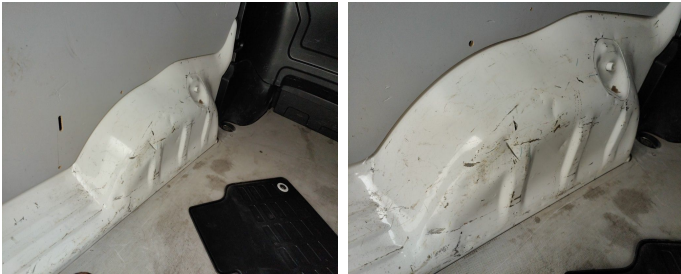
| Damages | Type | Acceptable |
|---|---|---|
| 540 | Interior // Repair 1 | Y |

Interior // Repair 1-scratch + dent

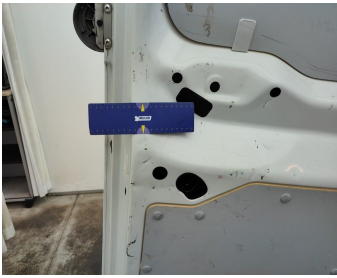
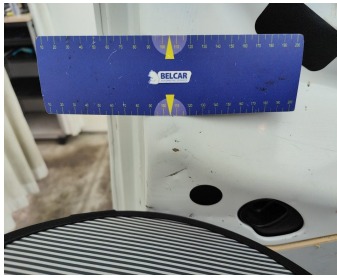
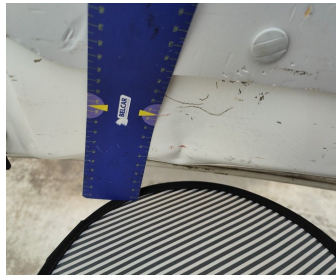
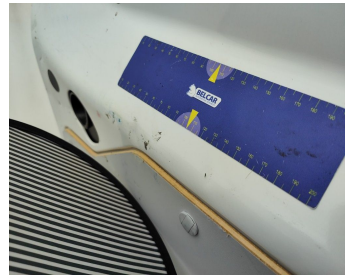
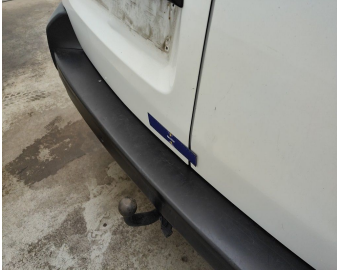
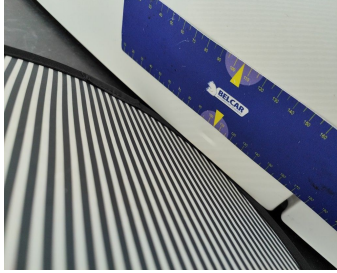
| Damages | Type | Acceptable |
|---|---|---|
| 294 | Rear Loading Door Left // Repair & Painting | Y |

Rear Loading Door Left // Repair & Painting-scratch + dent

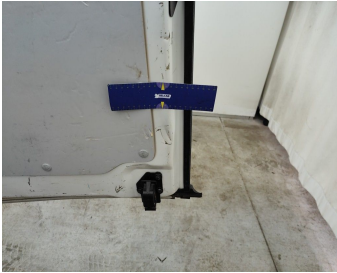
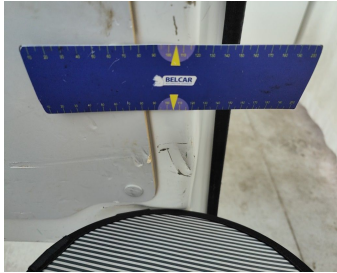
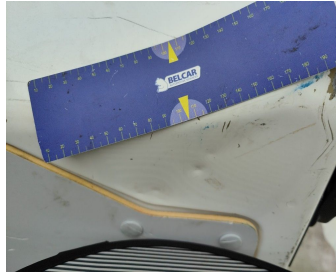
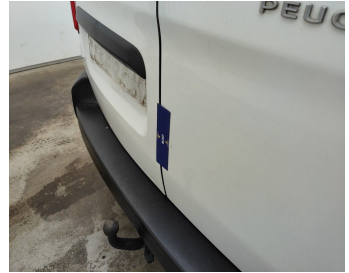
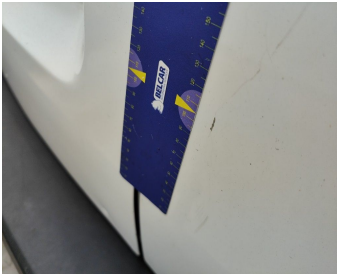
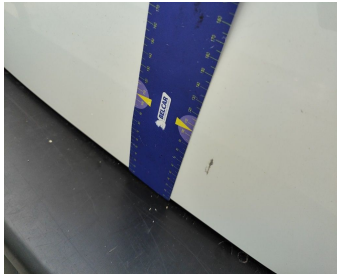
| Damages | Type | Acceptable |
|---|---|---|
| 304 | Rear Loading Door Right // Repair & Painting | Y |

Rear Loading Door Right // Repair & Painting-scratch + dent

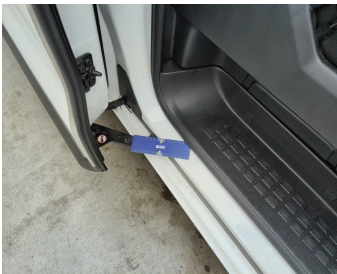
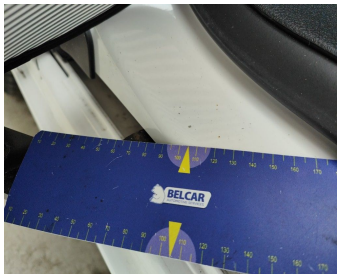
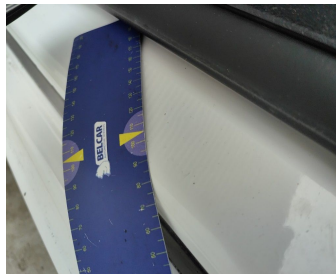
| Damages | Type | Acceptable |
|---|---|---|
| 201 | Rocker Panel Right // Smart Repair Medium | Y |

Rocker Panel Right // Smart Repair Medium-scratch + dent

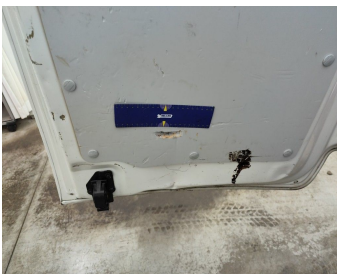
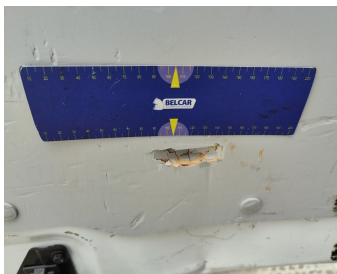
| Damages | Type | Acceptable |
|---|---|---|
| 592 | Trunk Lid Interior Coating / MDF Rear Left / Replace | N |

Trunk Lid Interior Coating / MDF Rear Left / Replace-cracked

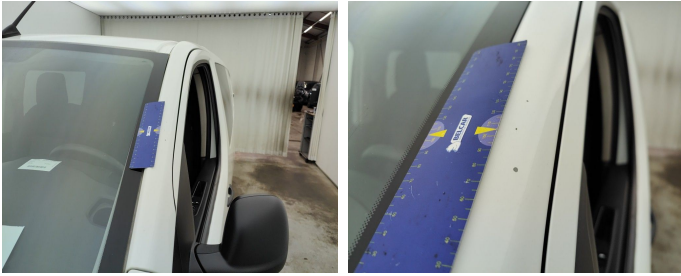
| Damages | Type | Acceptable |
|---|---|---|
| 161 | Roof // Smart Repair Medium | Y |

Roof // Smart Repair Medium-stone chipping

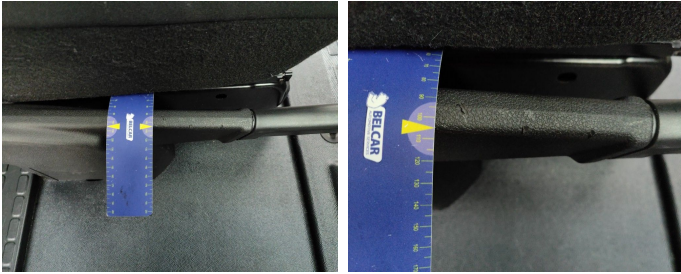
| Damages | Type | Acceptable |
|---|---|---|
| 557 | Central Console / Handbrake / Replace | Y |

Central Console / Handbrake / Replace-scratch

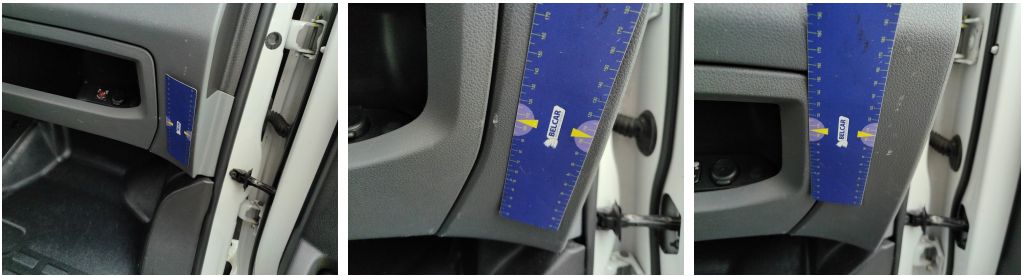
| Damages | Type | Acceptable |
|---|---|---|
| 561 | Dashboard // Repair | Y |

Dashboard // Repair-scratch

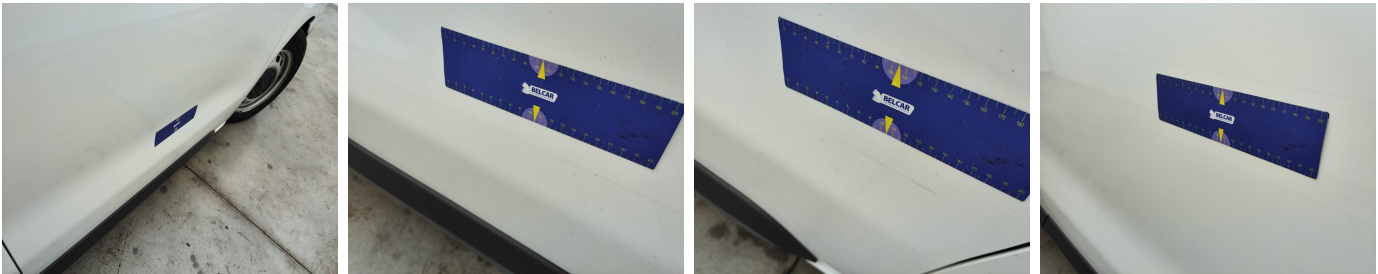
| Damages | Type | Acceptable |
|---|---|---|
| 216 | Door Front Right // Polish | Y |

Door Front Right // Polish-scratch

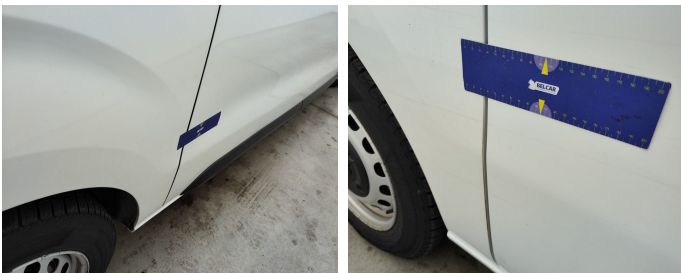
| Damages | Type | Acceptable |
|---|---|---|
| 196 | Door Rear Right // Polish | Y |

Door Rear Right // Polish-scratch

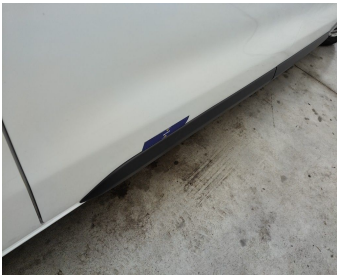
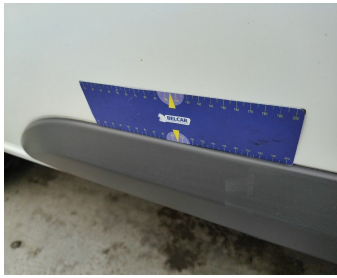
| Damages | Type | Acceptable |
|---|---|---|
| 197 | Door Rear Right / Trim / Replace | Y |

Door Rear Right / Trim / Replace-scratch

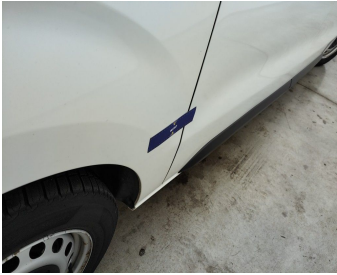
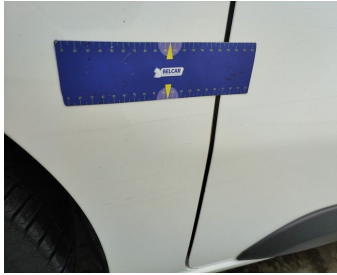
| Damages | Type | Acceptable |
|---|---|---|
| 186 | Wing Rear Right // Polish | Y |

Wing Rear Right // Polish-scratch

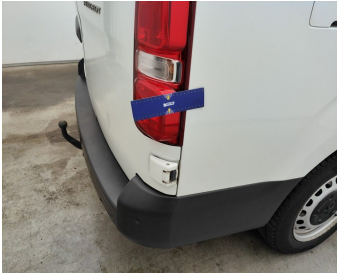
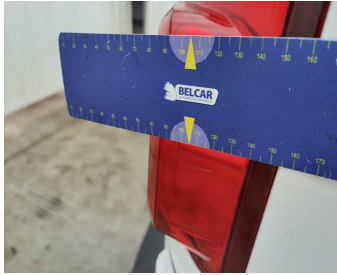
| Damages | Type | Acceptable |
|---|---|---|
| 174 | Light / Rear Right / Replace | Y |

Light / Rear Right / Replace-scratch

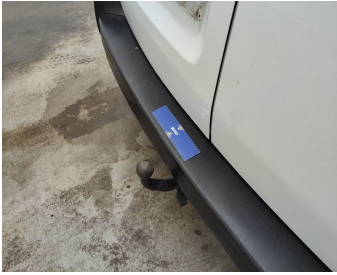
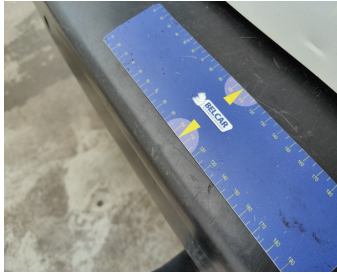
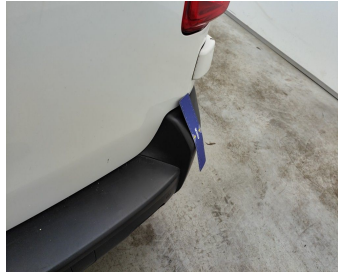
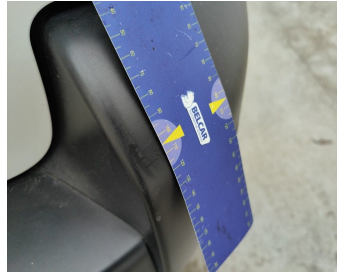
| Damages | Type | Acceptable |
|---|---|---|
| 137 | Bumper Rear // Replace without painting | Y |

Bumper Rear // Replace without painting-scratch

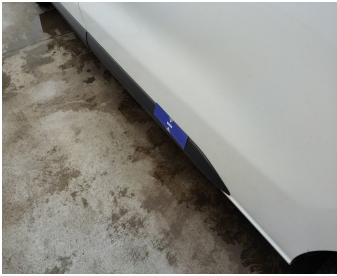
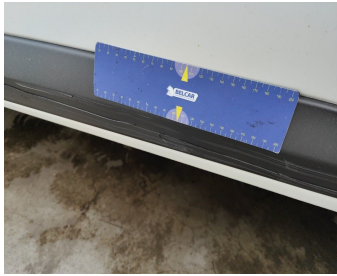
| Damages | Type | Acceptable |
|---|---|---|
| 117 | Wing Rear Left / Trim / Replace | N |

Wing Rear Left / Trim / Replace-scratch

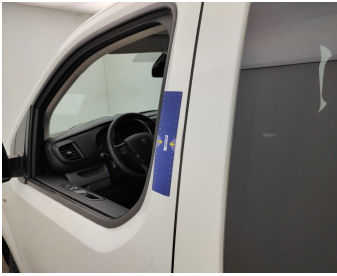
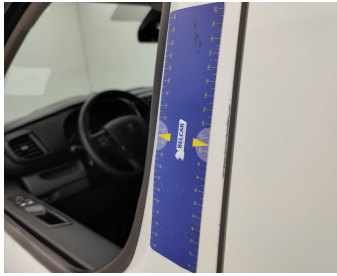
| Damages | Type | Acceptable |
|---|---|---|
| 81 | Door Front Left // Smart Repair Medium | Y |

Door Front Left // Smart Repair Medium-scratch

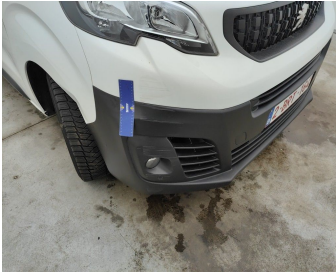
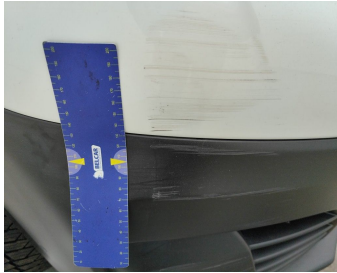
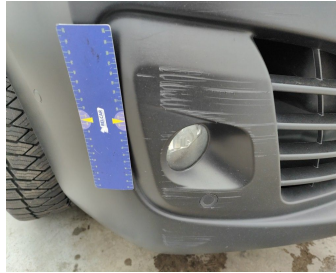
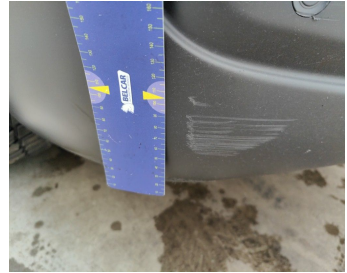
| Damages | Type | Acceptable |
|---|---|---|
| 17 | Bumper Front // Replace without painting | N |

Bumper Front // Replace without painting-scratch

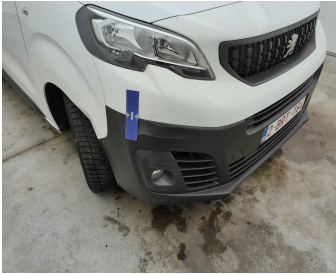
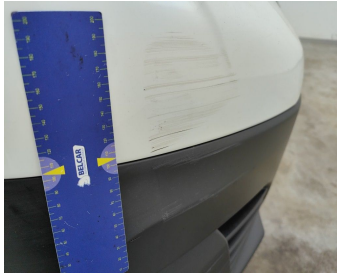
| Damages | Type | Acceptable |
|---|---|---|
| 12 | Bumper Front // Smart Repair Large | N |

Bumper Front // Smart Repair Large-scratch
