INSPECTION REPORT

End of contract

| License plate | 2ACD238 |
| Make | Skoda Oct.Com.2.0TDI 85kW Ambi |

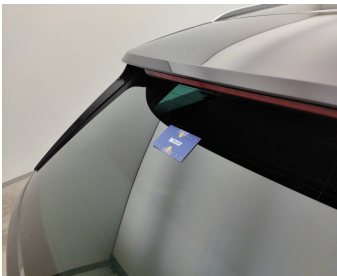
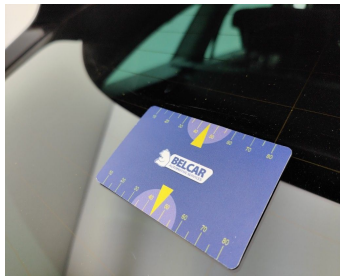
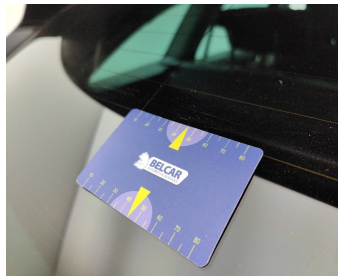
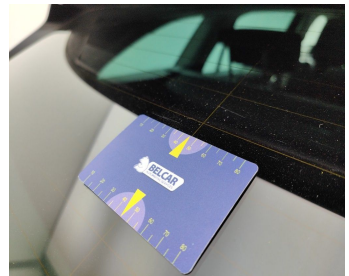
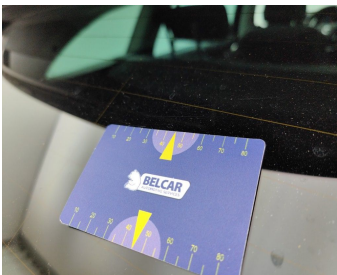
| Damages | Type | Acceptable |
|---|--|---|
| 159 | Rear Bonnet / Rear Window / Replace | Y |

Rear Bonnet / Rear Window / Replace-scratch

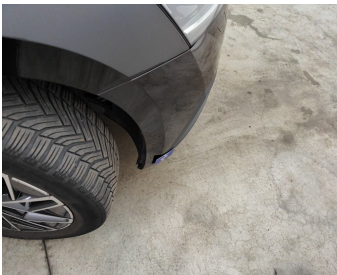
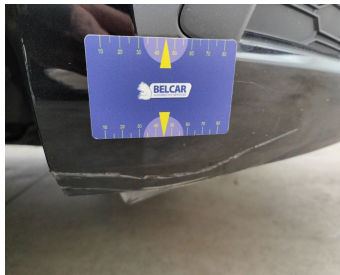
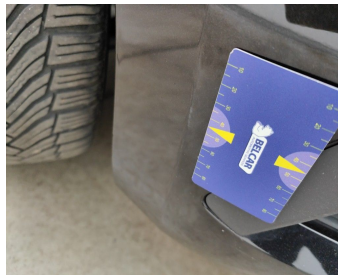
| Damages | Type | Acceptable |
|---|--|---|
| 12 | Bumper Front // Smart Repair Large | N |

Bumper Front // Smart Repair Large-scratch

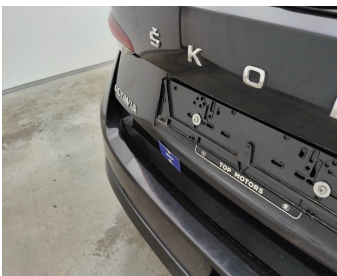
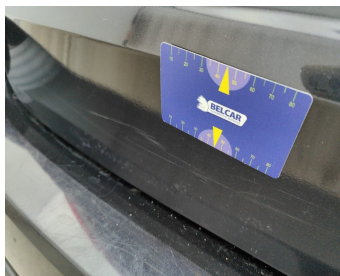
| Damages | Type | Acceptable |
|---|--|---|
| 156 | Rear Bonnet // Polish | Y |

Rear Bonnet // Polish-scratch

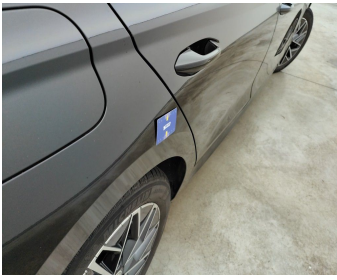
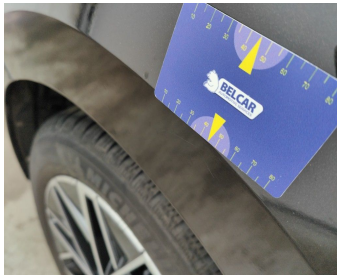
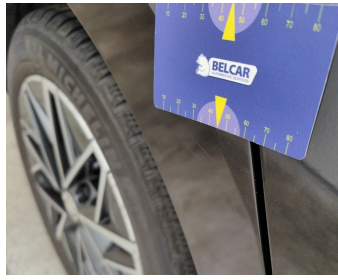
| Damages | Type | Acceptable |
|---|--|---|
| 186 | Wing Rear Right // Polish | Y |

Wing Rear Right // Polish-scratch

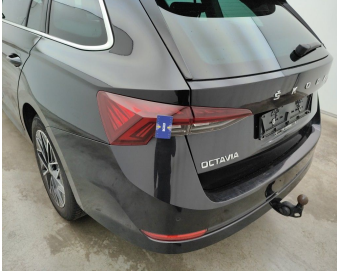
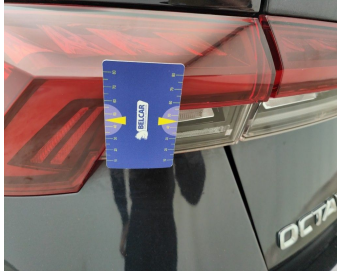
| Damages | Type | Acceptable |
|---|--|---|
| 124 | Light / Rear left / Replace | N |

Light / Rear left / Replace-cracked

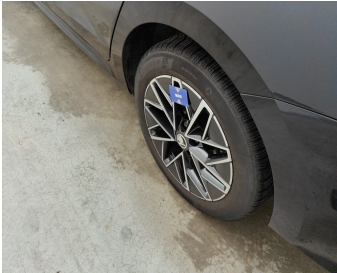
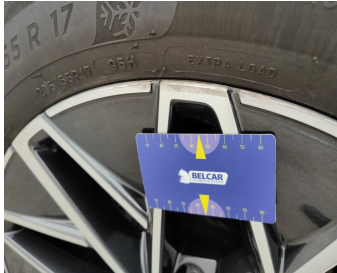
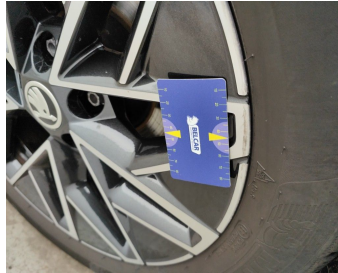
| Damages | Type | Acceptable |
|---|--|---|
| 320 | Wheel Two Tone Rear Left // Repair | Y |

Wheel Two Tone Rear Left // Repair-Chemical reaction

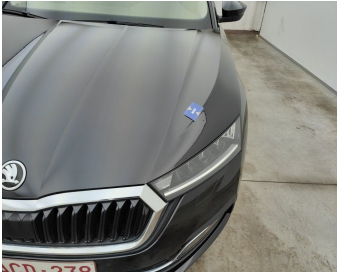
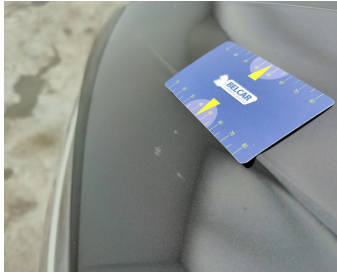
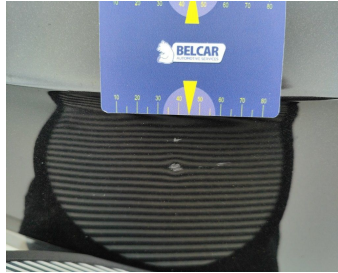
| Damages | Type | Acceptable |
|---|--|---|
| 32 | Front Bonnet // Painting | Y |

Front Bonnet // Painting-stone chipping

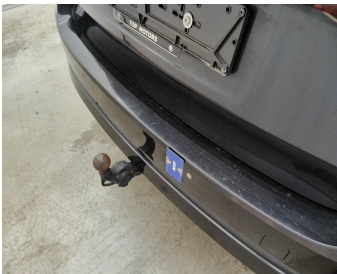
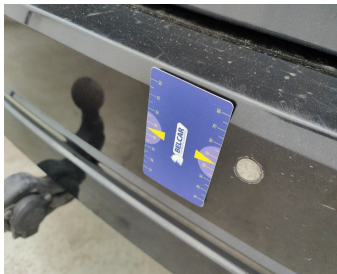
| Damages | Type | Acceptable |
|---|--|---|
| 149 | Back Side / Park Assist Sensor / Replace | N |

Back Side / Park Assist Sensor / Replace-Chipped paint
