# INSPECTION REPORT

**End of contract**

| License plate | 2ATV828 |
| Make | Hyundai Tuc.TGD <sup>i</sup> PHEV 195kW 4x |

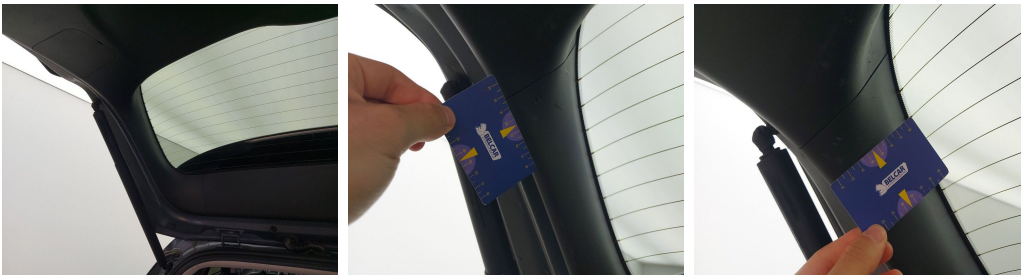
Trunk Compartment / Side Cover Left / Replace-scratch

| Damages | Type | Acceptable |
|---|---|---|
| 532 | Trunk Compartment / Side Cover Left / Replace | Y |

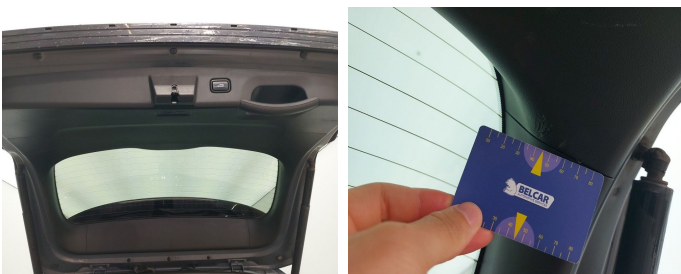
Trunk Lid Interior Coating / Complete Panel / Replace-scratch

| Damages | Type | Acceptable |
|---|---|---|
| 594 | Trunk Lid Interior Coating / Complete Panel / Replace | Y |

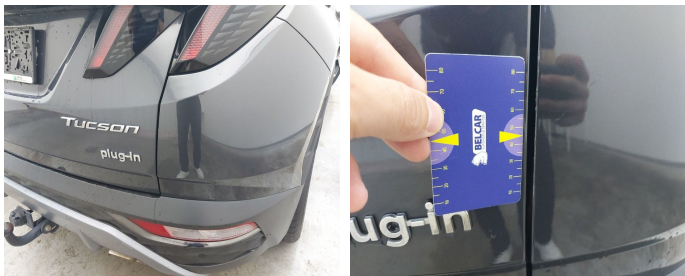
Bumper Rear // Smart Repair Small-scratch

| Damages | Type | Acceptable |
|---|---|---|
| 130 | Bumper Rear // Smart Repair Small | Y |

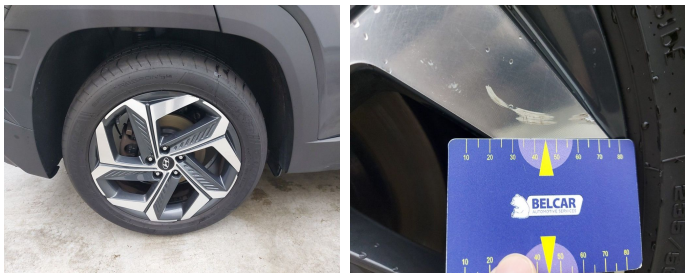
Wheel Two Tone Rear Right // Repair-scratch

| Damages | Type | Acceptable |
|---|---|---|
| 330 | Wheel Two Tone Rear Right // Repair | Y |

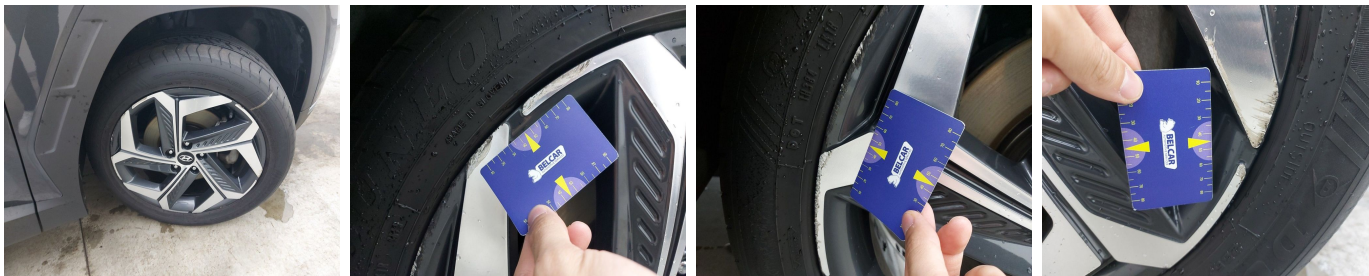
Wheel Two Tone Front Right // Repair-scratch

| Damages | Type | Acceptable |
|---|---|---|
| 340 | Wheel Two Tone Front Right // Repair | N |

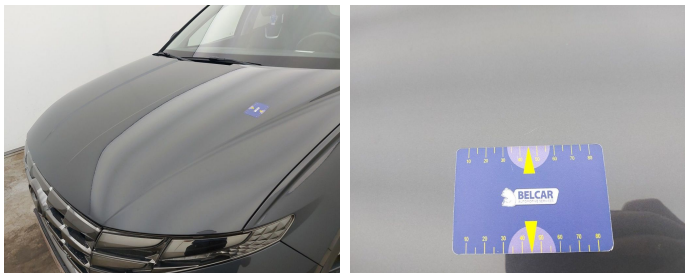
Front Bonnet // Painting-scratch

| Damages | Type | Acceptable |
|---|---|---|
| 32 | Front Bonnet // Painting | Y |

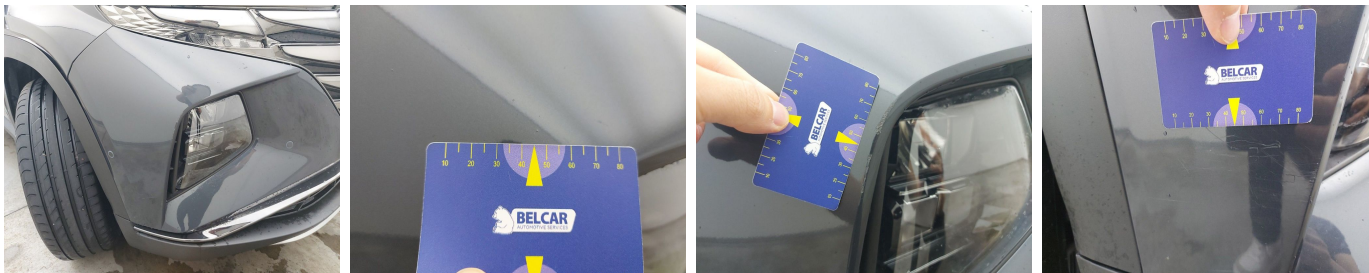
Bumper Front // Painting-scratch

| Damages | Type | Acceptable |
|---|---|---|
| 13 | Bumper Front // Painting | N |

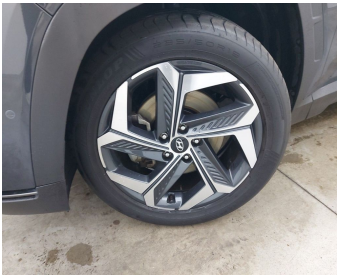
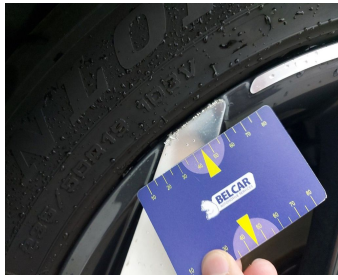
Wheel Two Tone Front Left // Repair-scratch

| Damages | Type | Acceptable |
|---|---|---|
| 310 | Wheel Two Tone Front Left // Repair | Y |

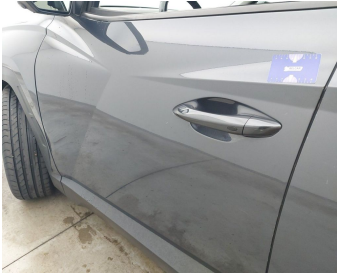
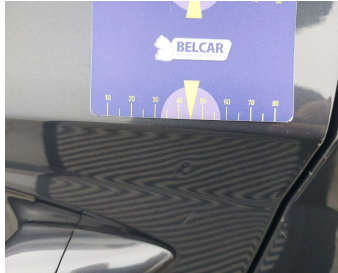
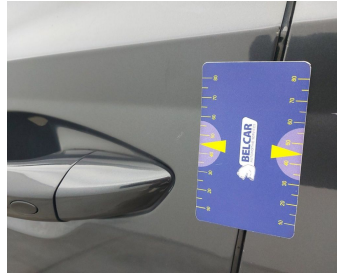
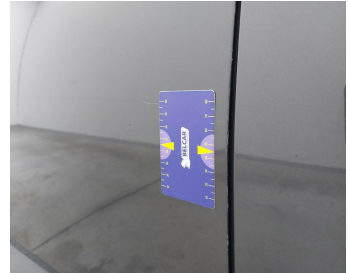
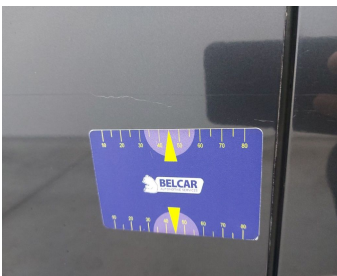
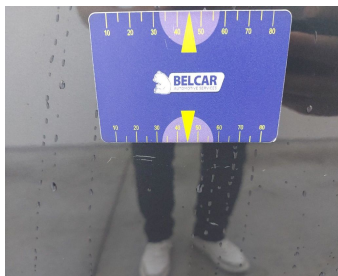
Door Front Left // Painting-scratch

| Damages | Type | Acceptable |
|---|---|---|
| 83 | Door Front Left // Painting | N |

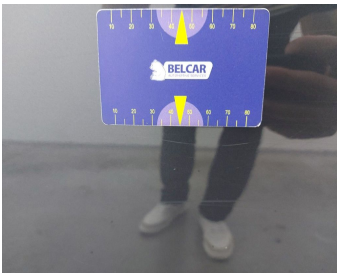
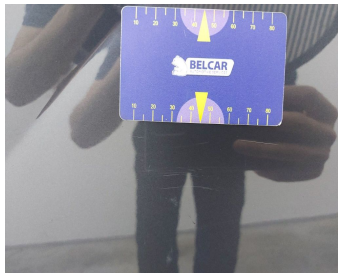
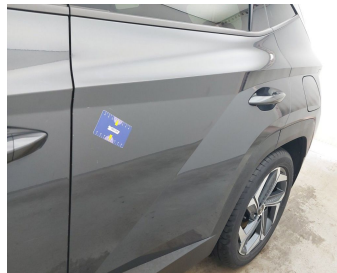
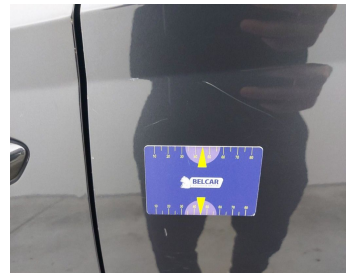
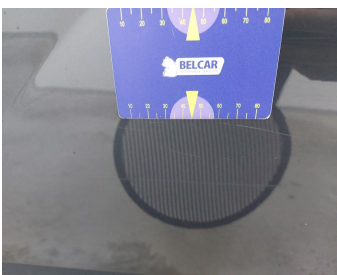
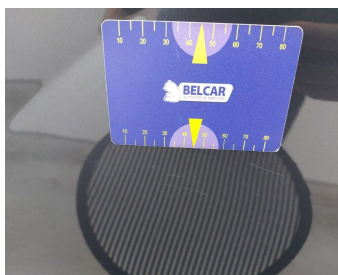
Door Rear Left // Painting-scratch

| Damages | Type | Acceptable |
|---|---|---|
| 103 | Door Rear Left // Painting | N |

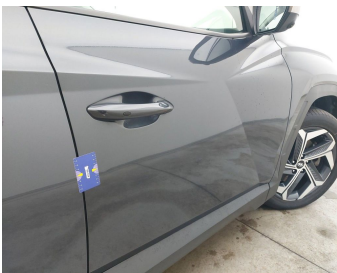
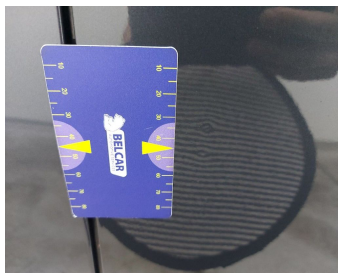
Door Front Right // Smart Repair Small-dent

| Damages | Type | Acceptable |
|---|---|---|
| 210 | Door Front Right // Smart Repair Small | Y |

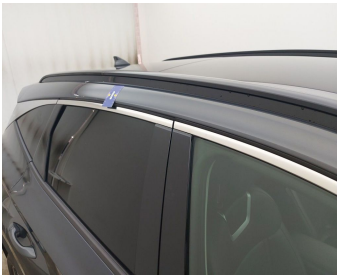
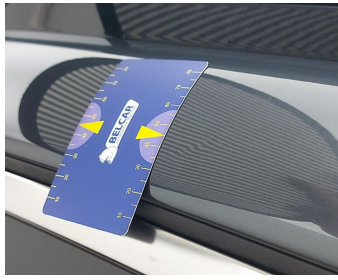
Roof // Smart Repair Medium-dent

| Damages | Type | Acceptable |
|---|---|---|
| 161 | Roof // Smart Repair Medium | Y |

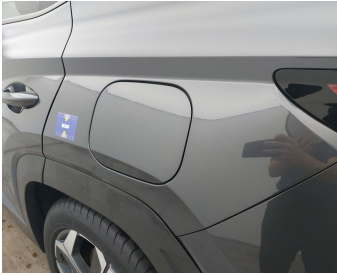
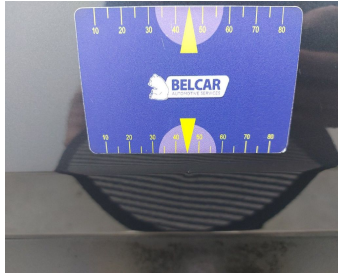
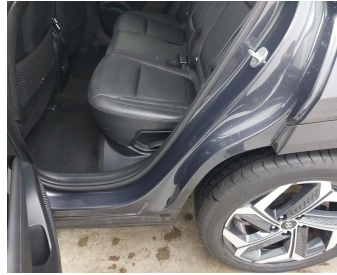
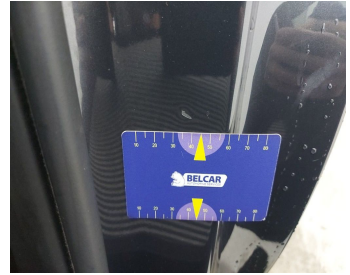
Wing Rear Left // Smart Repair Medium-scratch + dent

| Damages | Type | Acceptable |
|---|---|---|
| 111 | Wing Rear Left // Smart Repair Medium | N |

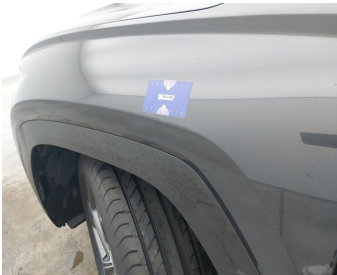
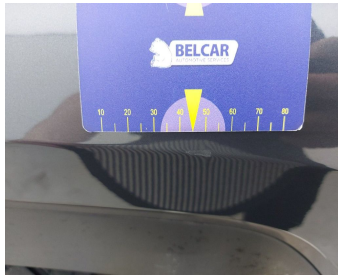
Wing Front Left // Smart Repair Medium-scratch + dent

| Damages | Type | Acceptable |
|---|---|---|
| 61 | Wing Front Left // Smart Repair Medium | N |

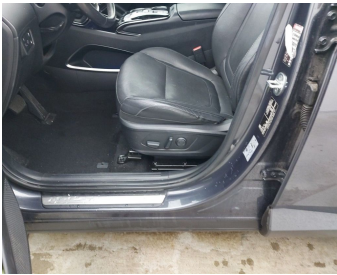
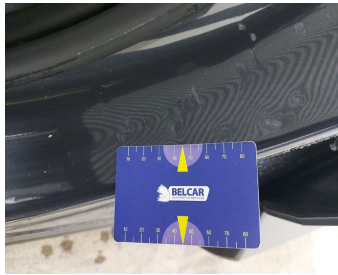
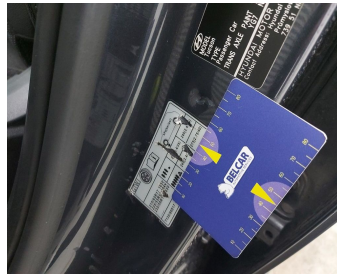
Rocker Panel Left // Smart Repair Medium-scratch + dent

| Damages | Type | Acceptable |
|---|---|---|
| 91 | Rocker Panel Left // Smart Repair Medium | N |

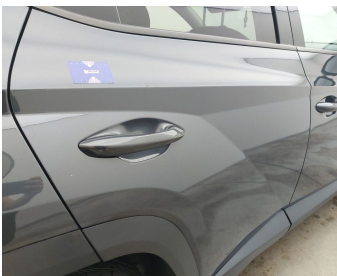
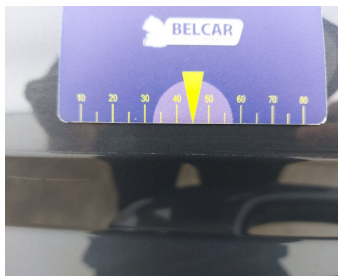
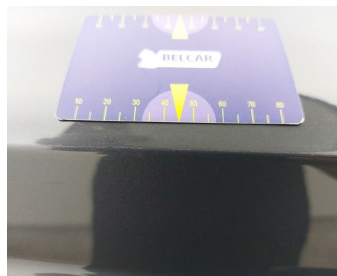
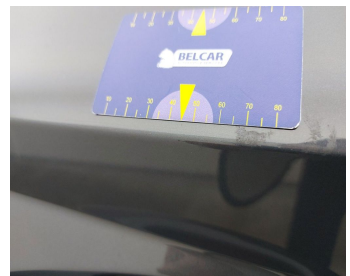
Door Rear Right // Painting-bad repair

| Damages | Type | Acceptable |
|---|---|---|
| 193 | Door Rear Right // Painting | N |

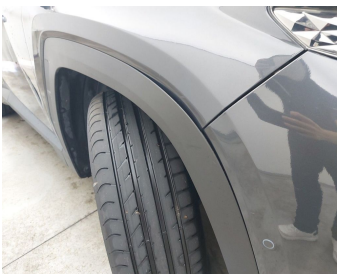
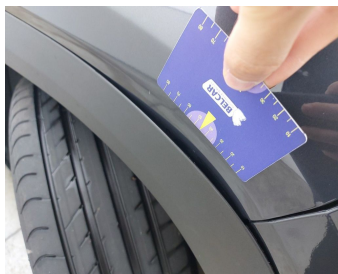
Wing Front right / Trim / Replace-worn

| Damages | Type | Acceptable |
|---|---|---|
| 237 | Wing Front right / Trim / Replace | Y |
