INSPECTION REPORT

End of contract

File	303731
License plate	2BEE527
Vehicle identification number	W1K1771101J334758
Dossier	2021090080
Make	Mercedes A Berline 180 d Bus.S
Mileage	94206
First registration	19/10/2021
client availability date	26/01/2026
inspectionDate	26/02/2026

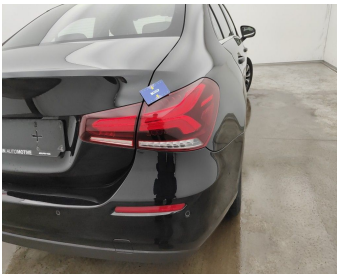
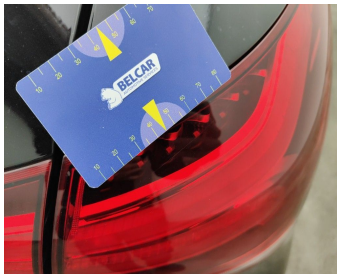
Light / Rear Right / Replace-scratch

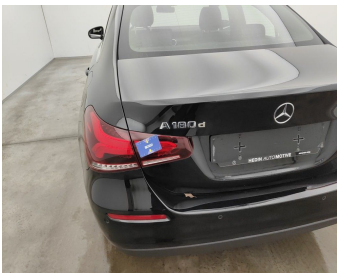
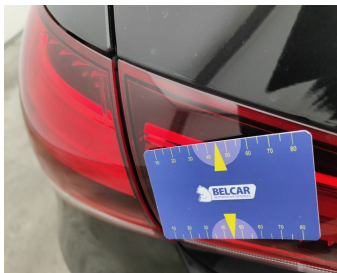
Light / Rear Left On Rear Bonnet / Replace-scratch

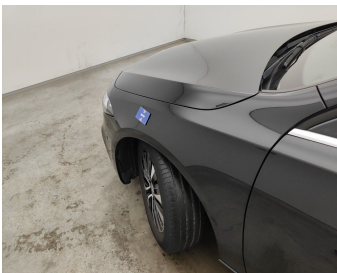
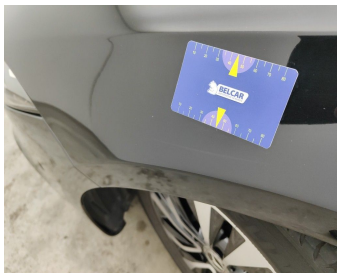
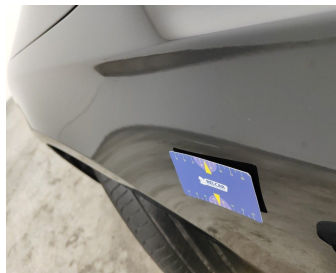
Wing Front Left // Polish-scratch

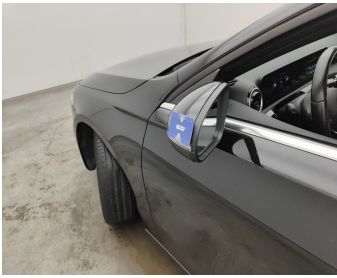
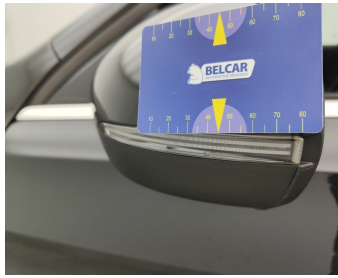
Side View Mirror Left / Direction Indicator / Replace-scratch

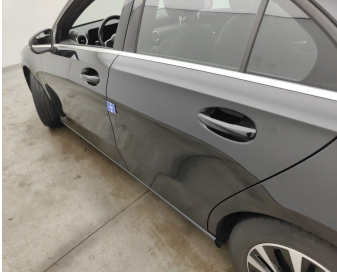
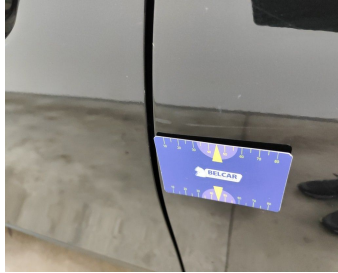
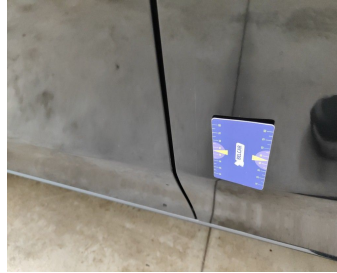
Door Rear Left // Polish-scratch

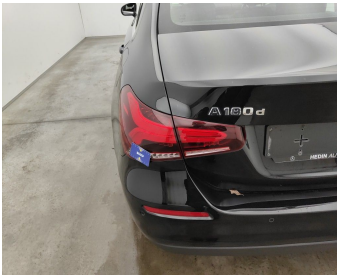
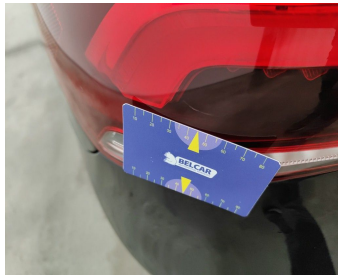
Light / Rear left / Replace-scratch

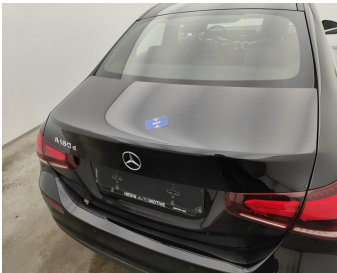
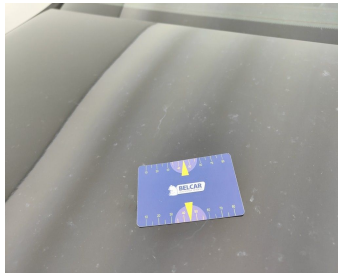
Rear Bonnet // Polish-scratch

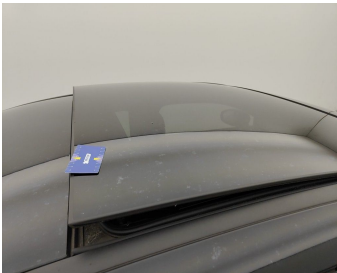
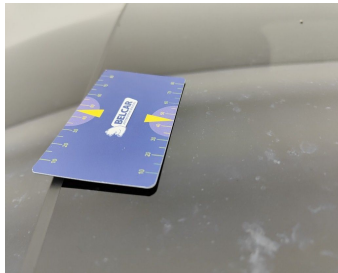
Roof / Full Panoramic Roof Medium / Replace-scratch

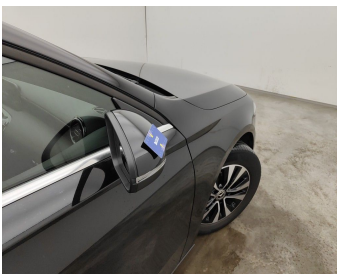
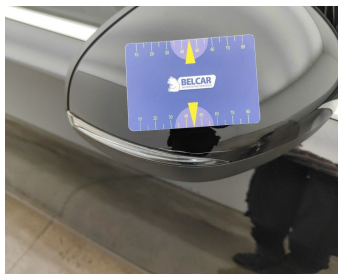
Side View Mirror Right // Painting-scratch

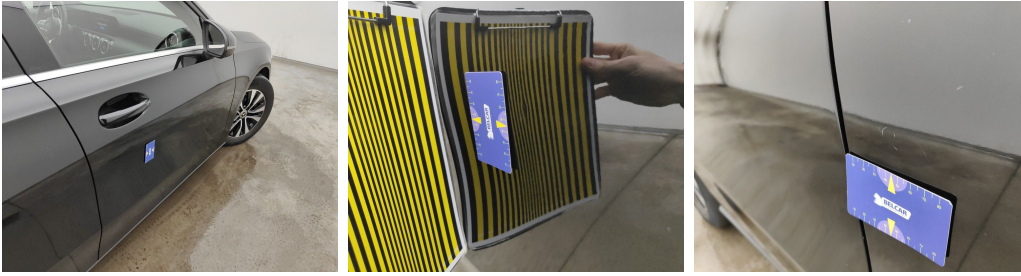
Door Front Right // Smart Repair Medium-scratch + dent

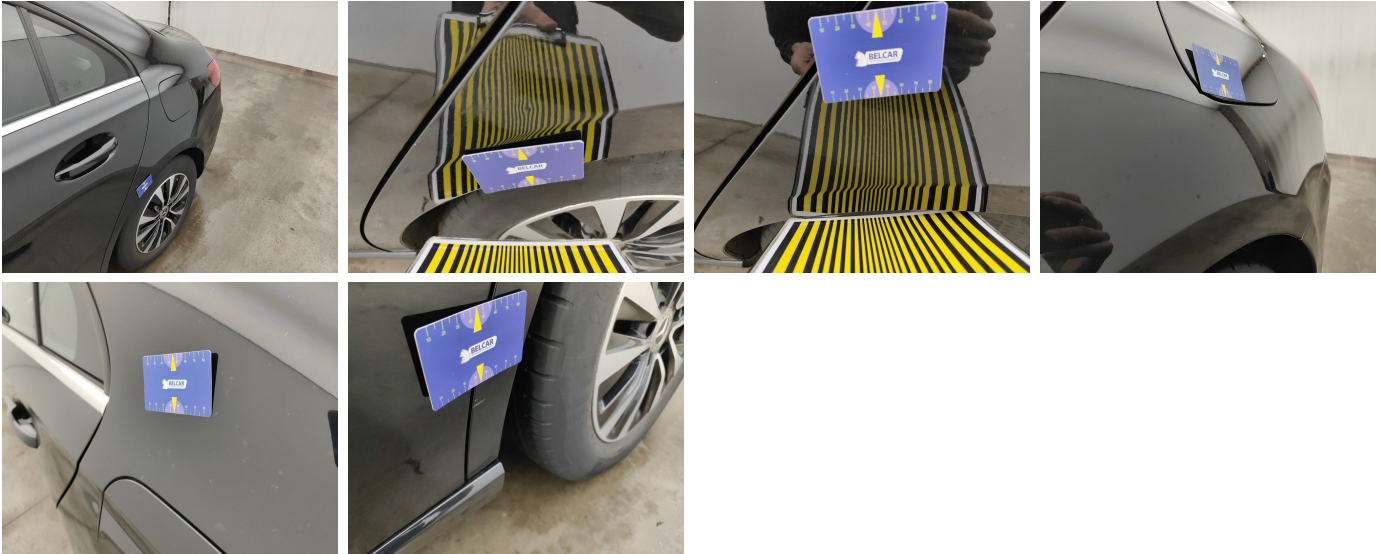
Wing Rear Left // Painting-bad repair

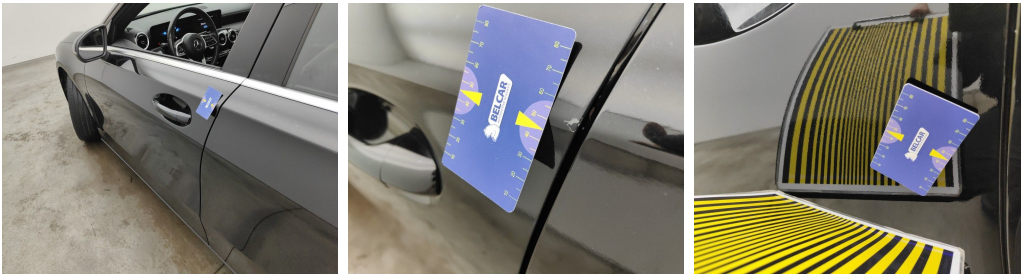
Door Front Left // Painting-bad repair

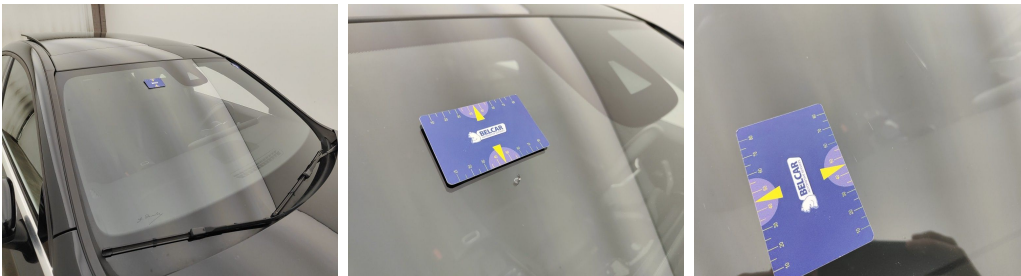
Windshield // Repair-cracked

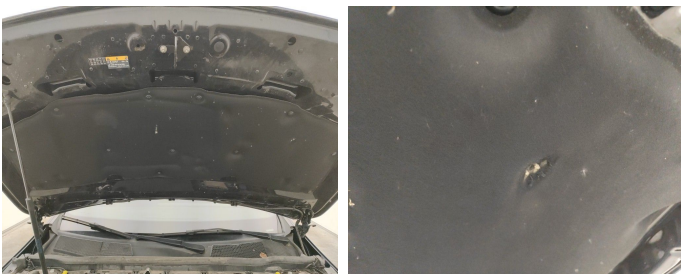
Front Bonnet / Insulation / Replace-cracked

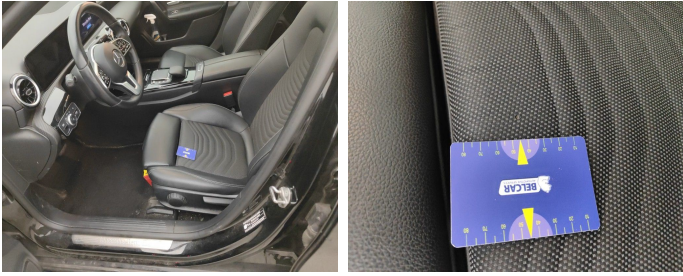
Seat Front Left / Bottom Coating / Replace-Incinerated

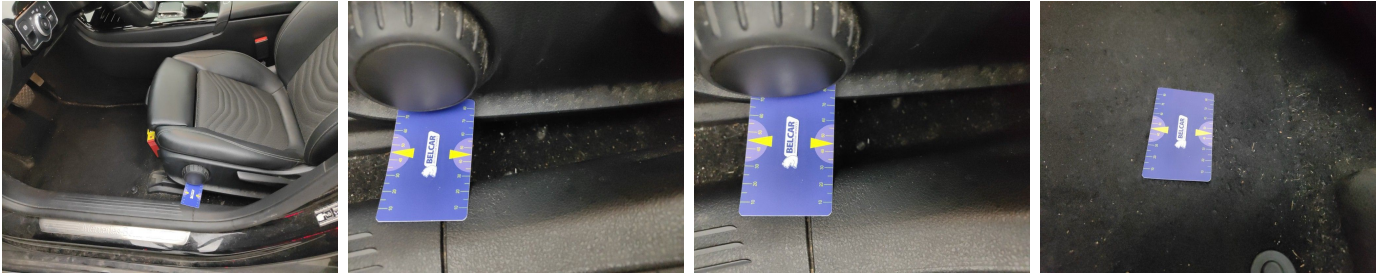
Interior // Repair 2-Incinerated

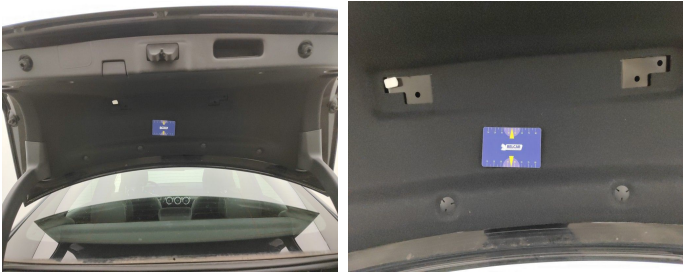
Interior // Repair 1-missing

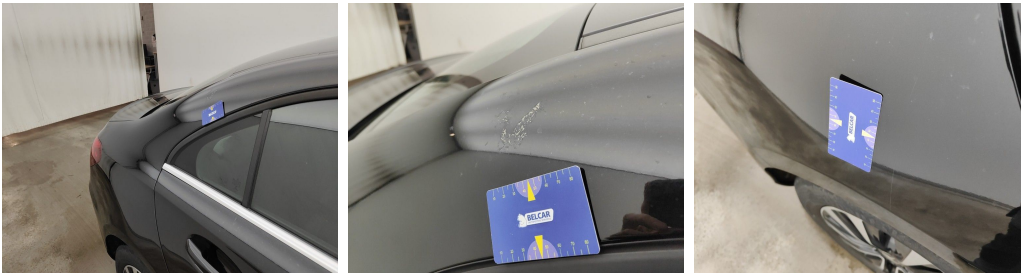
Wing Rear Right // Painting-Chemical reaction

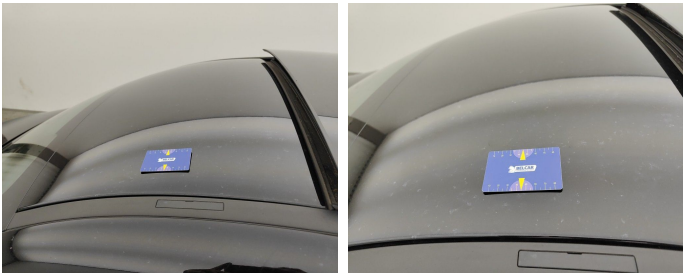
Roof // Polish-Chemical reaction

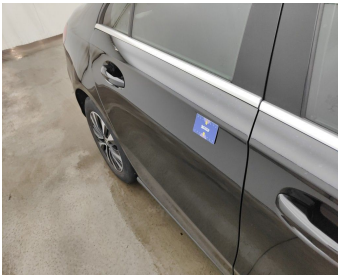
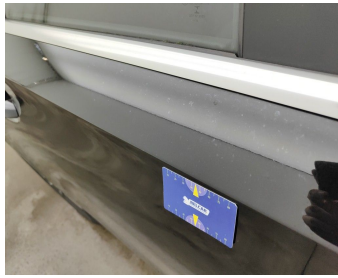
Door Rear Right // Polish-Chemical reaction

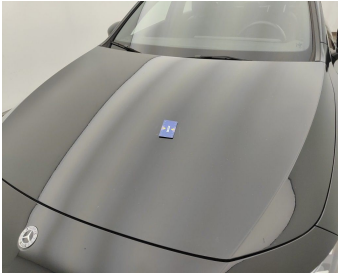
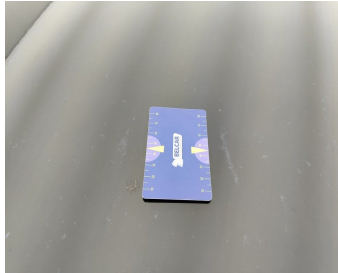
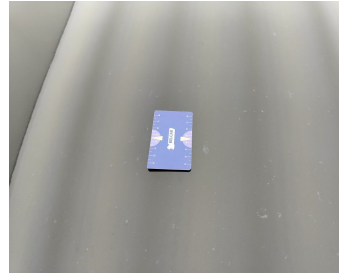
Front Bonnet // Polish-Chemical reaction

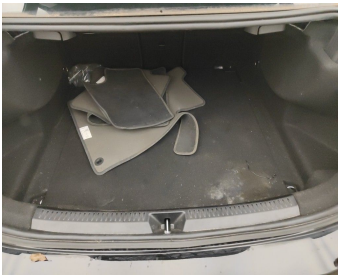
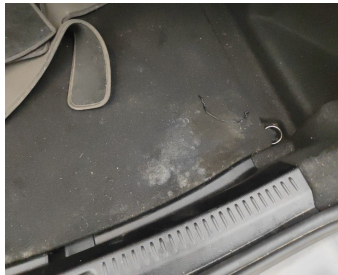
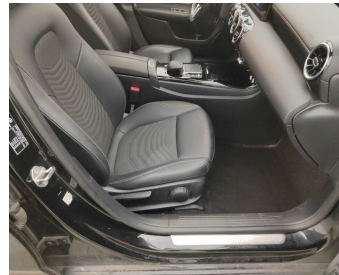
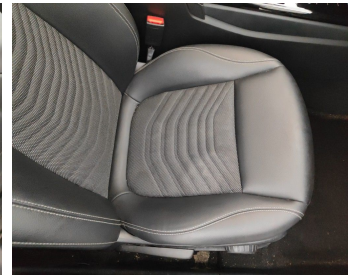
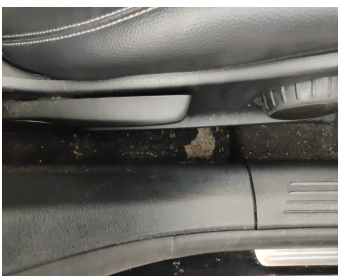
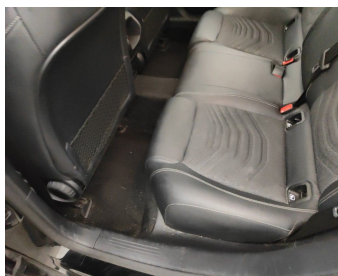
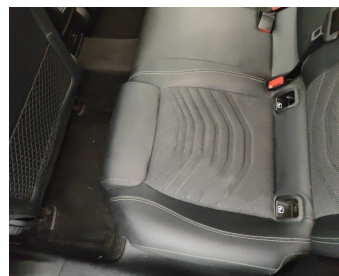
Interior Cleaning // Small-stain

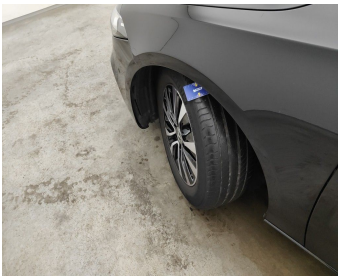
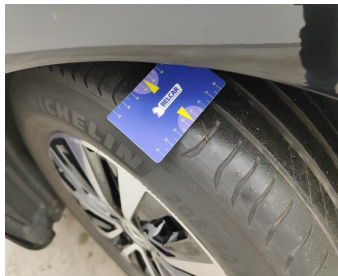
Tyre Front Left // Replace-worn

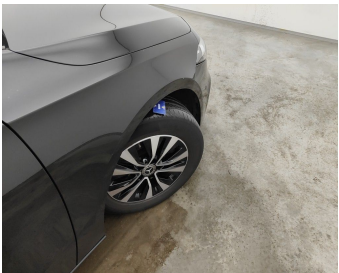
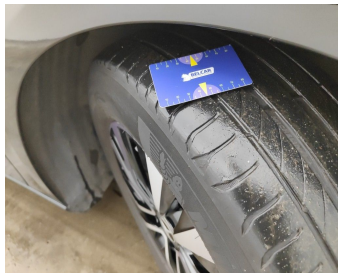
Tyre Front Right // Replace-worn

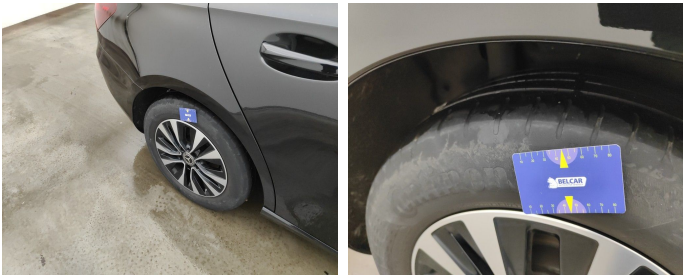
Tyre Rear Right // Replace-hole
