# INSPECTION REPORT

End of contract

| License plate | 2HJH377 |
| Make | Hyundai i30 1.0T-GDI 73kW Twis |

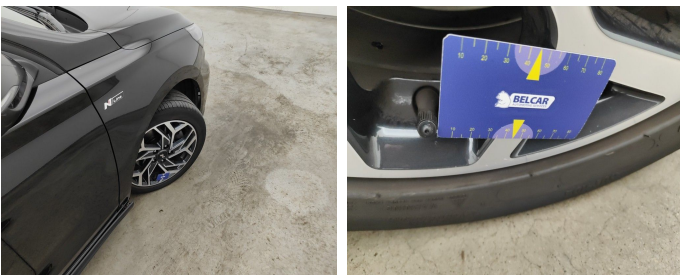
| Damages | Type | Acceptable |
|---|---|---|
| 340 | Wheel Two Tone Front Right // Repair | Y |

Wheel Two Tone Front Right // Repair-scratch

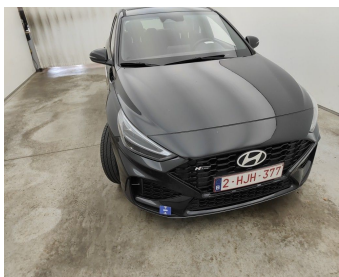
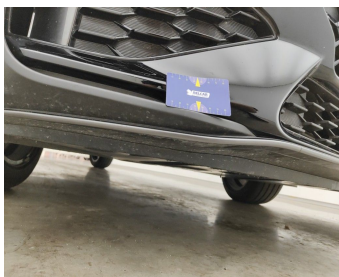
| Damages | Type | Acceptable |
|---|---|---|
| 272 | Bumper Front / Trim Right / Replace | N |

Bumper Front / Trim Right / Replace-scratch

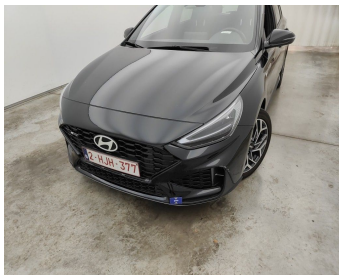
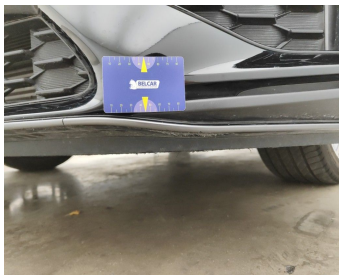
| Damages | Type | Acceptable |
|---|---|---|
| 271 | Bumper Front / Trim Left / Replace | N |

Bumper Front / Trim Left / Replace-scratch

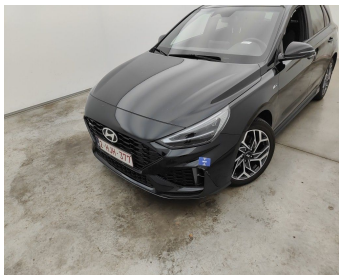
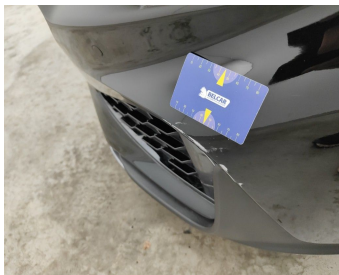
| Damages | Type | Acceptable |
|---|---|---|
| 13 | Bumper Front // Painting | N |

Bumper Front // Painting-scratch

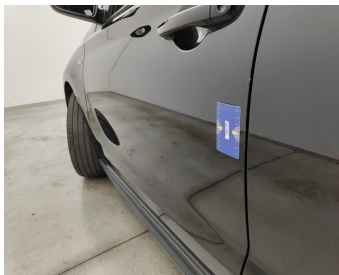
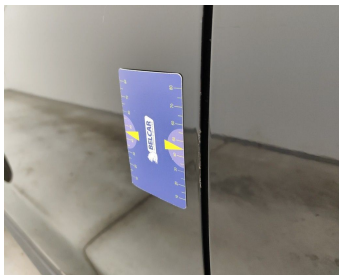
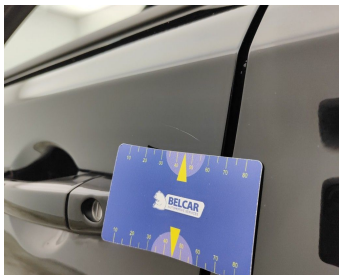
| Damages | Type | Acceptable |
|---|---|---|
| 81 | Door Front Left // Smart Repair Medium | Y |

Door Front Left // Smart Repair Medium-scratch

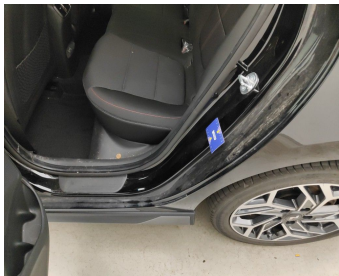
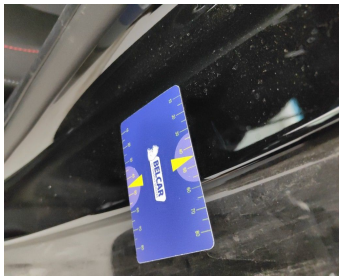
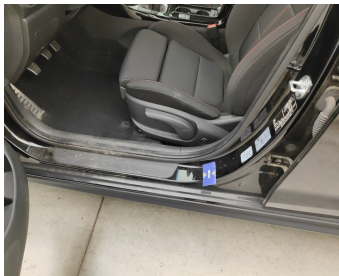
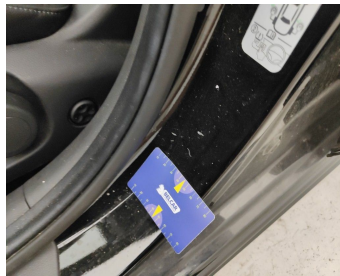
| Damages | Type | Acceptable |
|---|---|---|
| 92 | Rocker Panel Left // Painting | Y |

Rocker Panel Left // Painting-scratch

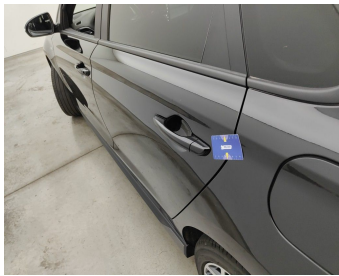
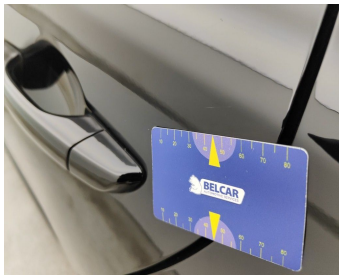
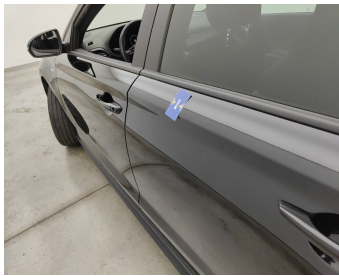
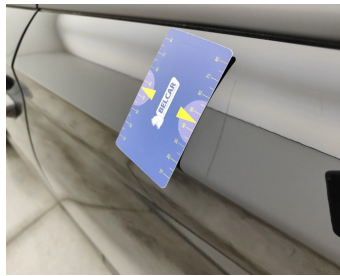
| Damages | Type | Acceptable |
|---|---|---|
| 106 | Door Rear Left // Polish | Y |

Door Rear Left // Polish-scratch

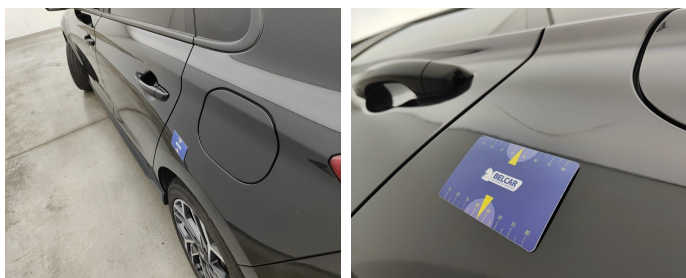
| Damages | Type | Acceptable |
|---|---|---|
| 116 | Wing Rear Left // Polish | Y |

Wing Rear Left // Polish-scratch

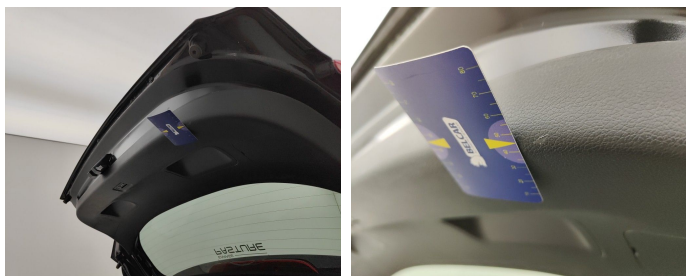
| Damages | Type | Acceptable |
|---|---|---|
| 594 | Trunk Lid Interior Coating / Complete Panel / Replace | Y |

Trunk Lid Interior Coating / Complete Panel / Replace-scratch

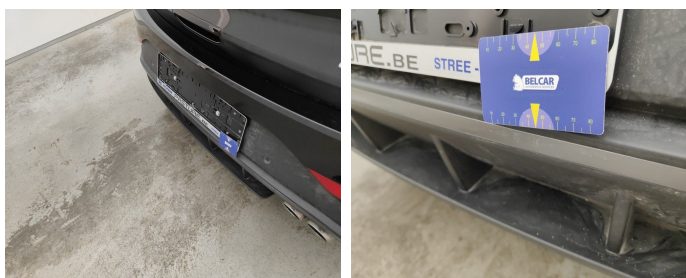
| Damages | Type | Acceptable |
|---|---|---|
| 138 | Bumper Rear / Lower Cover Not Painted / Replace | Y |

Bumper Rear / Lower Cover Not Painted / Replace-scratch

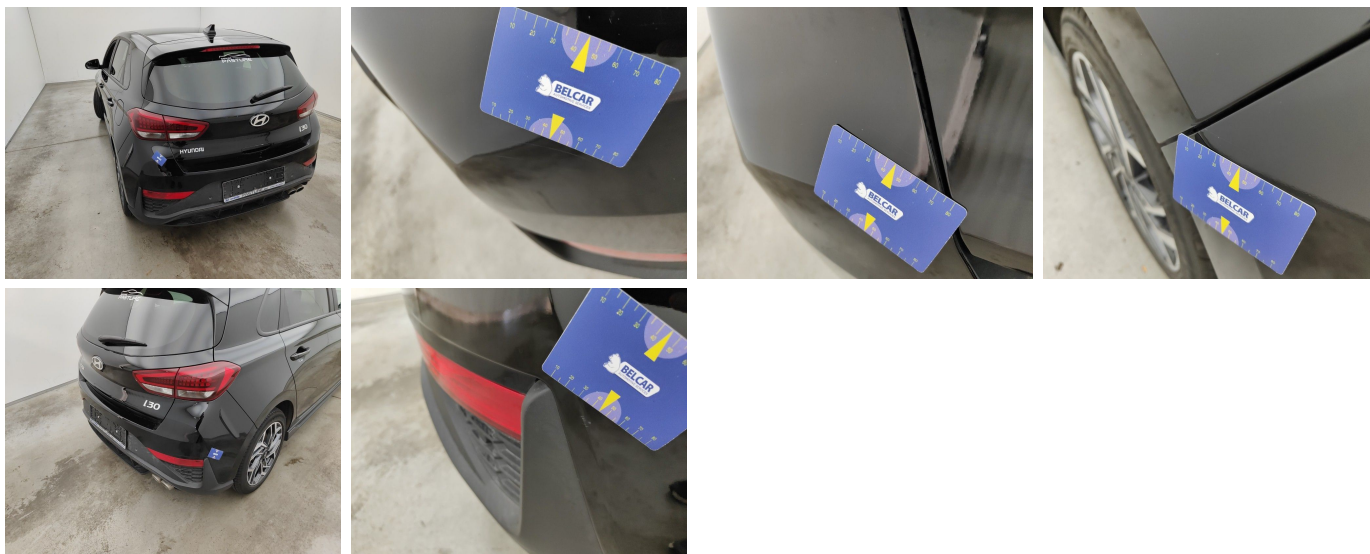
| Damages | Type | Acceptable |
|---|---|---|
| 136 | Bumper Rear // Polish | Y |

Bumper Rear // Polish-scratch

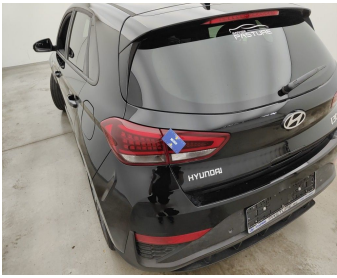
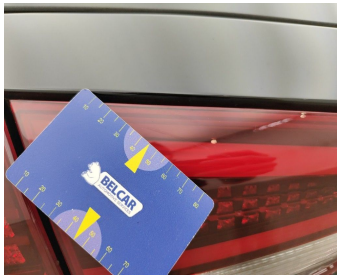
| Damages | Type | Acceptable |
|---|---|---|
| 125 | Light / Rear Left On Rear Bonnet / Replace | Y |

Light / Rear Left On Rear Bonnet / Replace-scratch

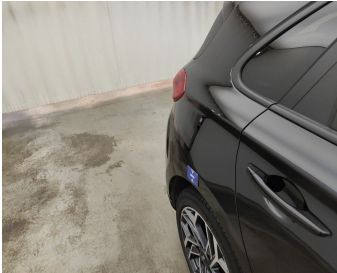
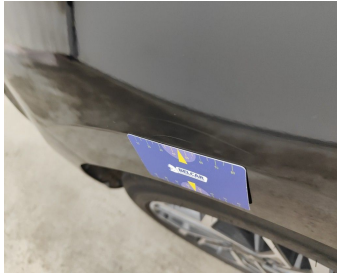
| Damages | Type | Acceptable |
|---|---|---|
| 186 | Wing Rear Right // Polish | Y |

Wing Rear Right // Polish-scratch

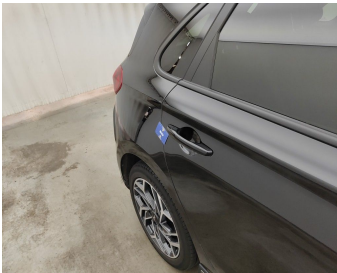
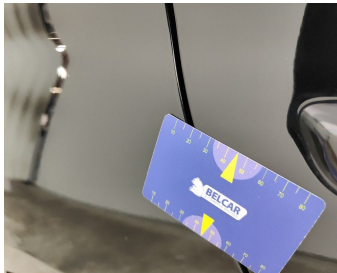
| Damages | Type | Acceptable |
|---|---|---|
| 196 | Door Rear Right // Polish | Y |

Door Rear Right // Polish-scratch

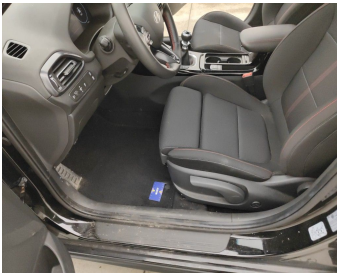
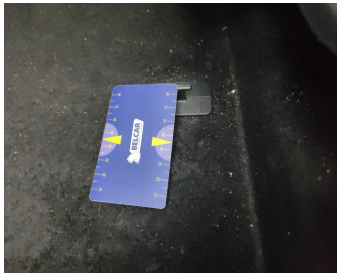
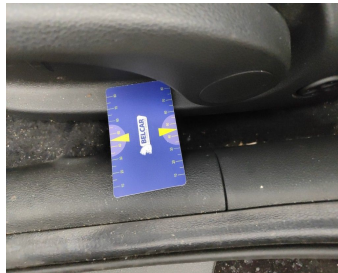
| Damages | Type | Acceptable |
|---|---|---|
| 540 | Interior // Repair 1 | N |

Interior // Repair 1-Incinerated

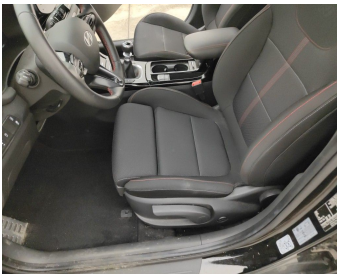
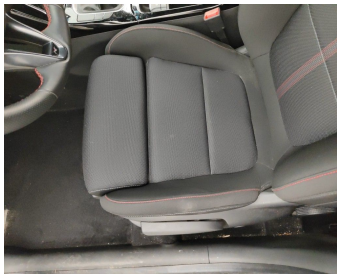
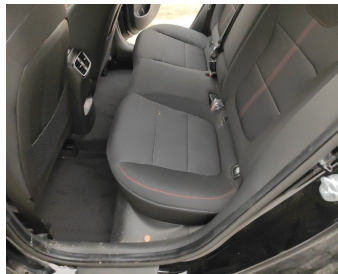
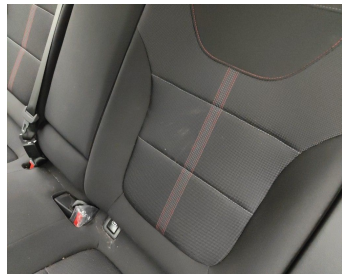
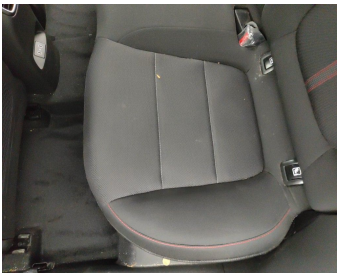
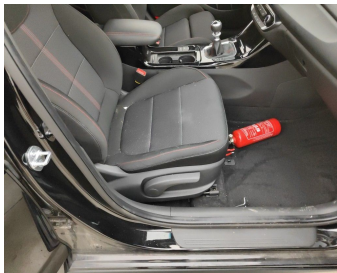
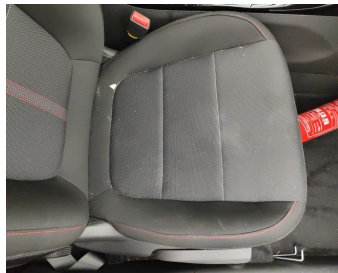
| Damages | Type | Acceptable |
|---|---|---|
| 860 | Interior Cleaning // Small | N |

Interior Cleaning // Small-stain

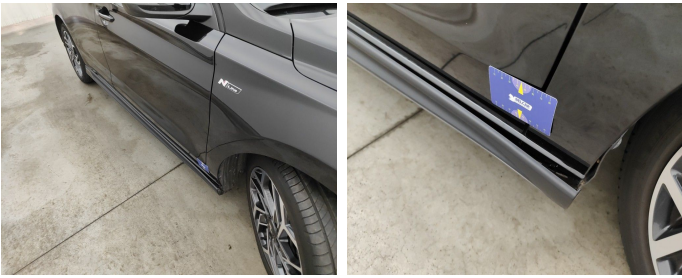
| Damages | Type | Acceptable |
|---|---|---|
| 208 | Rocker Panel Right / Cover Not Painted / Replace | Y |

Rocker Panel Right / Cover Not Painted / Replace-bad position
