INSPECTION REPORT

End of contract

File	304070
License plate	1XGG879
Vehicle identification number	WDB9066331P635450
Dossier	2019 255 072
Make	Mercedes Spr.314CDi A2H2 3.5T
Mileage	139170
First registration	23/12/2019
client availability date	20/02/2026
inspectionDate	16/03/2026

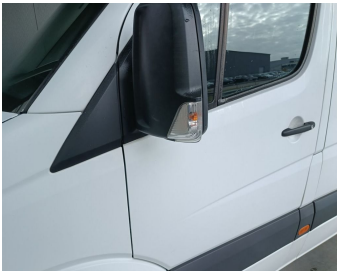
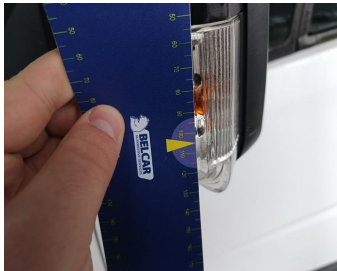
Side View Mirror Left / Direction Indicator / Replace-scratch

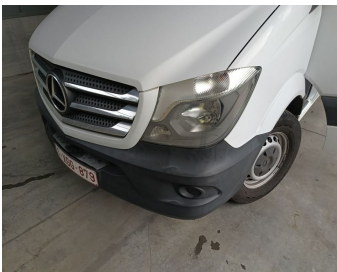
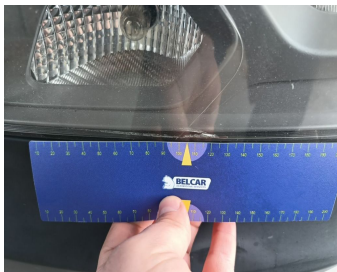
Headlight / Front left / Repair-scratch

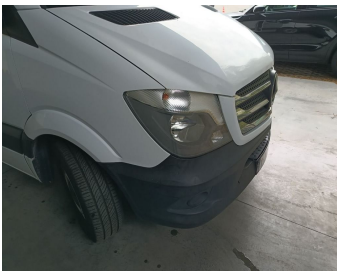
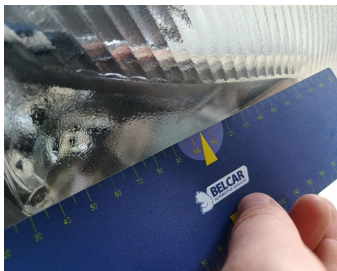
Headlight / Front Right/ Repair-scratch

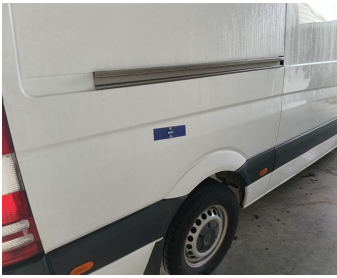
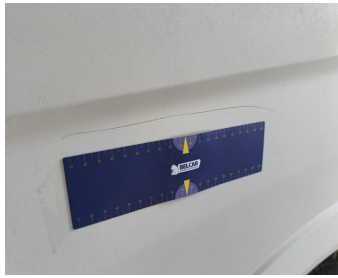
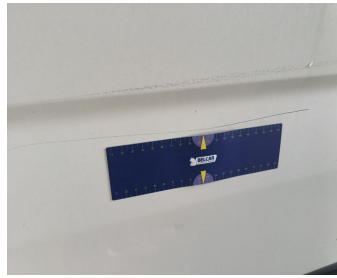
Wing Rear Right // Painting-scratch

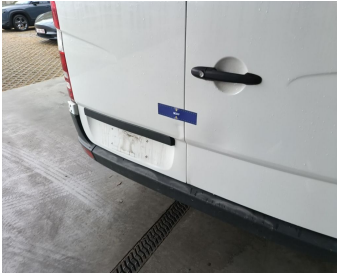
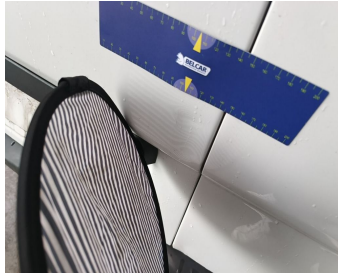
Rear Loading Door Left // Repair & Painting-dent

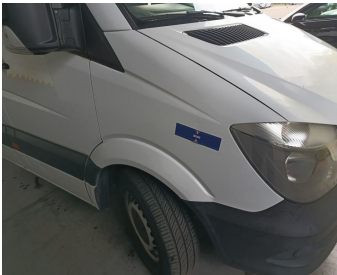
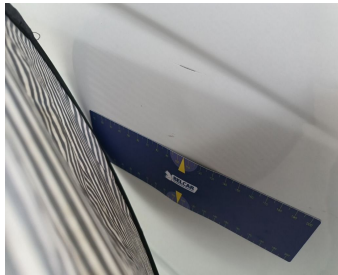
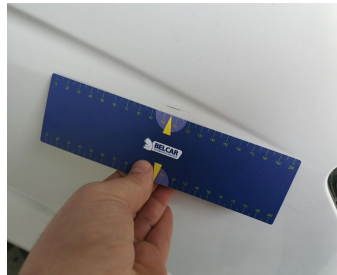
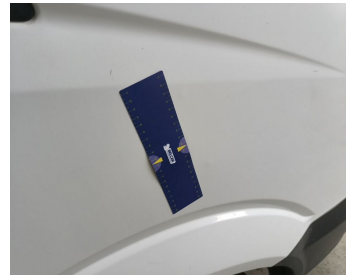
Wing Front right // Repair & Painting-scratch + dent

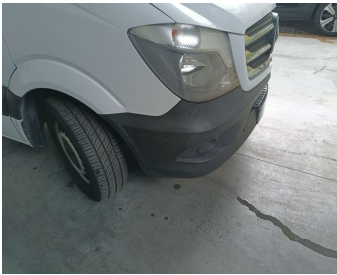
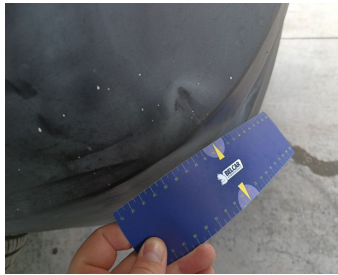
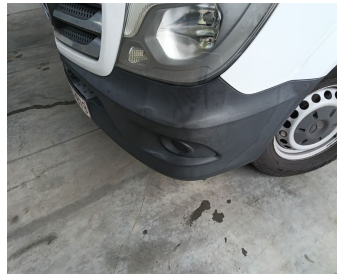
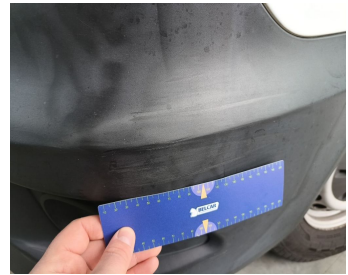
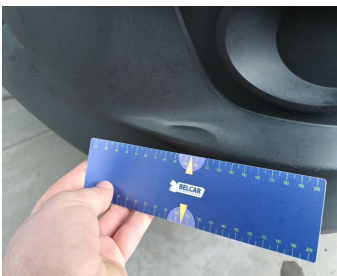
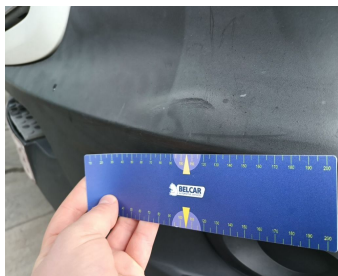
Bumper Front // Replace without painting-scratch + dent

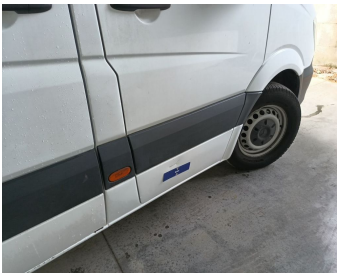
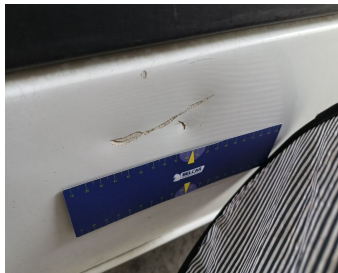
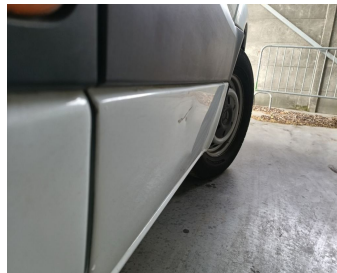
Door Front Right // Repair & Painting-scratch + dent

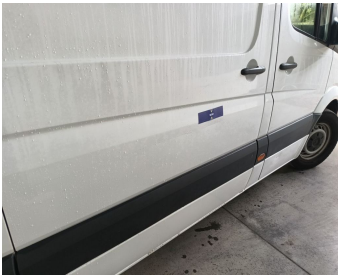
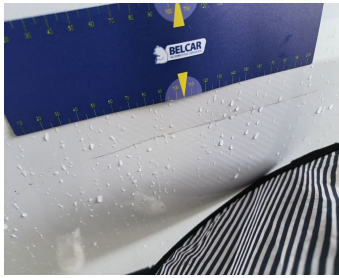
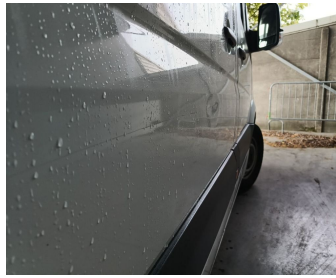
Door Rear Right // Repair & Painting-scratch + dent

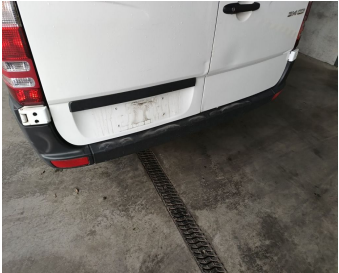
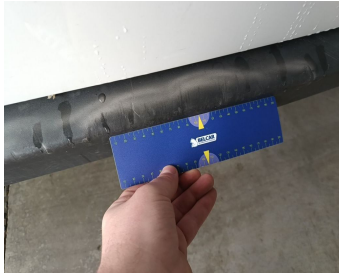
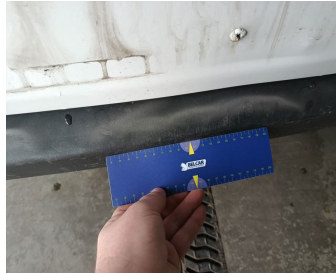
Bumper Rear // Replace without painting-scratch + dent

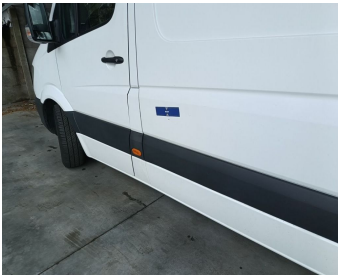
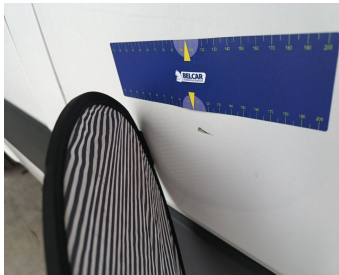
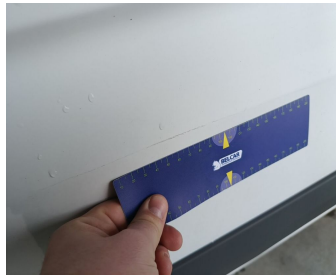
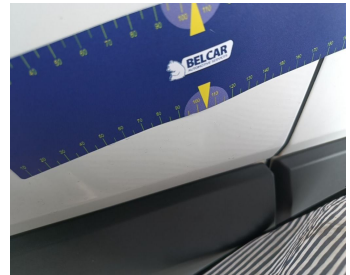
Wing Rear Left // Repair & Painting-scratch + dent

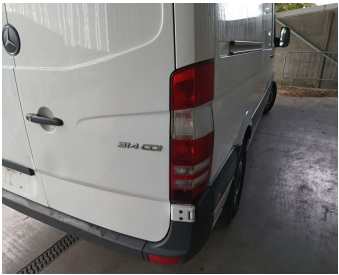
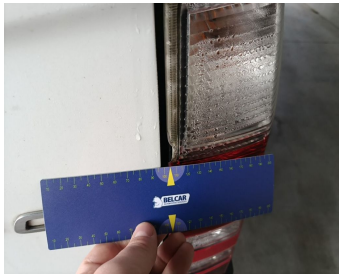
Light / Rear Right / Replace-cracked

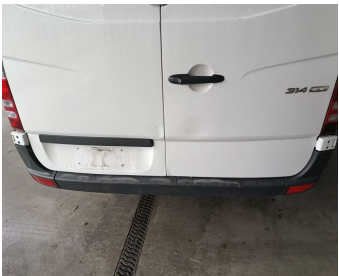
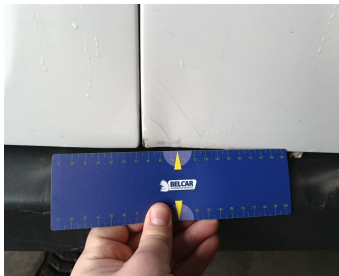
Rear Loading Door Right // Repair & Painting-cracked

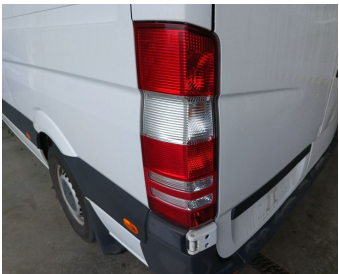
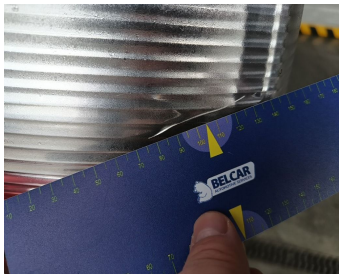
Light / Rear left / Replace-cracked

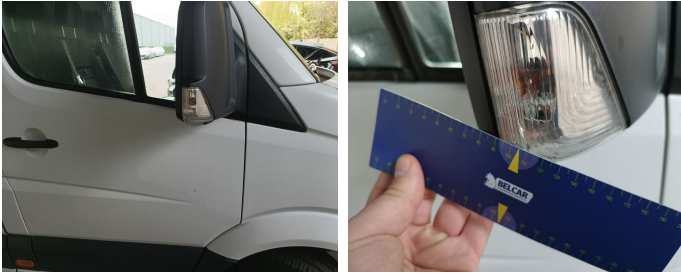
Side View Mirror Right / Direction Indicator / Replace-cracked

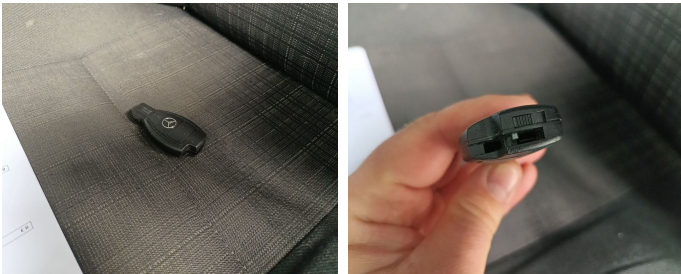
Emergency Key //-missing

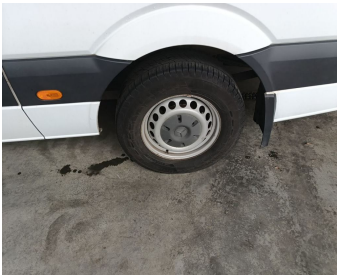
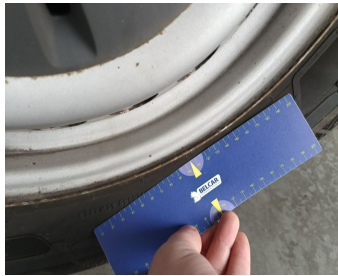
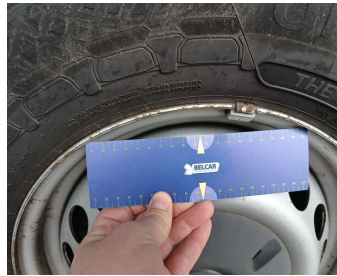
Wheel Steel Rear Left // Replace-rust

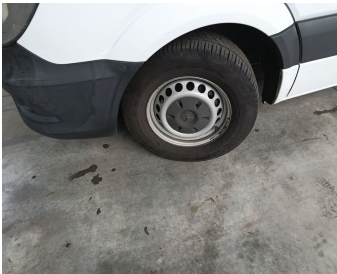
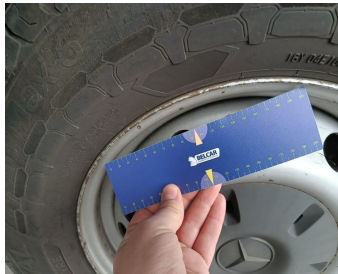
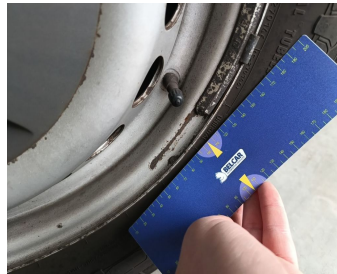
Wheel Steel Front Left // Replace-rust

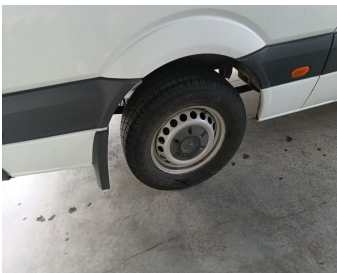
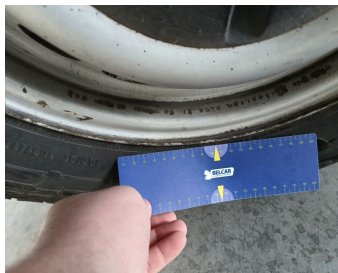
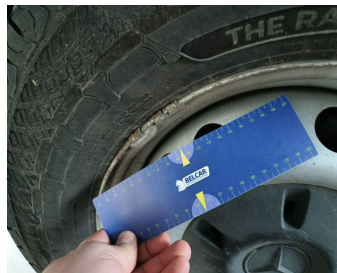
Wheel Steel Rear Right // Replace-rust

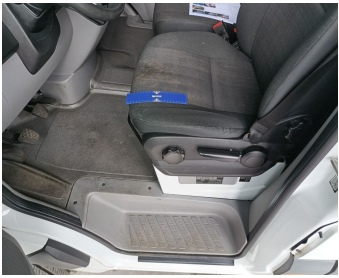
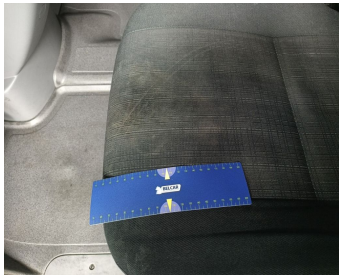
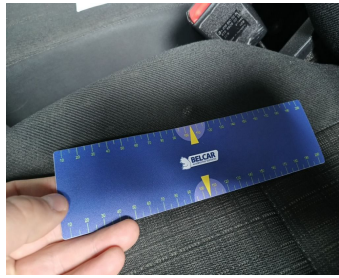
Interior Cleaning // Small-stain
